# **A Major Landslide on Greers Ferry Lake**

Arkansas Geological Commission

May 19, 2005

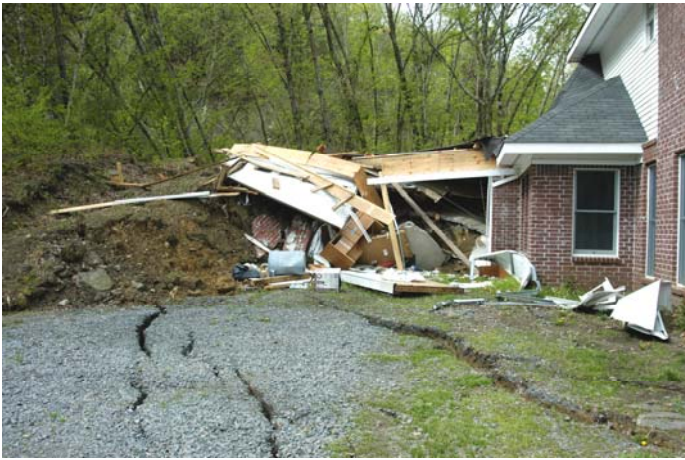
Early on the morning of March 28, 2005, after two days of rain, a significant landslide occurred on the north side of Stevens Point on the south shore of Greers Ferry Lake. The slide collided, in part, with a house owned by Shirley Bradford, crushing the garage (Figure 1) on the south side of the house and tearing a small room off the west side (Figure 2). The slide ultimately involved an area extending from a sandstone ledge over one hundred feet in elevation above the house down to and into the lake over one hundred feet in elevation below the house and extending to either side of the house.

Figure 1. Bradford garage.

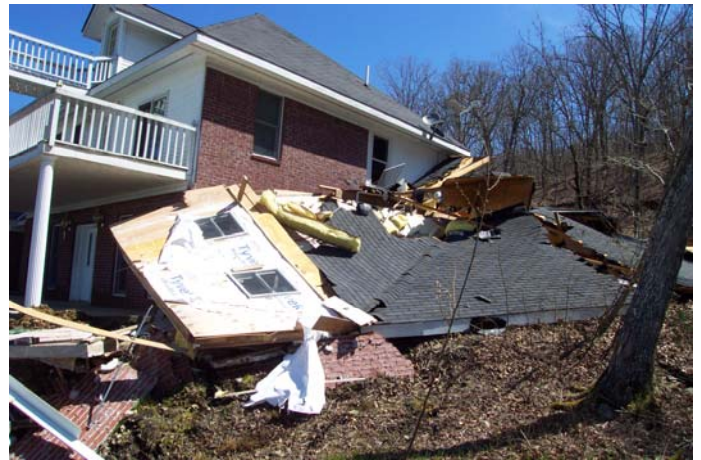
Figure 2. West side of Bradford house.

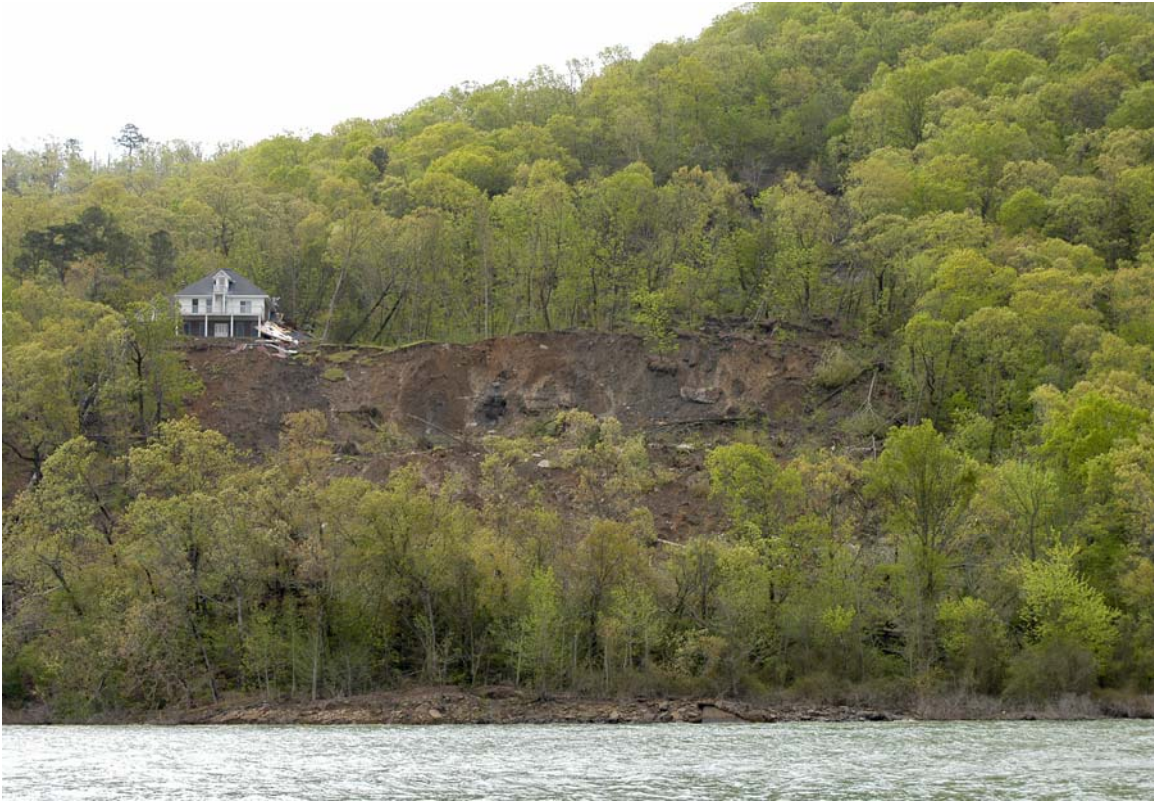
Figure 3. Slide area from Greers Ferry Lake. The upper portion of the slide is partially hidden by foliage still standing on the 600-foot contour ledge. (Photo courtesy of U.S. Army Corps of Engineers)

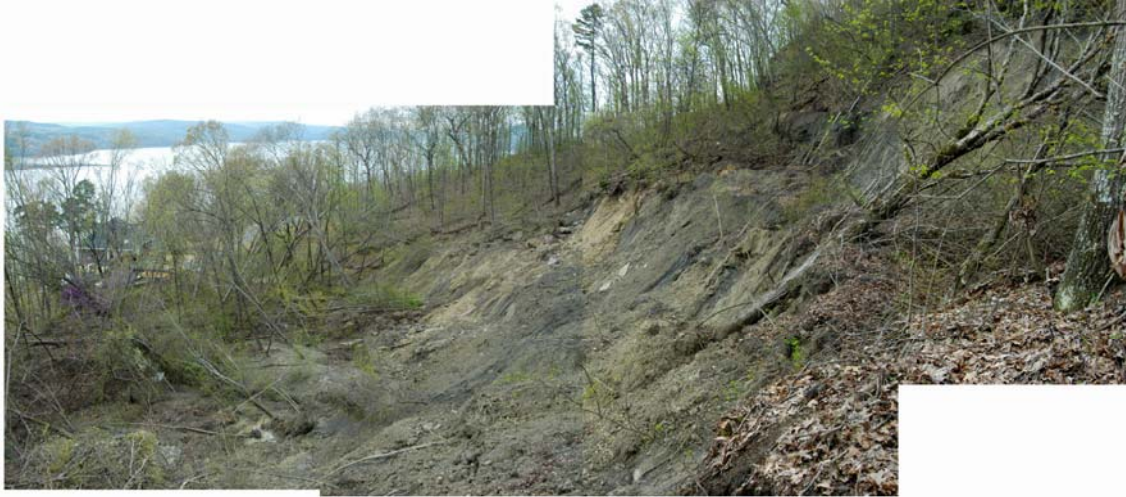
Figure 4. A view looking east north east at the upper portion of the slide area.

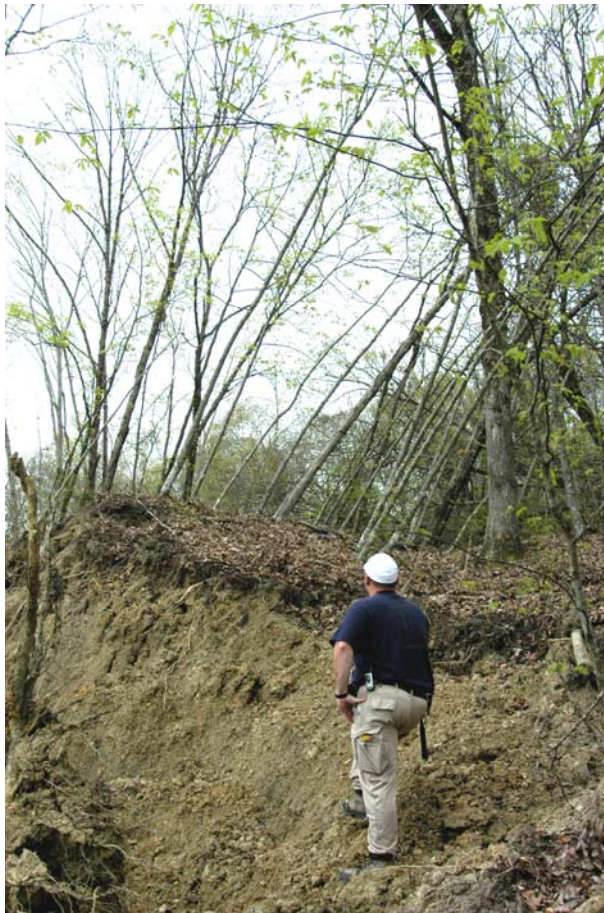
Figure 5. Rotational Slumping.

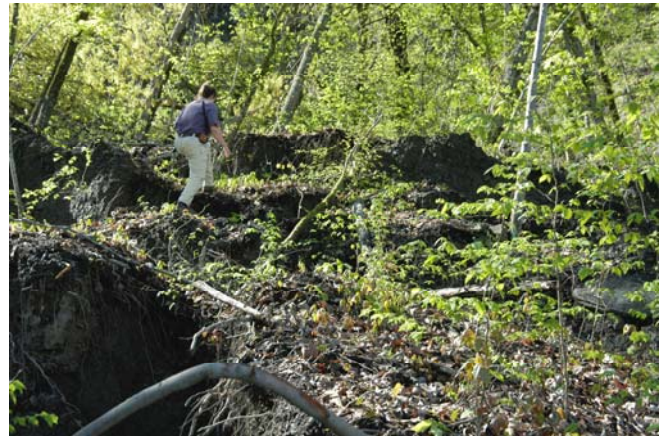
Figure 6 (above). Translational slumping.  
Figure 7 (below). Lower portion of slide area.

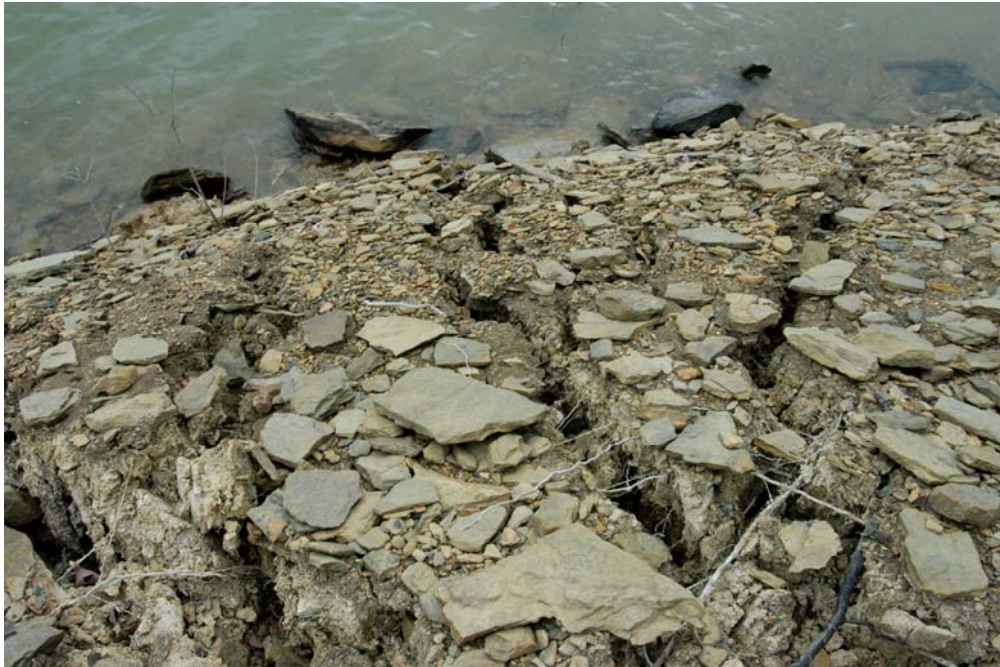
The small toe thrusts, noted in the lower reaches of each portion of the slide as lobes of debris, overran one another and stacked en echelon. These lobes were better developed on the lower portion of the slide near and in the lake. Some portions of the hillside apparently failed and were displaced somewhat intact. Groups of trees were transported laterally or slightly downslope with little disruption. Both rotational and translational slumping were noted on the west side of the 600-foot contour sandstone interval. However, most of the slide's failure seemed to be via debris flow and rafting

Figure 8. A pressure ridge extending into Greers Ferry Lake.

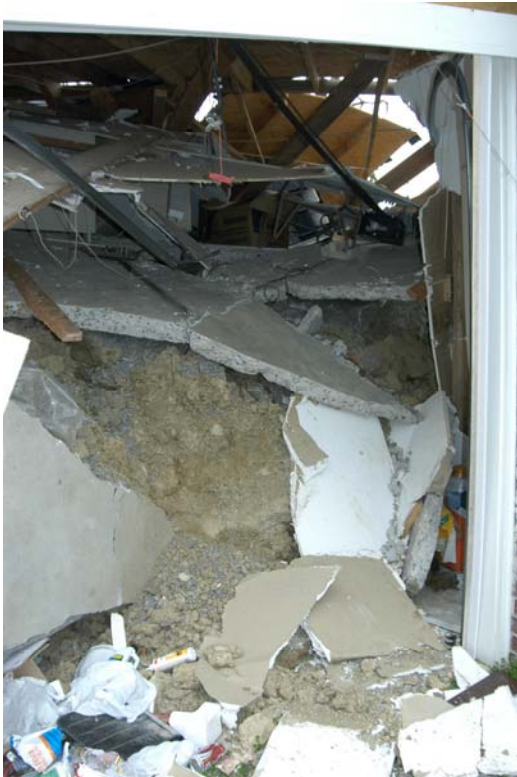
Figure 9 (left). A pressure ridge developed beneath the garage floor of the Bradford house.

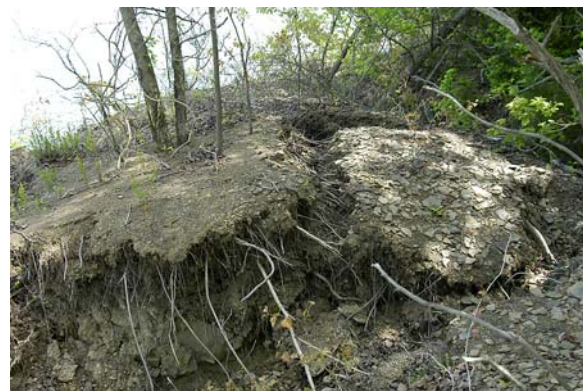
Figure 10 (above). Pressure ridge formed at lakeside.

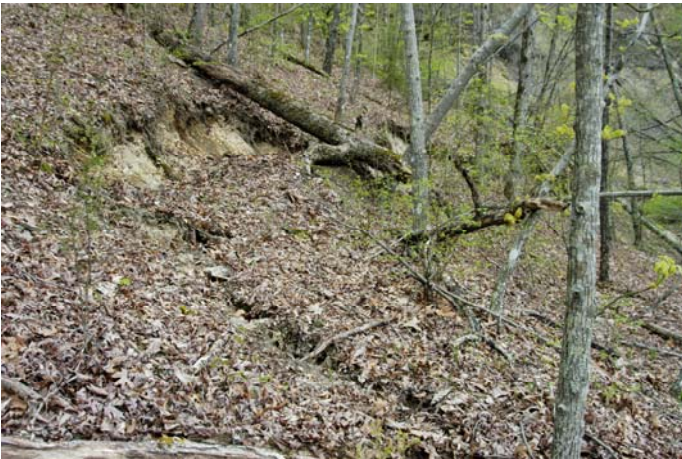
Displacements and cracked ground were noted adjacent to the main area of failure (Figures 11-13). These slide margin displacements tended to be shallow slips of just a few feet. Often their expression is presented via a low crown scarp dying out with distance from the main slide area. The toes of these marginal displacements are somewhat indeterminate due to the natural roughness of the slope and a thick forest-litter cover. These marginal slides extended up to a few tens of feet, reaching over a hundred feet in at least two cases, from the main slide track.

Figure 11. Slippage marginal to main slide.

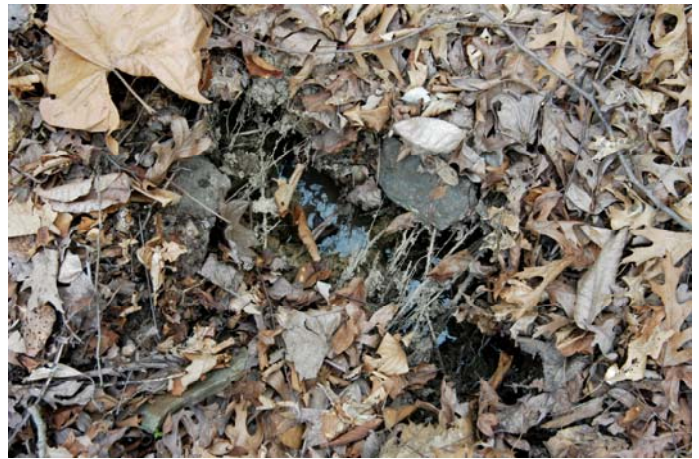
Figure 12. Incipient ground cracking due to minor slippage marginal to main slide. Note water in crack.

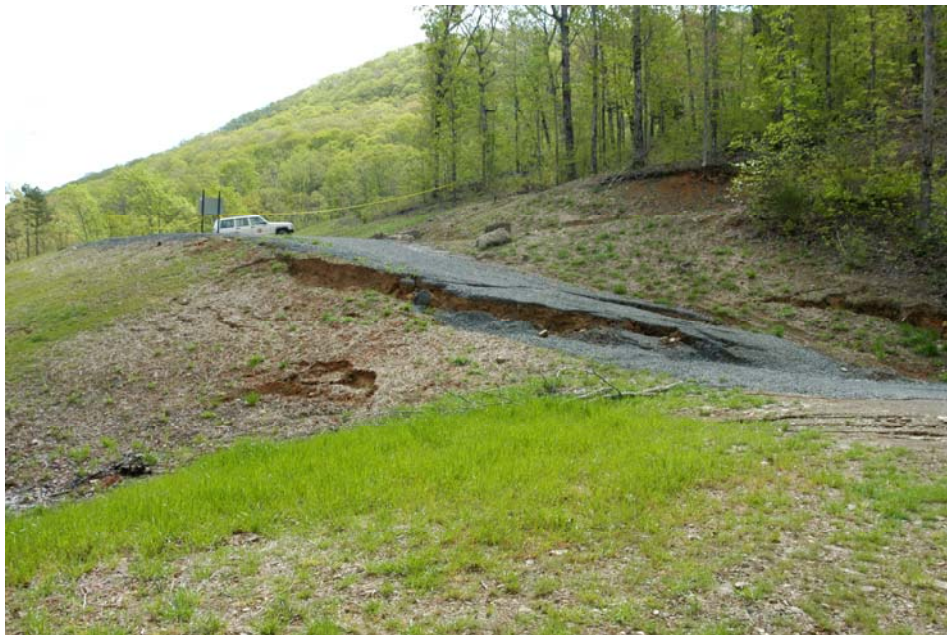
Figure 13. Ground displacement and subsidence east of the Bradford house.

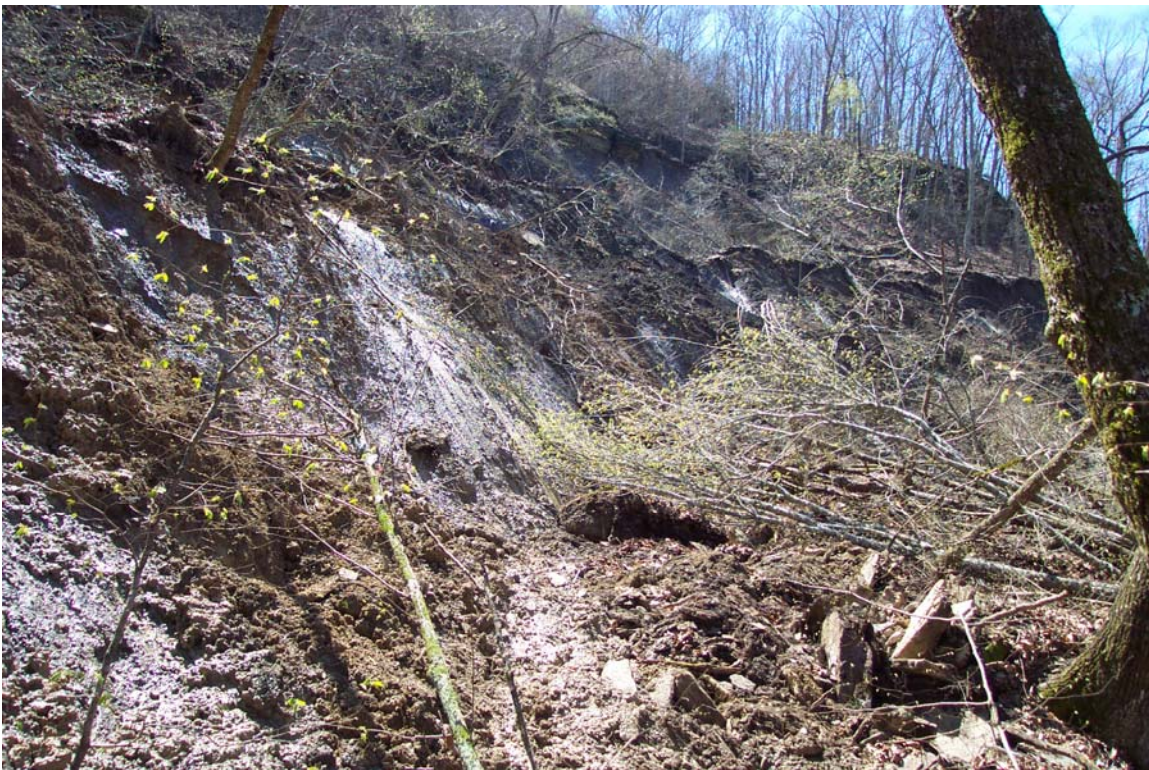
The March 28 events were preceded by two days of rain. On the day of the slide water was still running off the slope in several streams. Two of these streams formed small waterfalls over the main crown scarp (see figure 14). This water was mostly absorbed by the upper slide mass and did not result in overland flow much below the upper slide area. However, water was copiously seeping from the lower developing scarp formed by the 600-foot ledge. A week later the 600-foot contour ledge had more fully developed into a secondary crown scarp which displayed persistent flow from a joint in the sandstones several feet below the overlying surface. Observations around the slide area suggested that upslope runoff water was focused into this portion of the hillside. Open joints on the sandstone and siltstone outcroppings offered conduits for direct injection of water to the regolith/bedrock interface, promoting lubrication and instability.

Figure 14. Crown scarp March 28, 2005. Note water flowing freely over scarp surface.

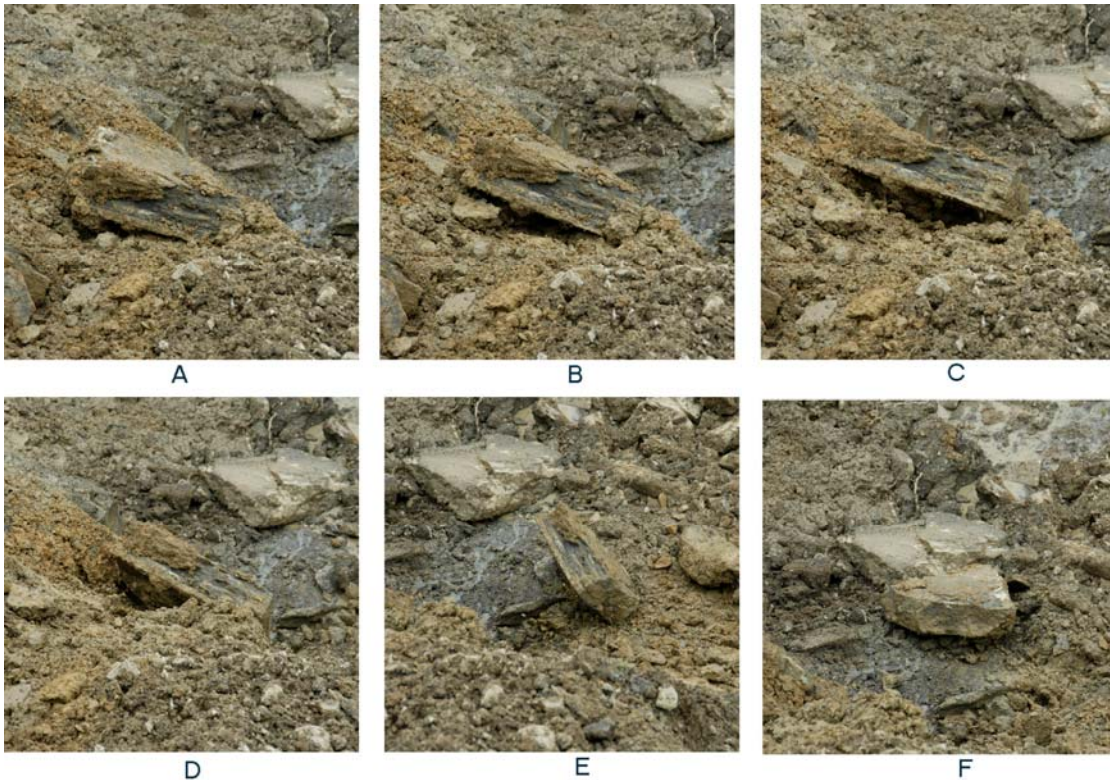
Although most of the movement on the slide occurred the morning of March 28, the slide continued to creep for several days. Trees, rocks, building debris, and soil continued to migrate to the edge of the 600-foot ledge and fall to the steeper slope below (Figure 15). The lower part of the slide (that is the part below the 600-foot contour ledge) continued to flow and creep toward the lake. Pressure ridges at the lake margin continued to inflate (Figures 8, 10). Trees that were initially only tilted fell. Experience has shown that this level of creep will continue for many months with slowing magnitude.

Figure 15. April 12, 2005. Rock fall due to continuing landslide creep

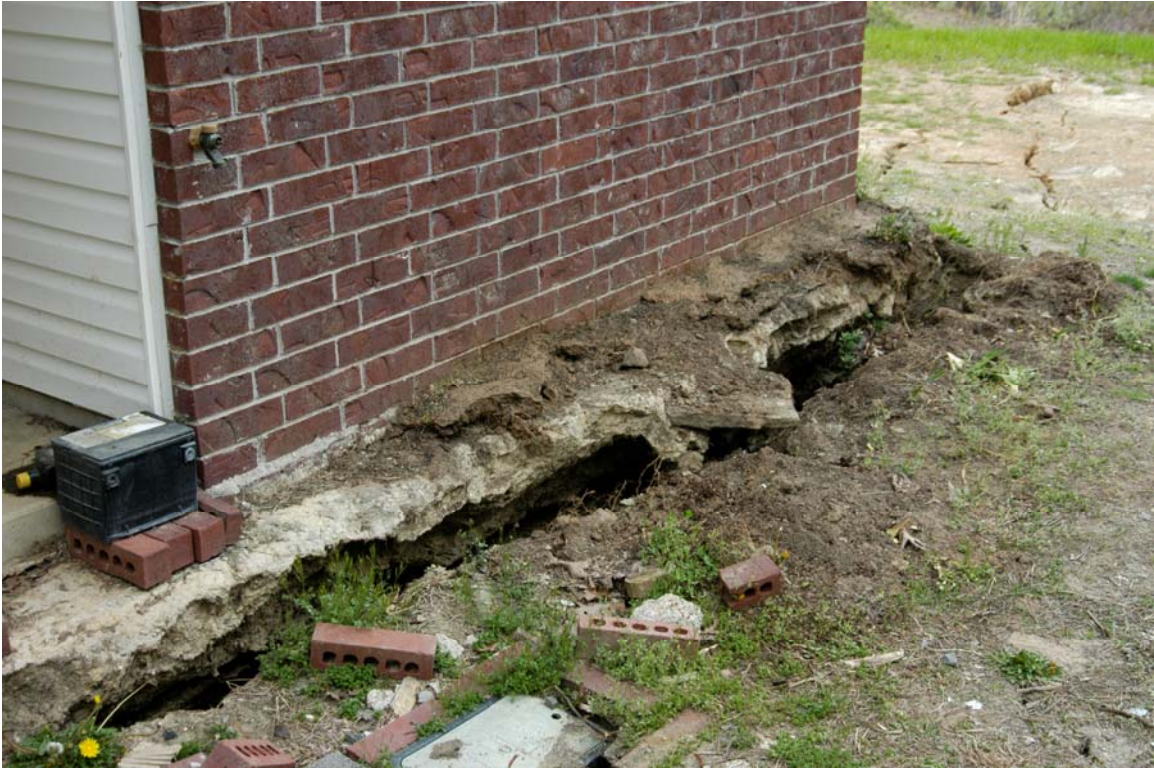
The Bradford house, except for the crushed garage and lost west wing seems to be relatively stable at the time of this report. We noted that the walls were still plumb and straight. The brick was generally undisturbed. In our initial examination of the house we noted one small old crack in the brick at the top corner of one window on the front of the house unrelated to the present activity. A visit to the site a month after the initial slide revealed a small fresh crack in the brick at the base of the front wall of the house. The ground surface to the south and east of the house has subsided several inches to a few feet leaving the footing exposed (Figure 18). This subsidence has compromised the underground utilities leading to and from the house. The house itself seems to be foundationed on or shortly above the 600-foot contour sandstone beds providing an island of stability. Whether this condition will persist, only time will tell. At the time of this report we have not yet had a period of protracted rainfall to test the stability of these features.

Figure 18. Surface subsidence on the east side of the Bradford house revealing its foundation.

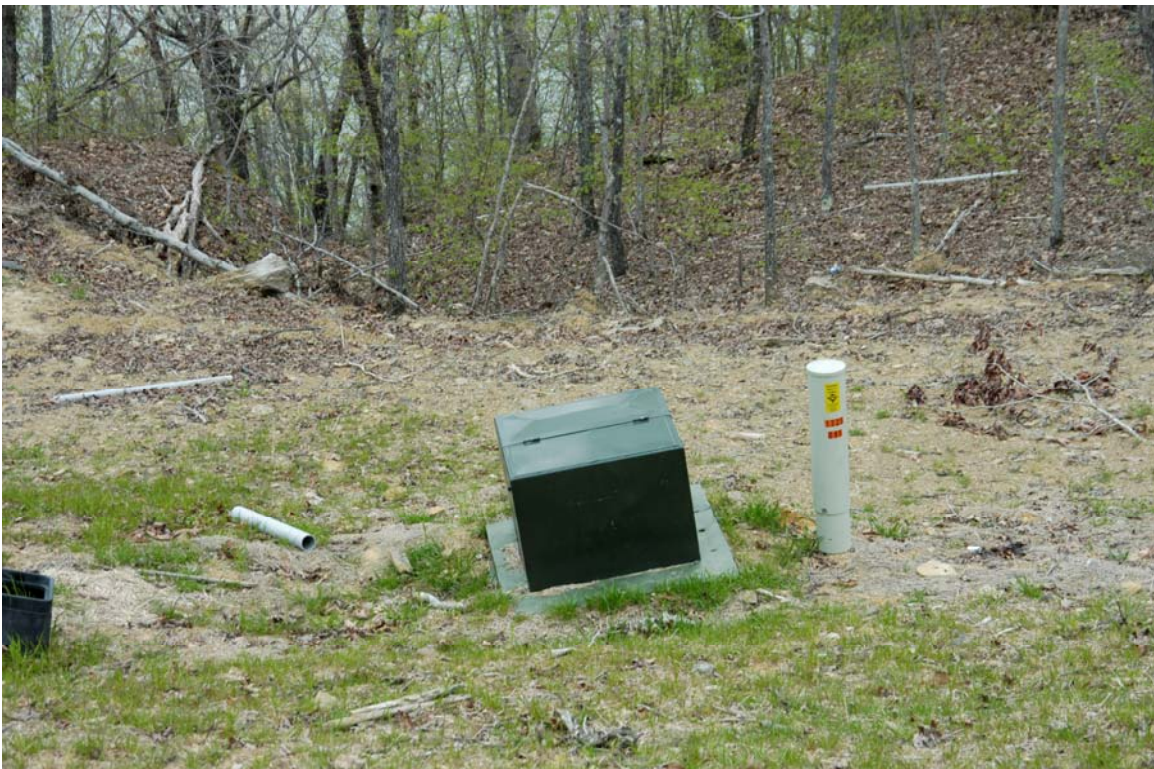
Figure 19. Phone and power boxes displaying effects of subsidence and displacement marginal to main slide area.

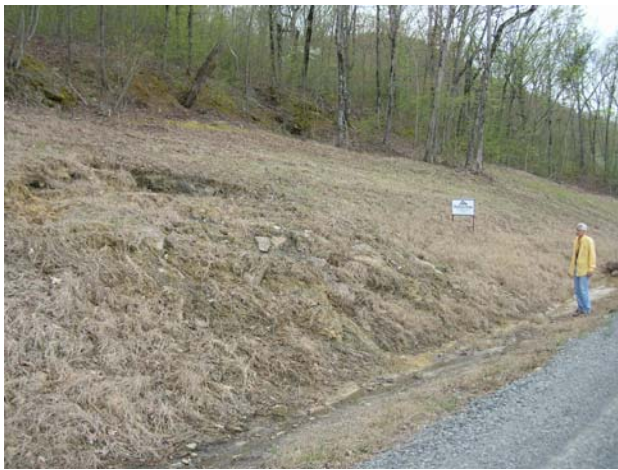
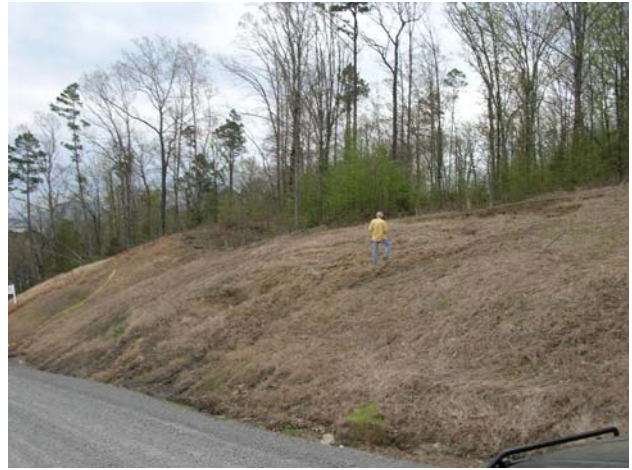
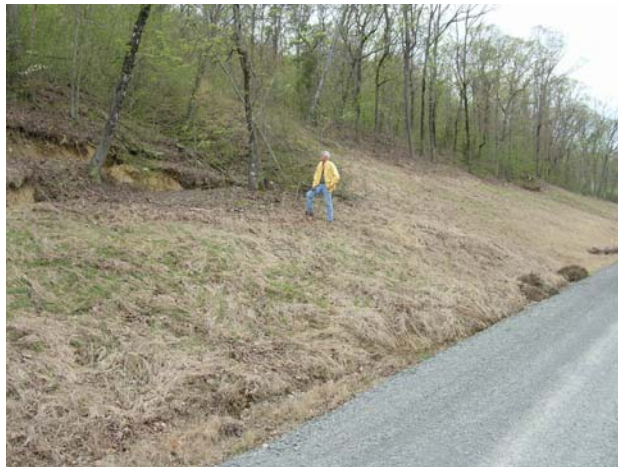
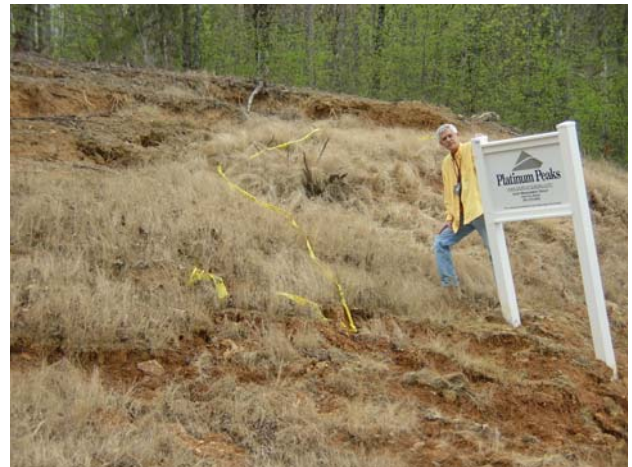
We noted 11 smaller landslides along the road leading to the Bradford house. We have no doubt that these slides were the direct result of the recent road building activity and the associated clearing of the forest to either side of the roadway. These slumps ranged from about 25 feet to 250 feet wide and about 20 feet to 100 feet toe to crown scarp (Figure 20). All of these unintendedly induced slumps were on the uphill side of the road. However, we did note that some cultural features normally expected to be level and or plumb deviated from the expectation downslope of the road suggesting wide spread slope instability (Figure 19). This hillside averages slightly less slope than the Bradford property, about 15 to 20 degrees. This area is under development at the present time. It is highly probable that additional modification or construction efforts on this hillside will induce more slope failure that will need to be addressed in non-traditional and creative constructional methodologies to be successful.

Figure 20. Small landslides on Platinum Peaks development along road leading to Bradford house.
