# Jones Landslide, Pottsville, Arkansas – 2 ½ years of Monitoring

By  
J. Michael Howard

# Background

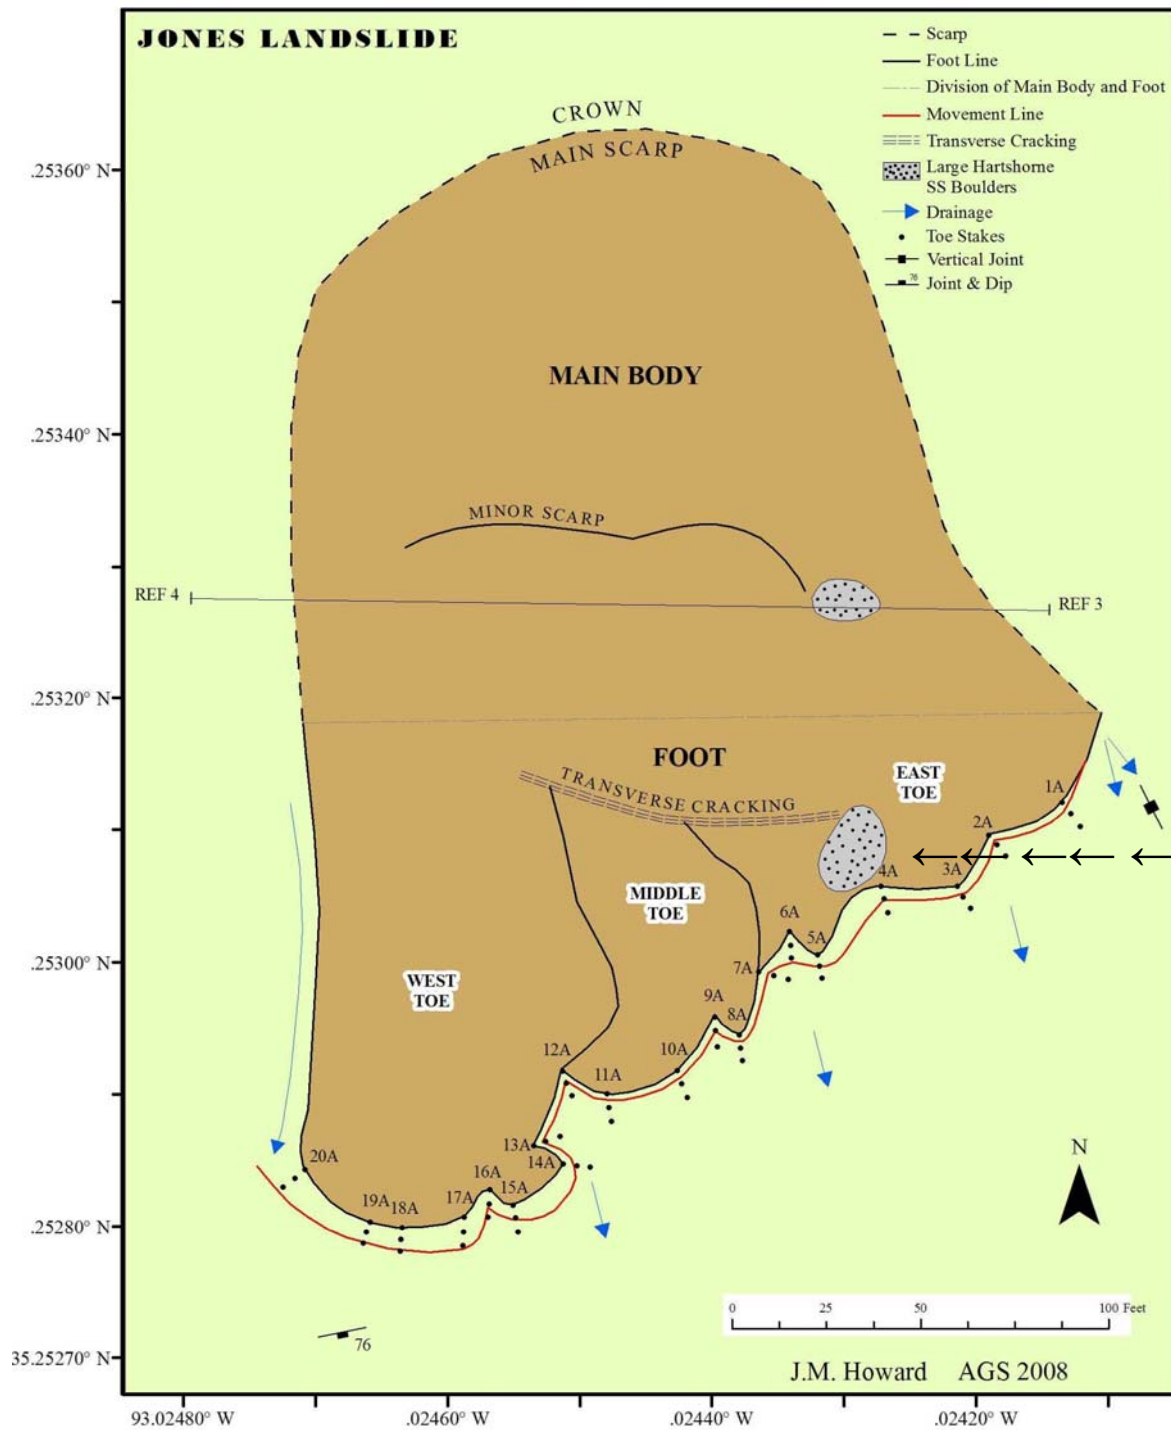
## Map displaying major features of Jones Landslide

Crown

← Main scarp

Reclaimed area  
that remains  
stable

3 toed foot

Bottom of abandoned  
shale pit

Note large boulder in colluvium

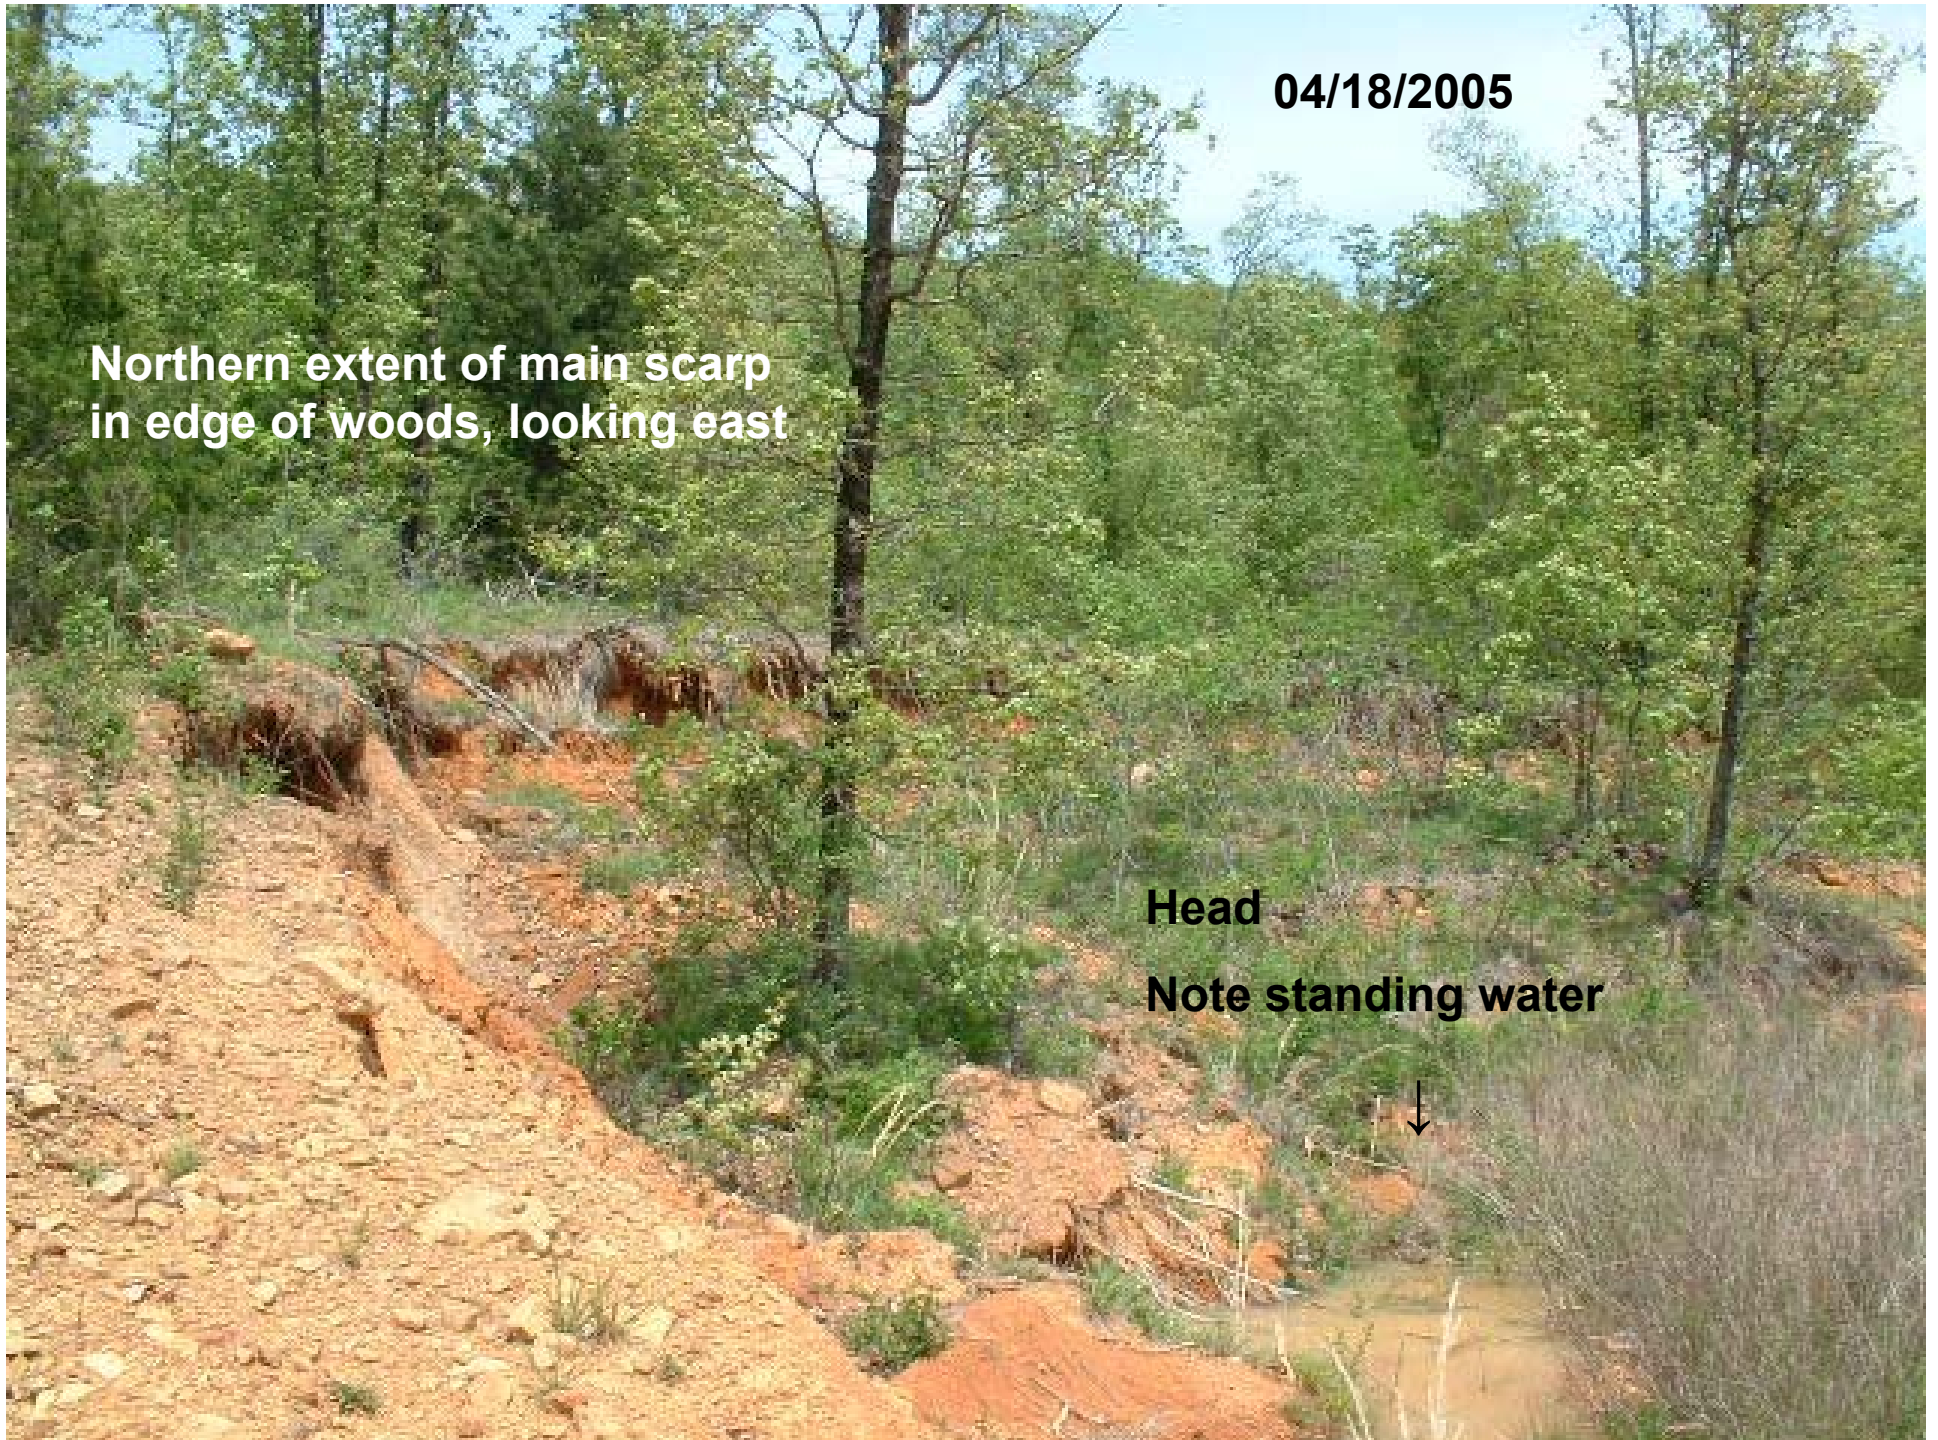
**Northern extent of main scarp  
in edge of woods, looking east**

**Note standing water**

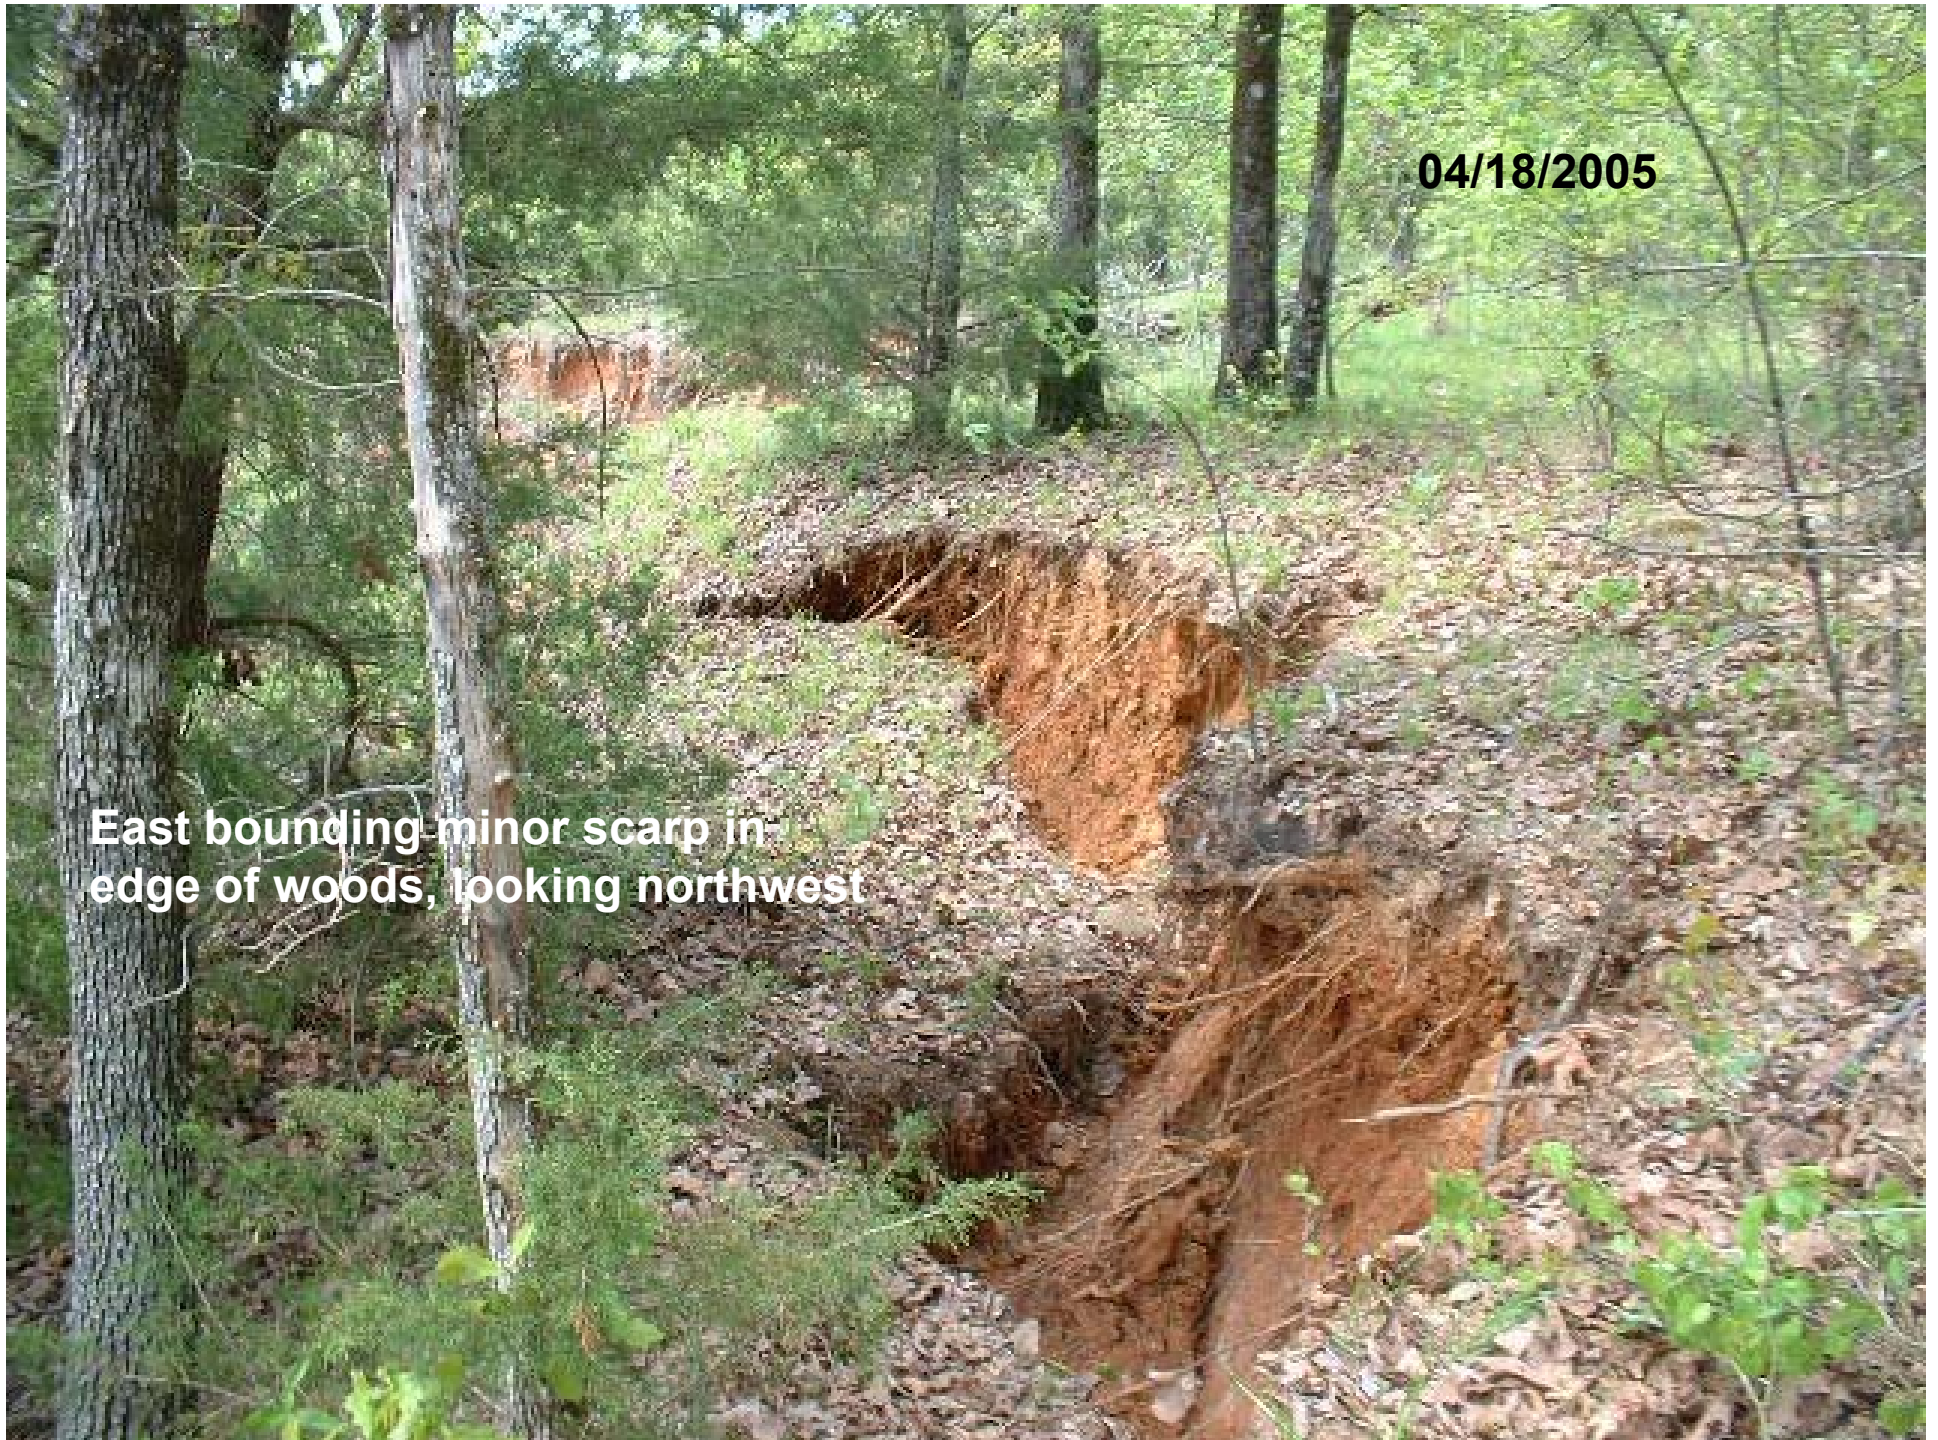
East bounding minor scarp in  
edge of woods, looking northwest

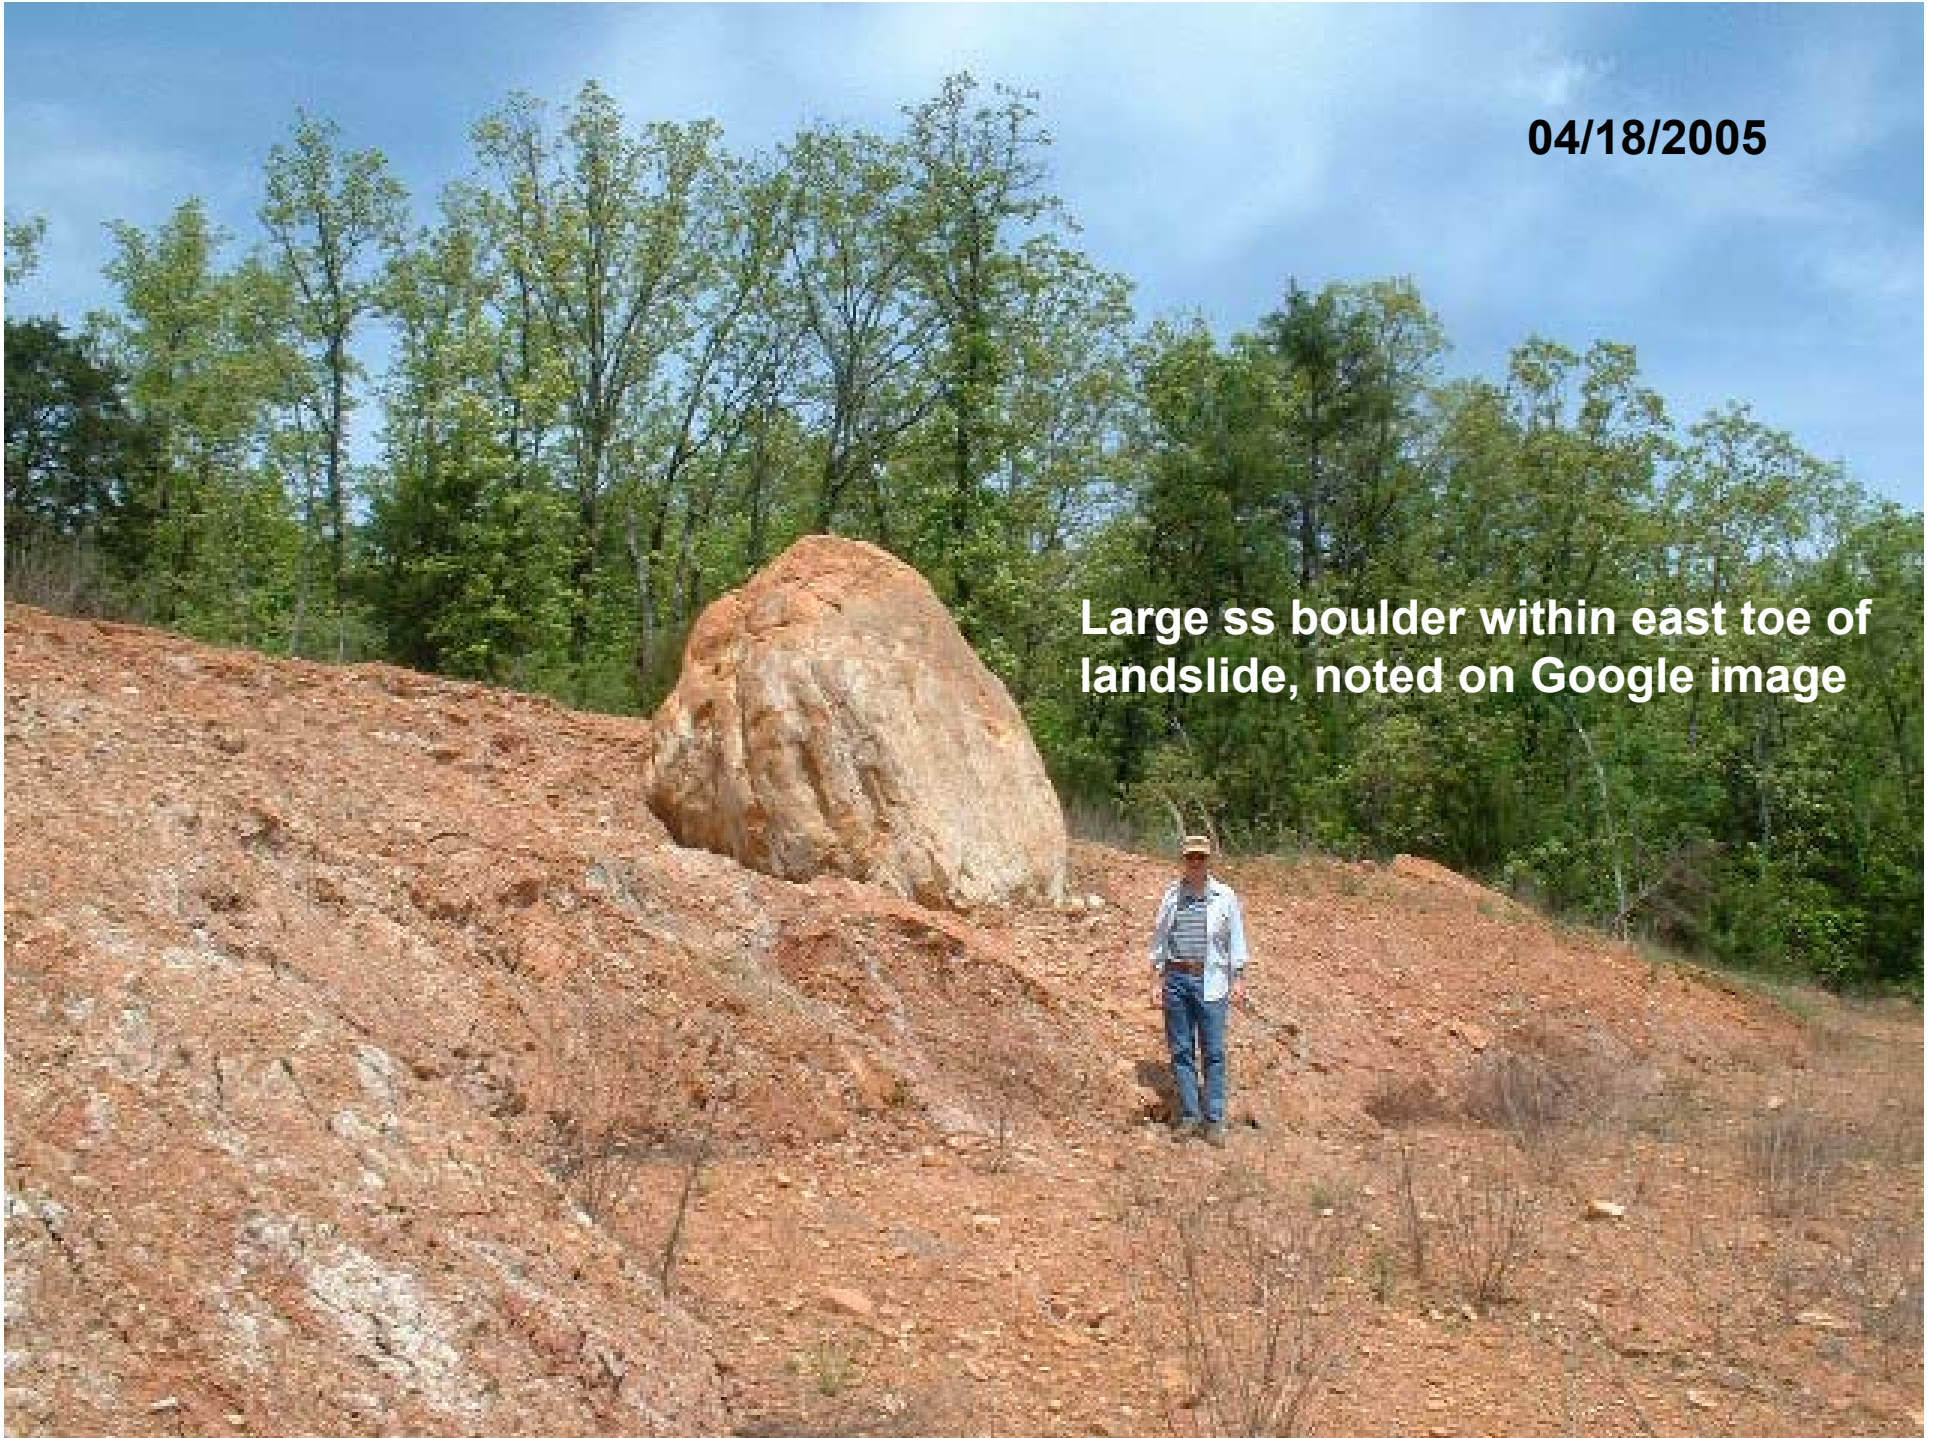
**Large ss boulder within east toe of landslide, noted on Google image**

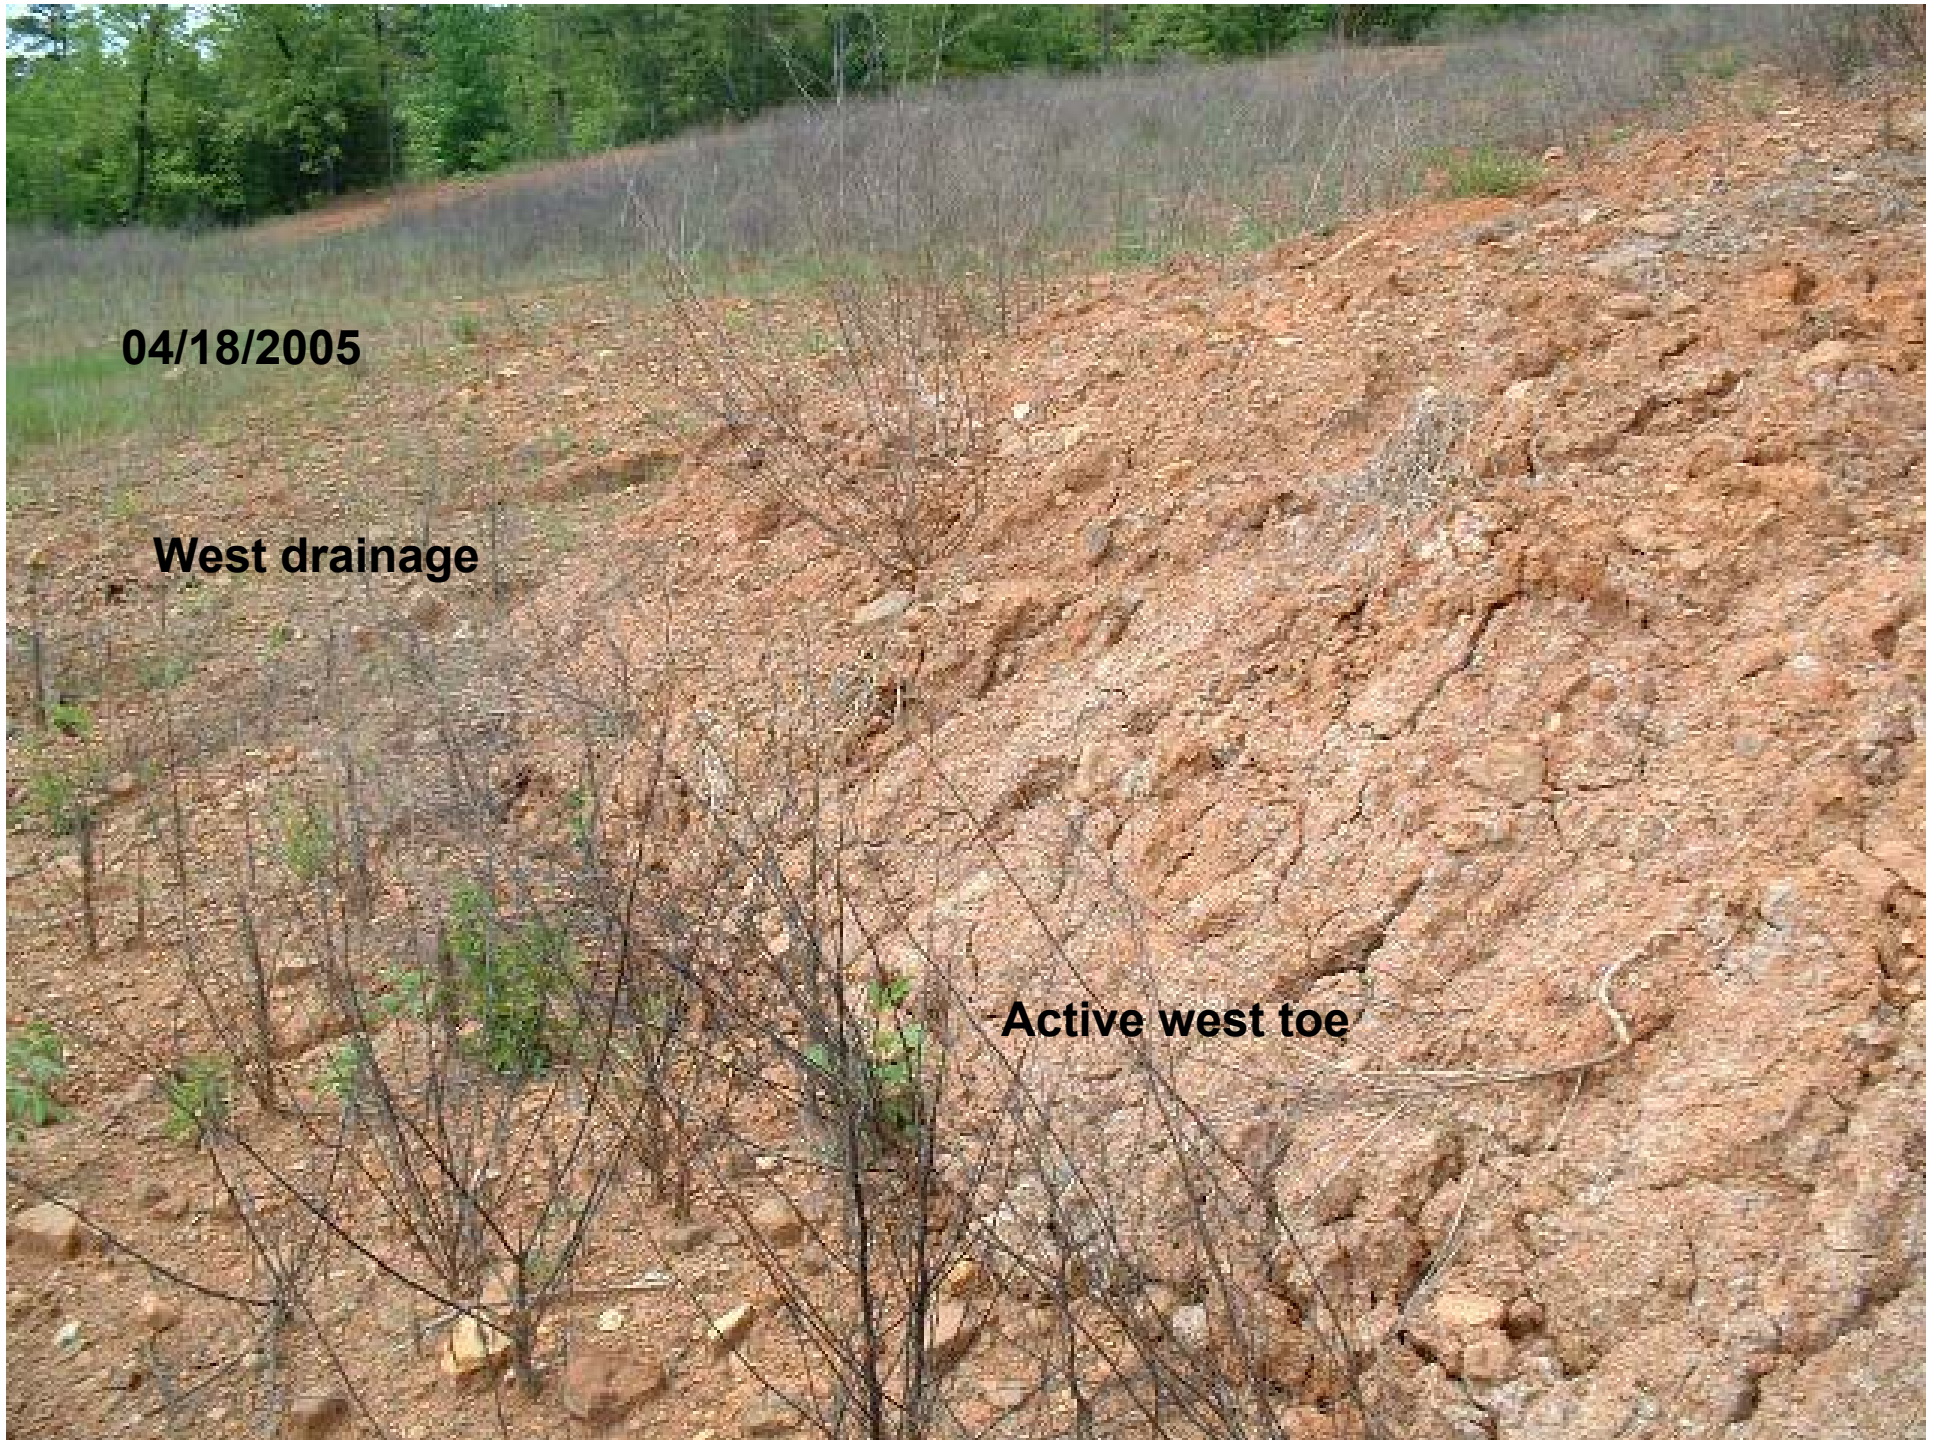
**West drainage**

**Active west toe**

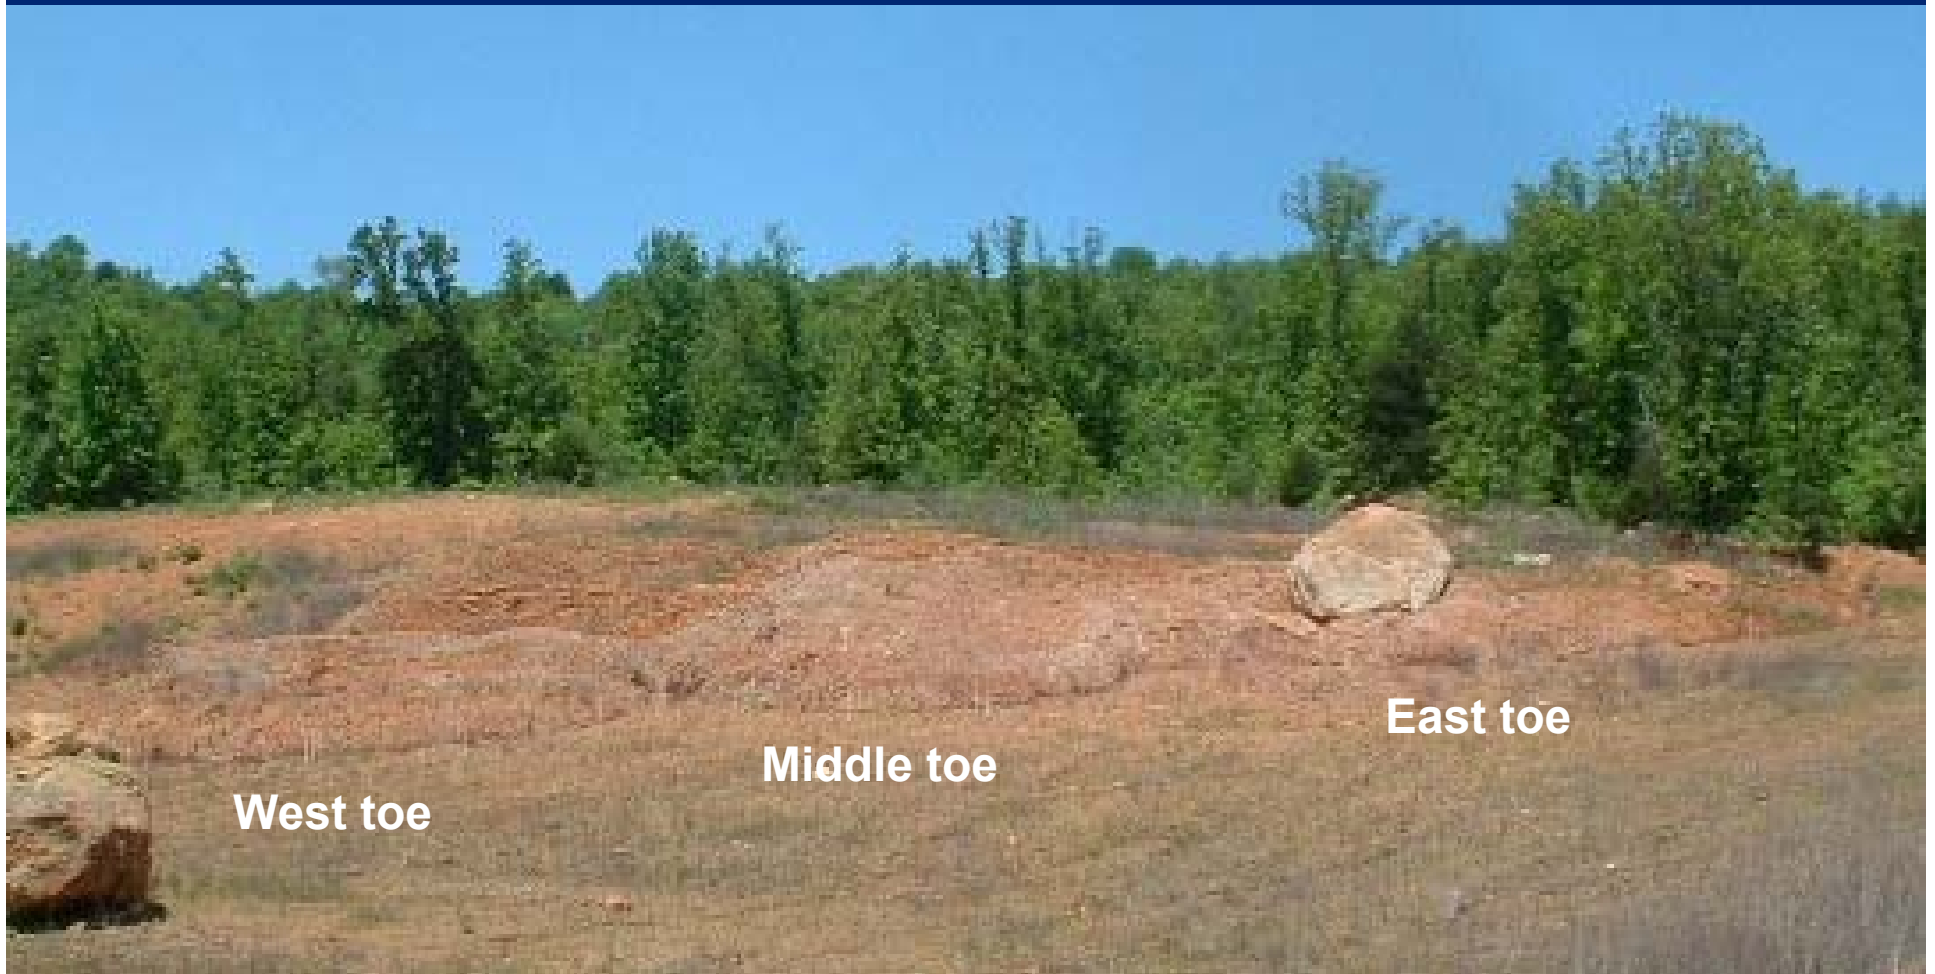
# View ~ normal to landslide toe showing 3 distinct toes

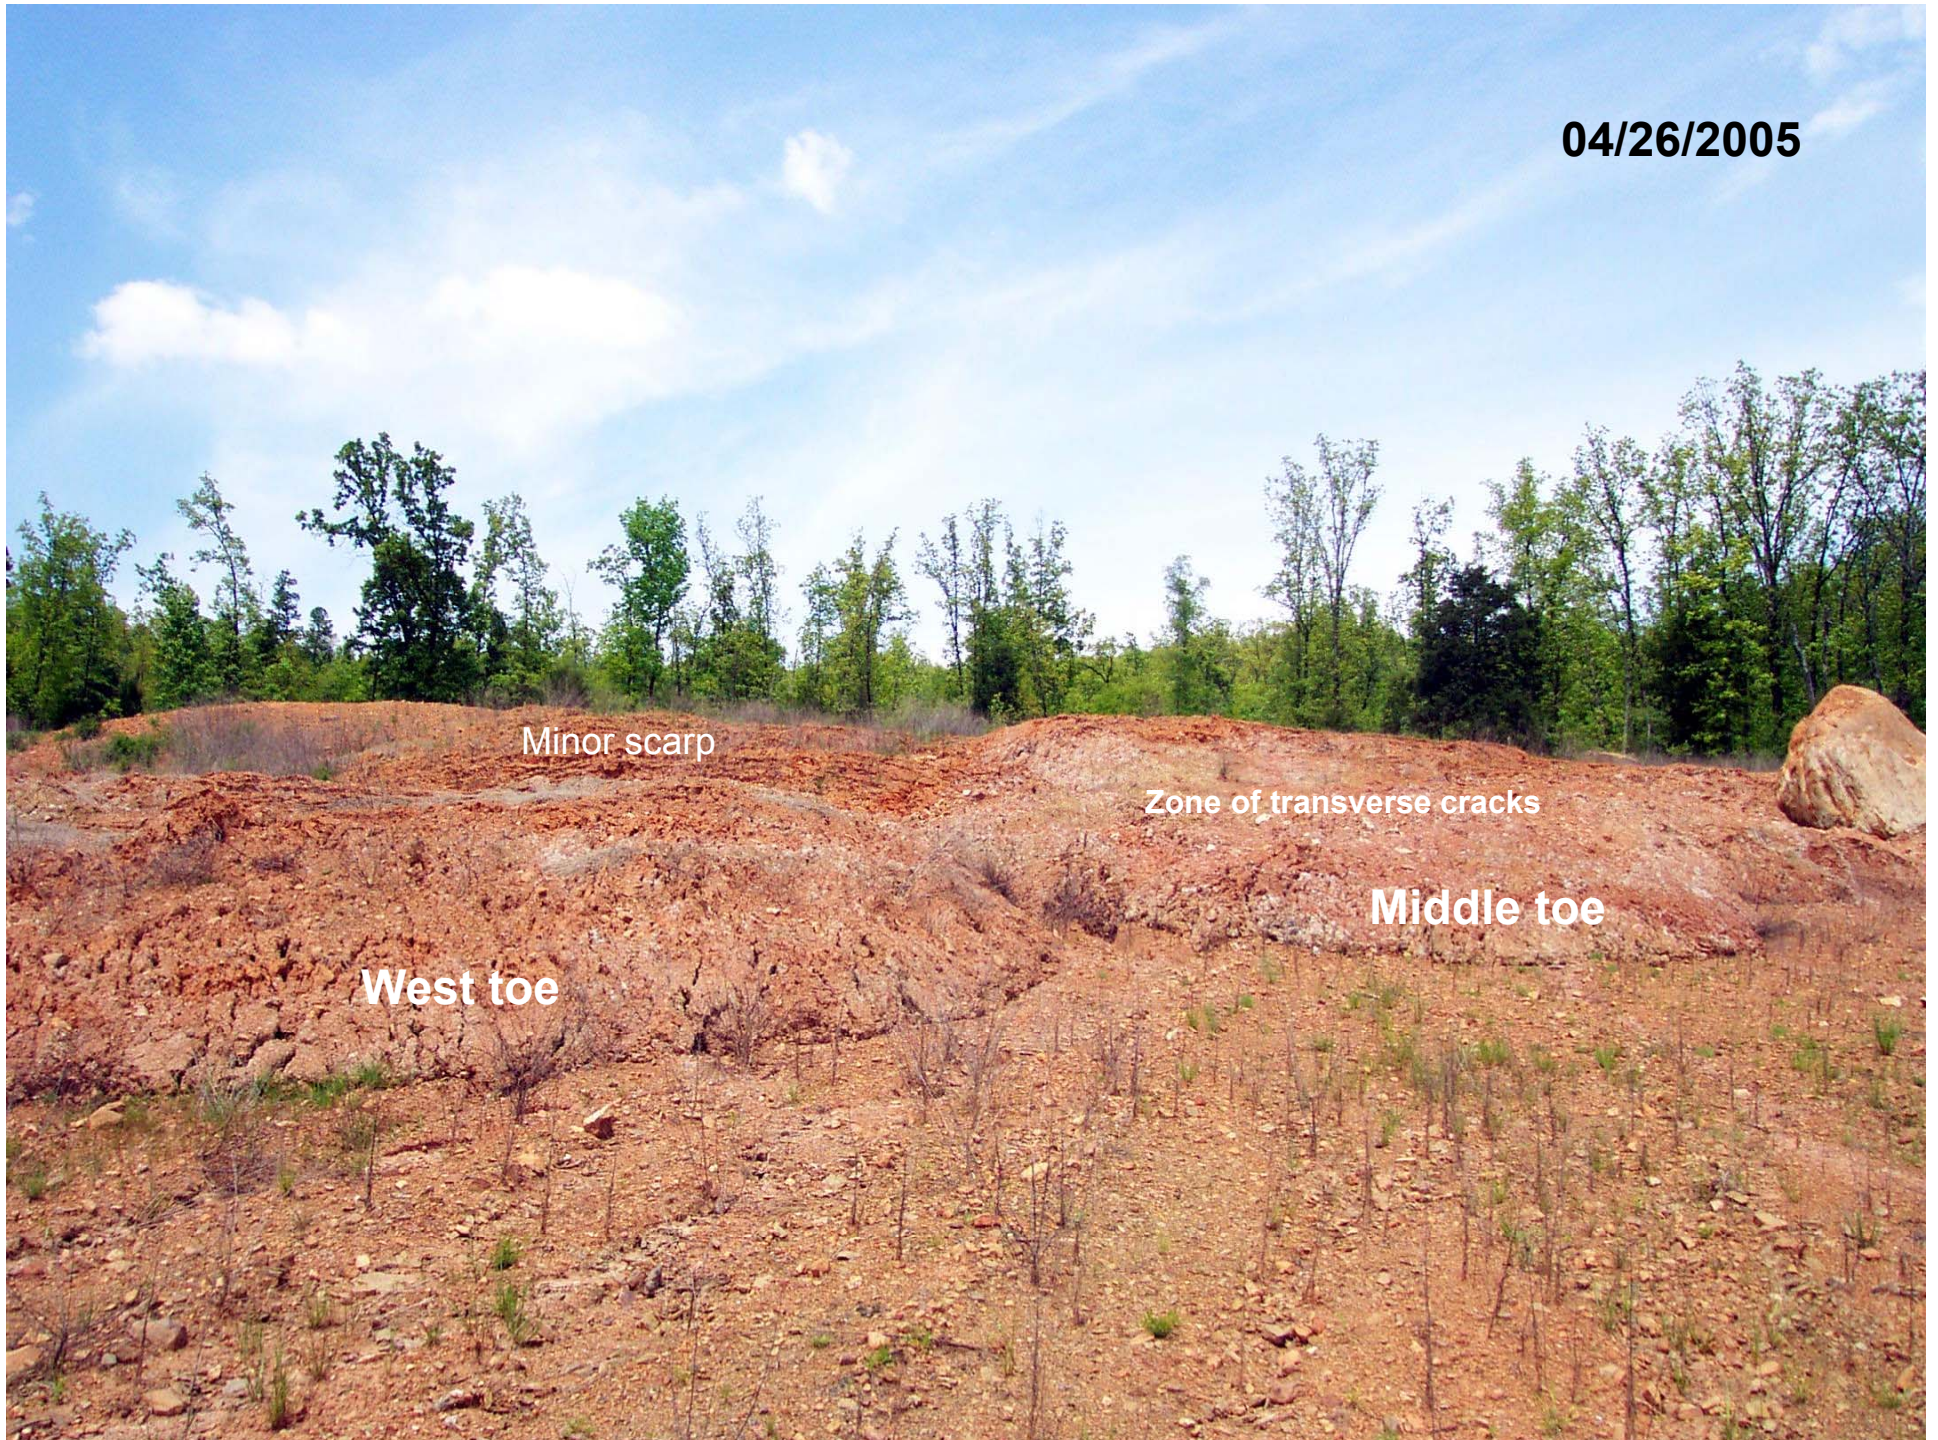
Minor scarp

Zone of transverse cracks

Middle toe

West toe

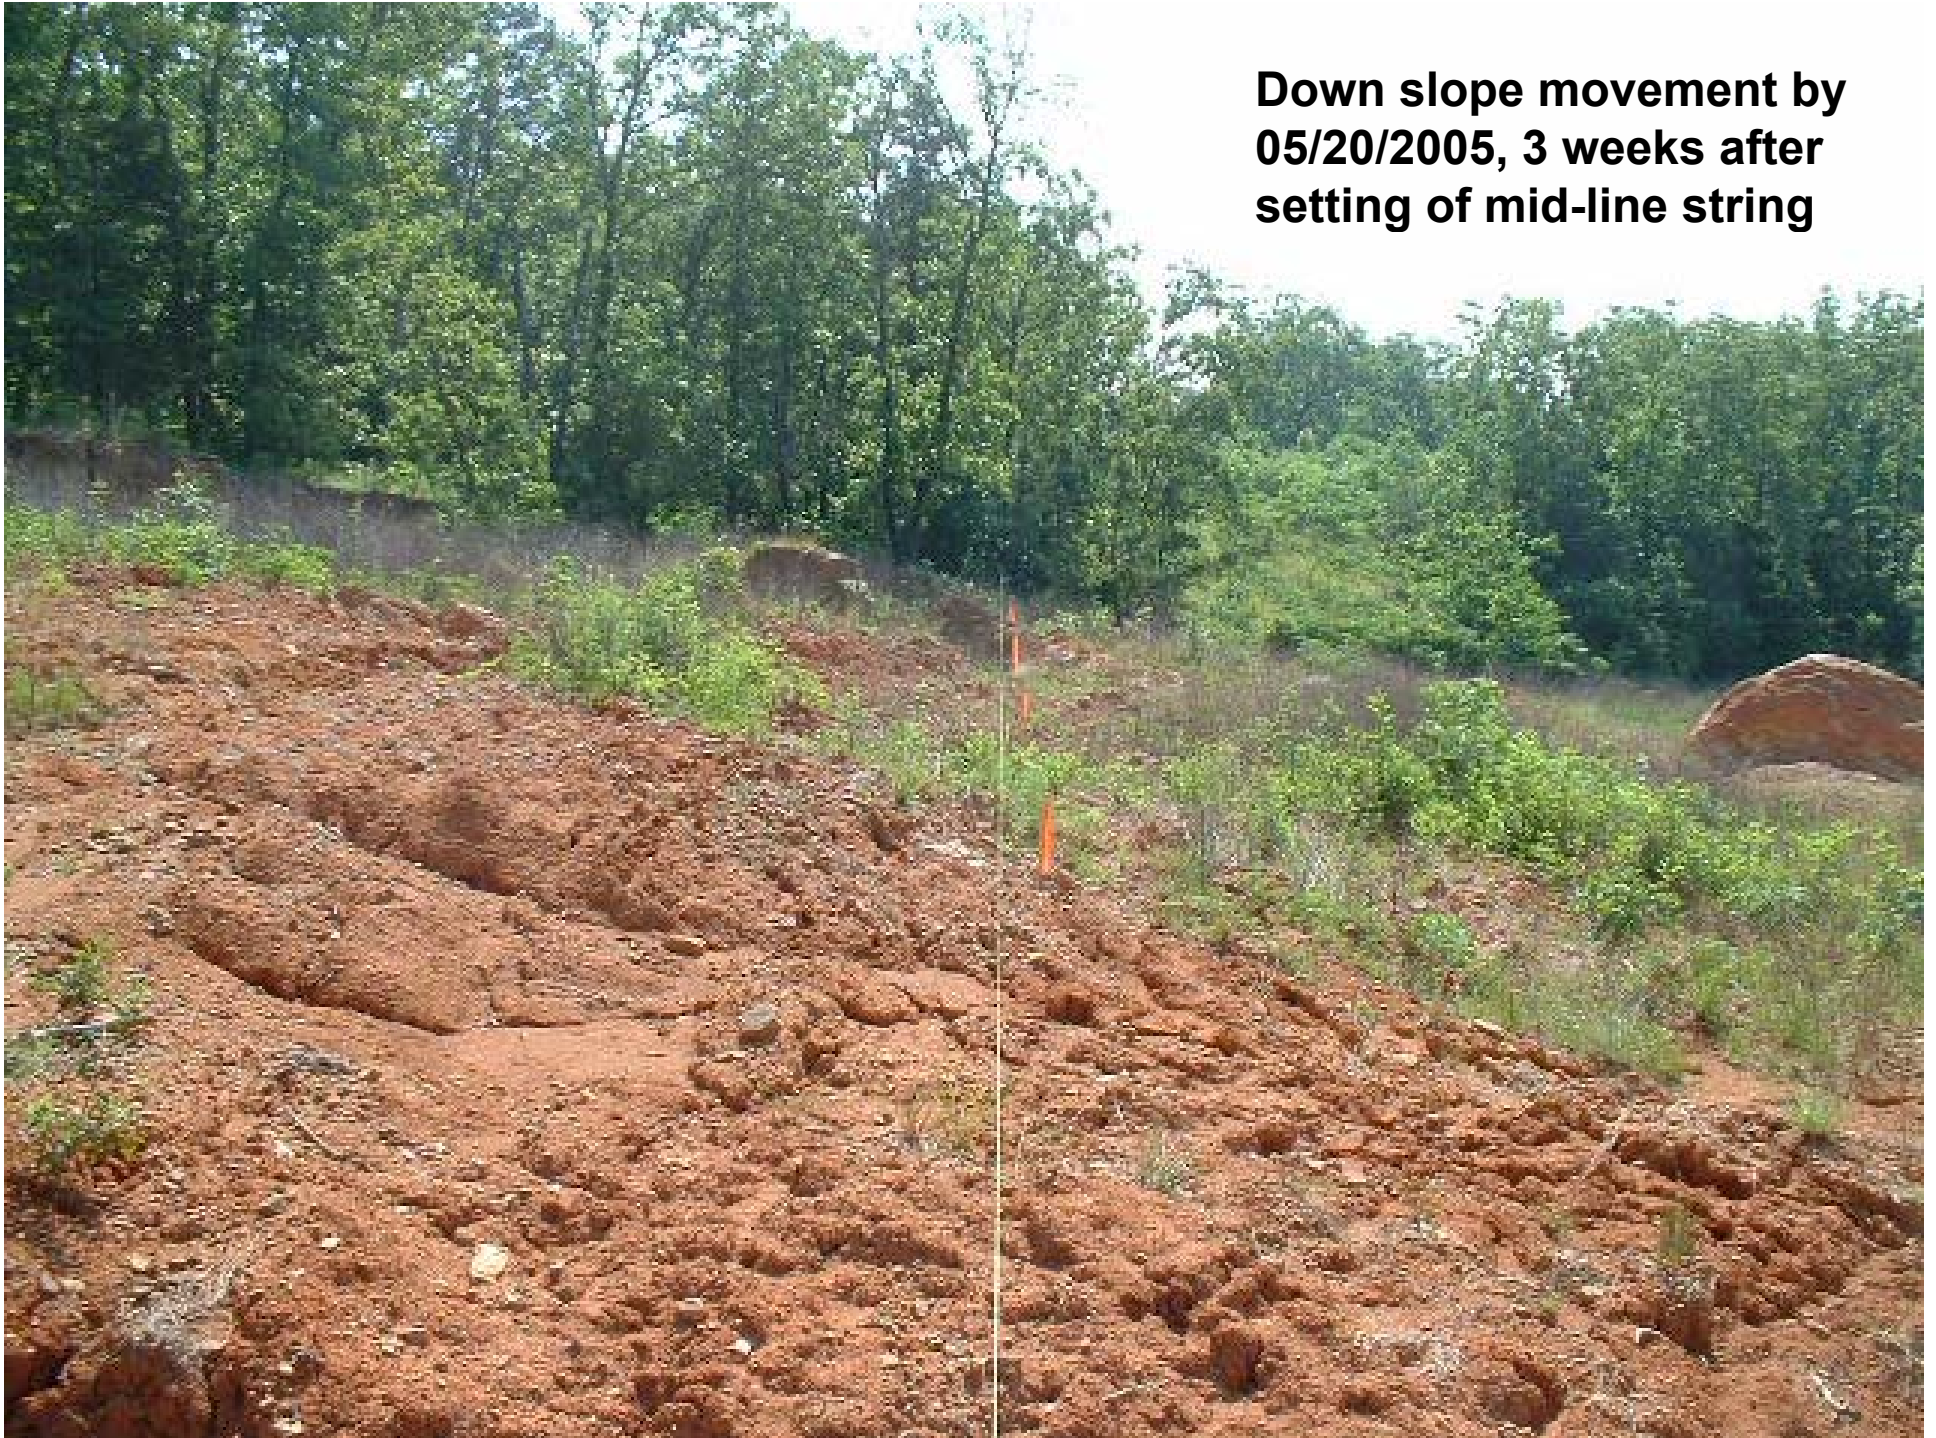
**Setting mid-line stakes  
04/26/2005**

**Stakes painted fluorescent orange**

**West edge drainage developed just east of minor western scarp**

**Stable reclaimed area west of slide**

**Down slope movement by  
05/20/2005, 3 weeks after  
setting of mid-line string**

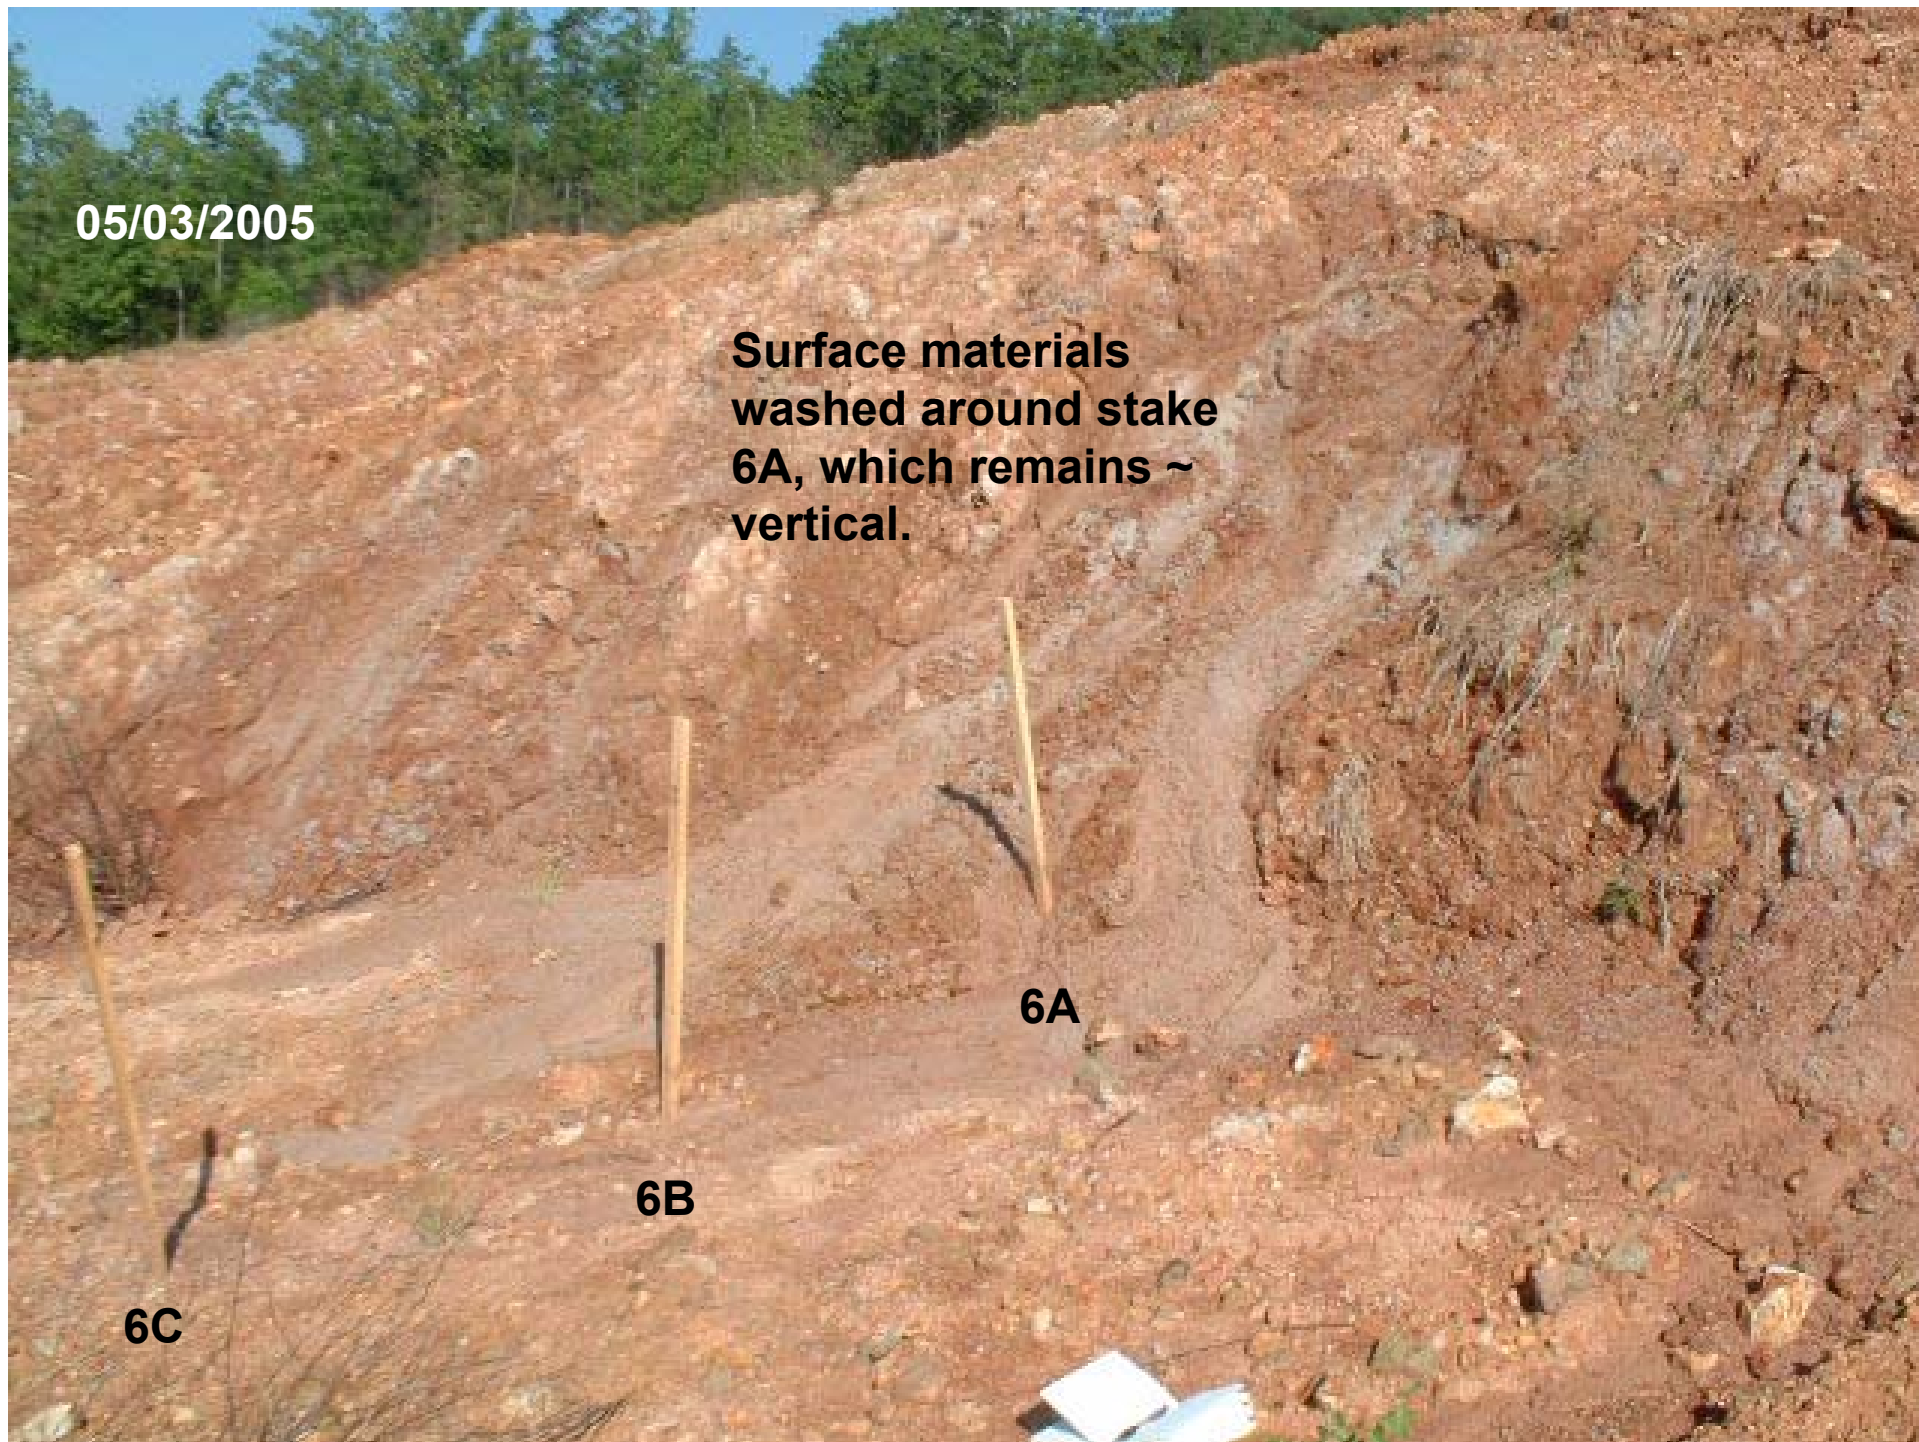
**Surface materials  
washed around stake  
6A, which remains ~  
vertical.**
