# Jones Landslide, Pottsville, Arkansas – 2 ½ years of Monitoring

By  
J. Michael Howard

# Background

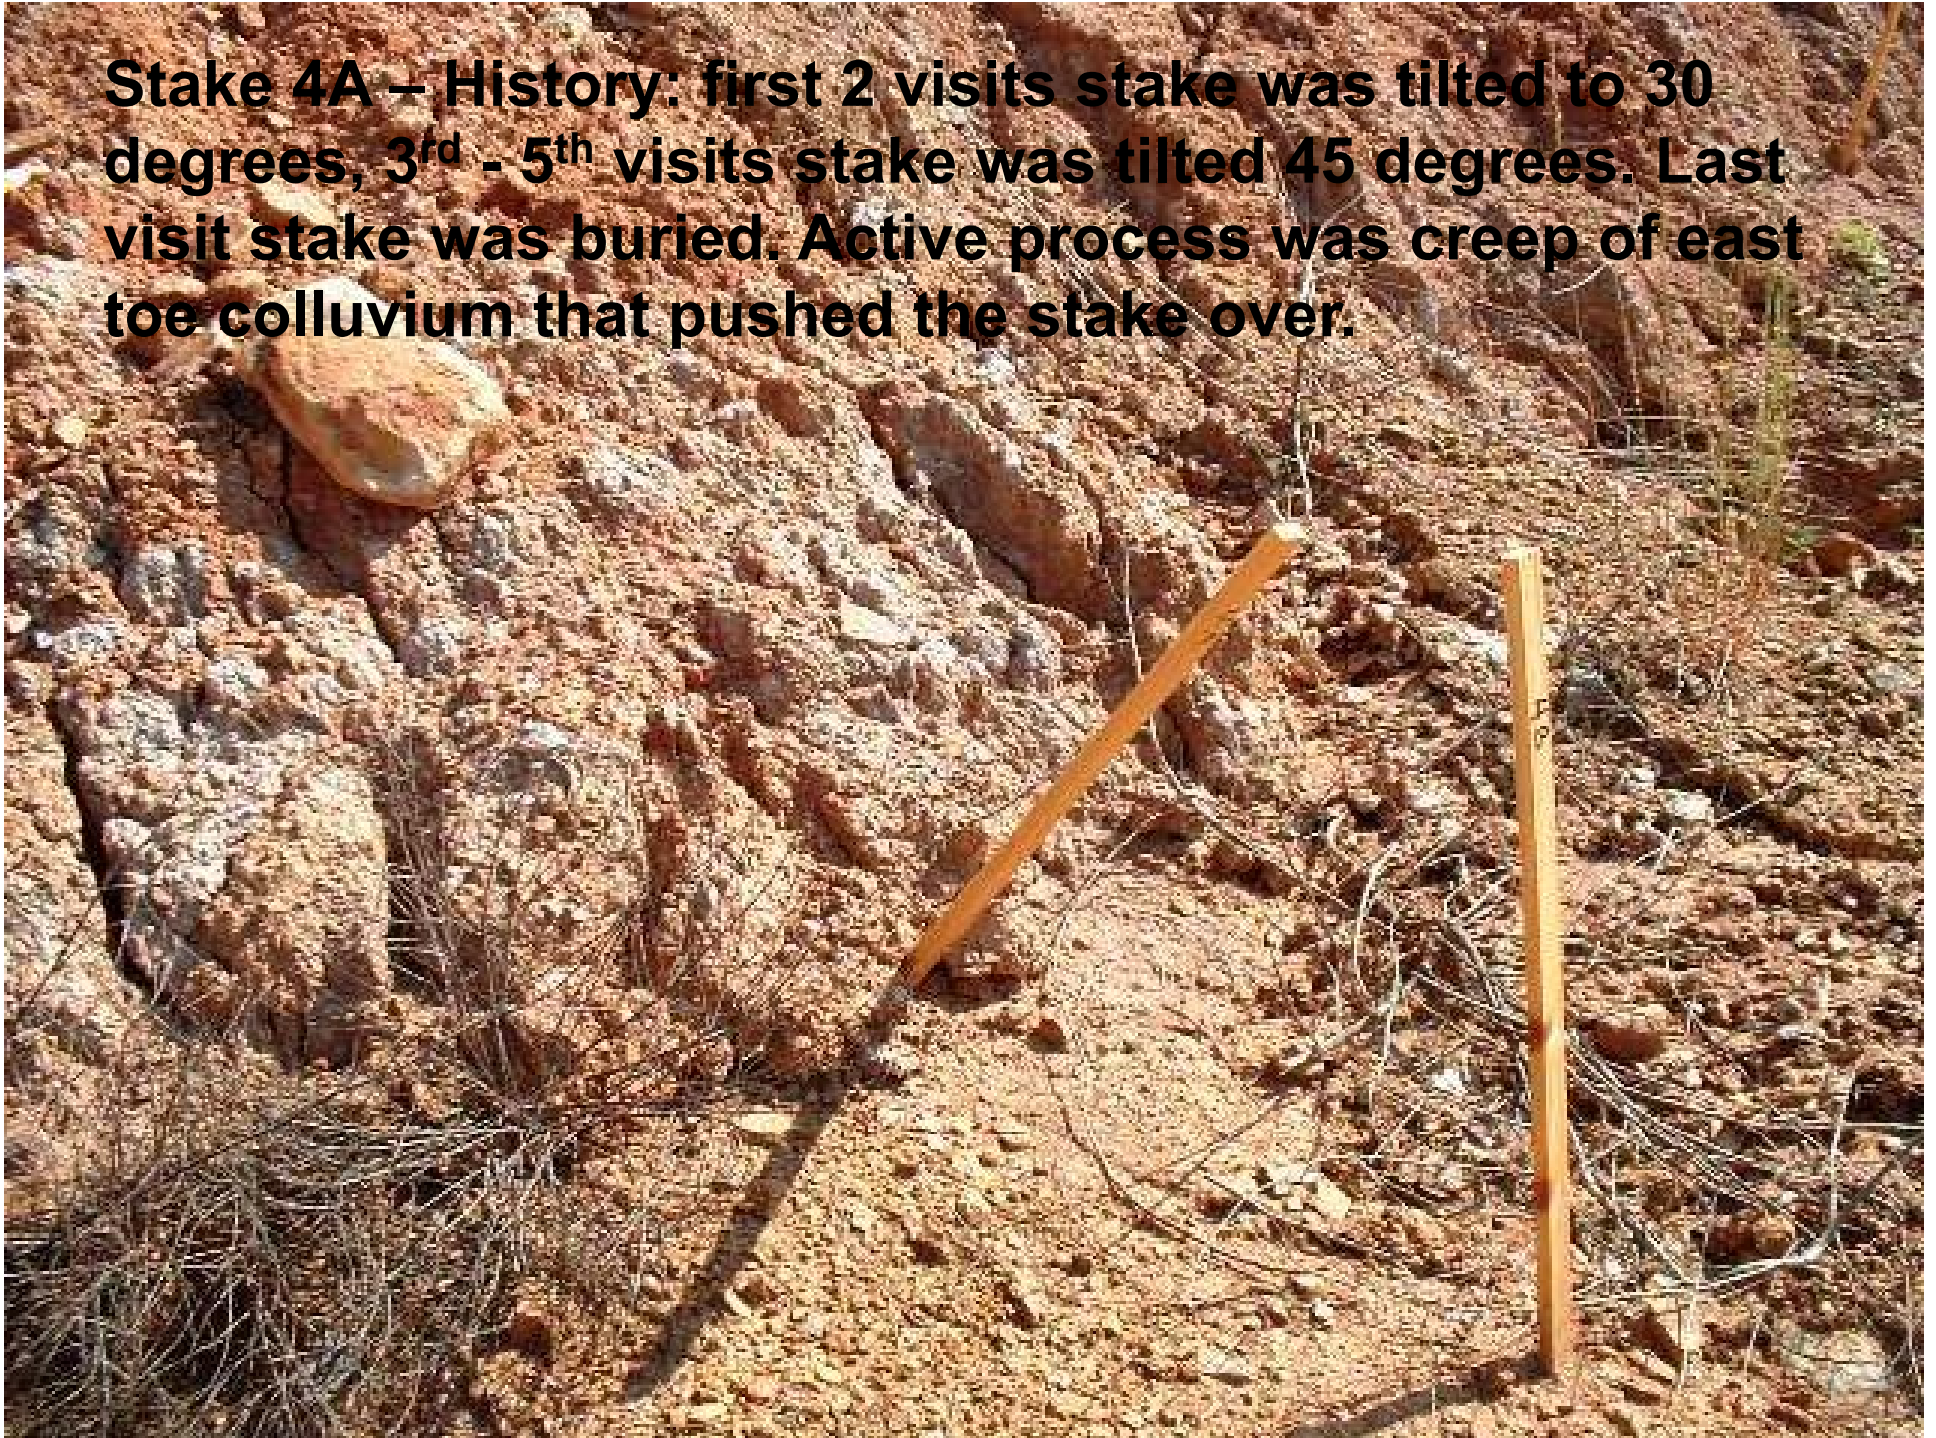
**Stake 4A – History: first 2 visits stake was tilted to 30 degrees, 3<sup>rd</sup> - 5<sup>th</sup> visits stake was tilted 45 degrees. Last visit stake was buried. Active process was creep of east toe colluvium that pushed the stake over.**

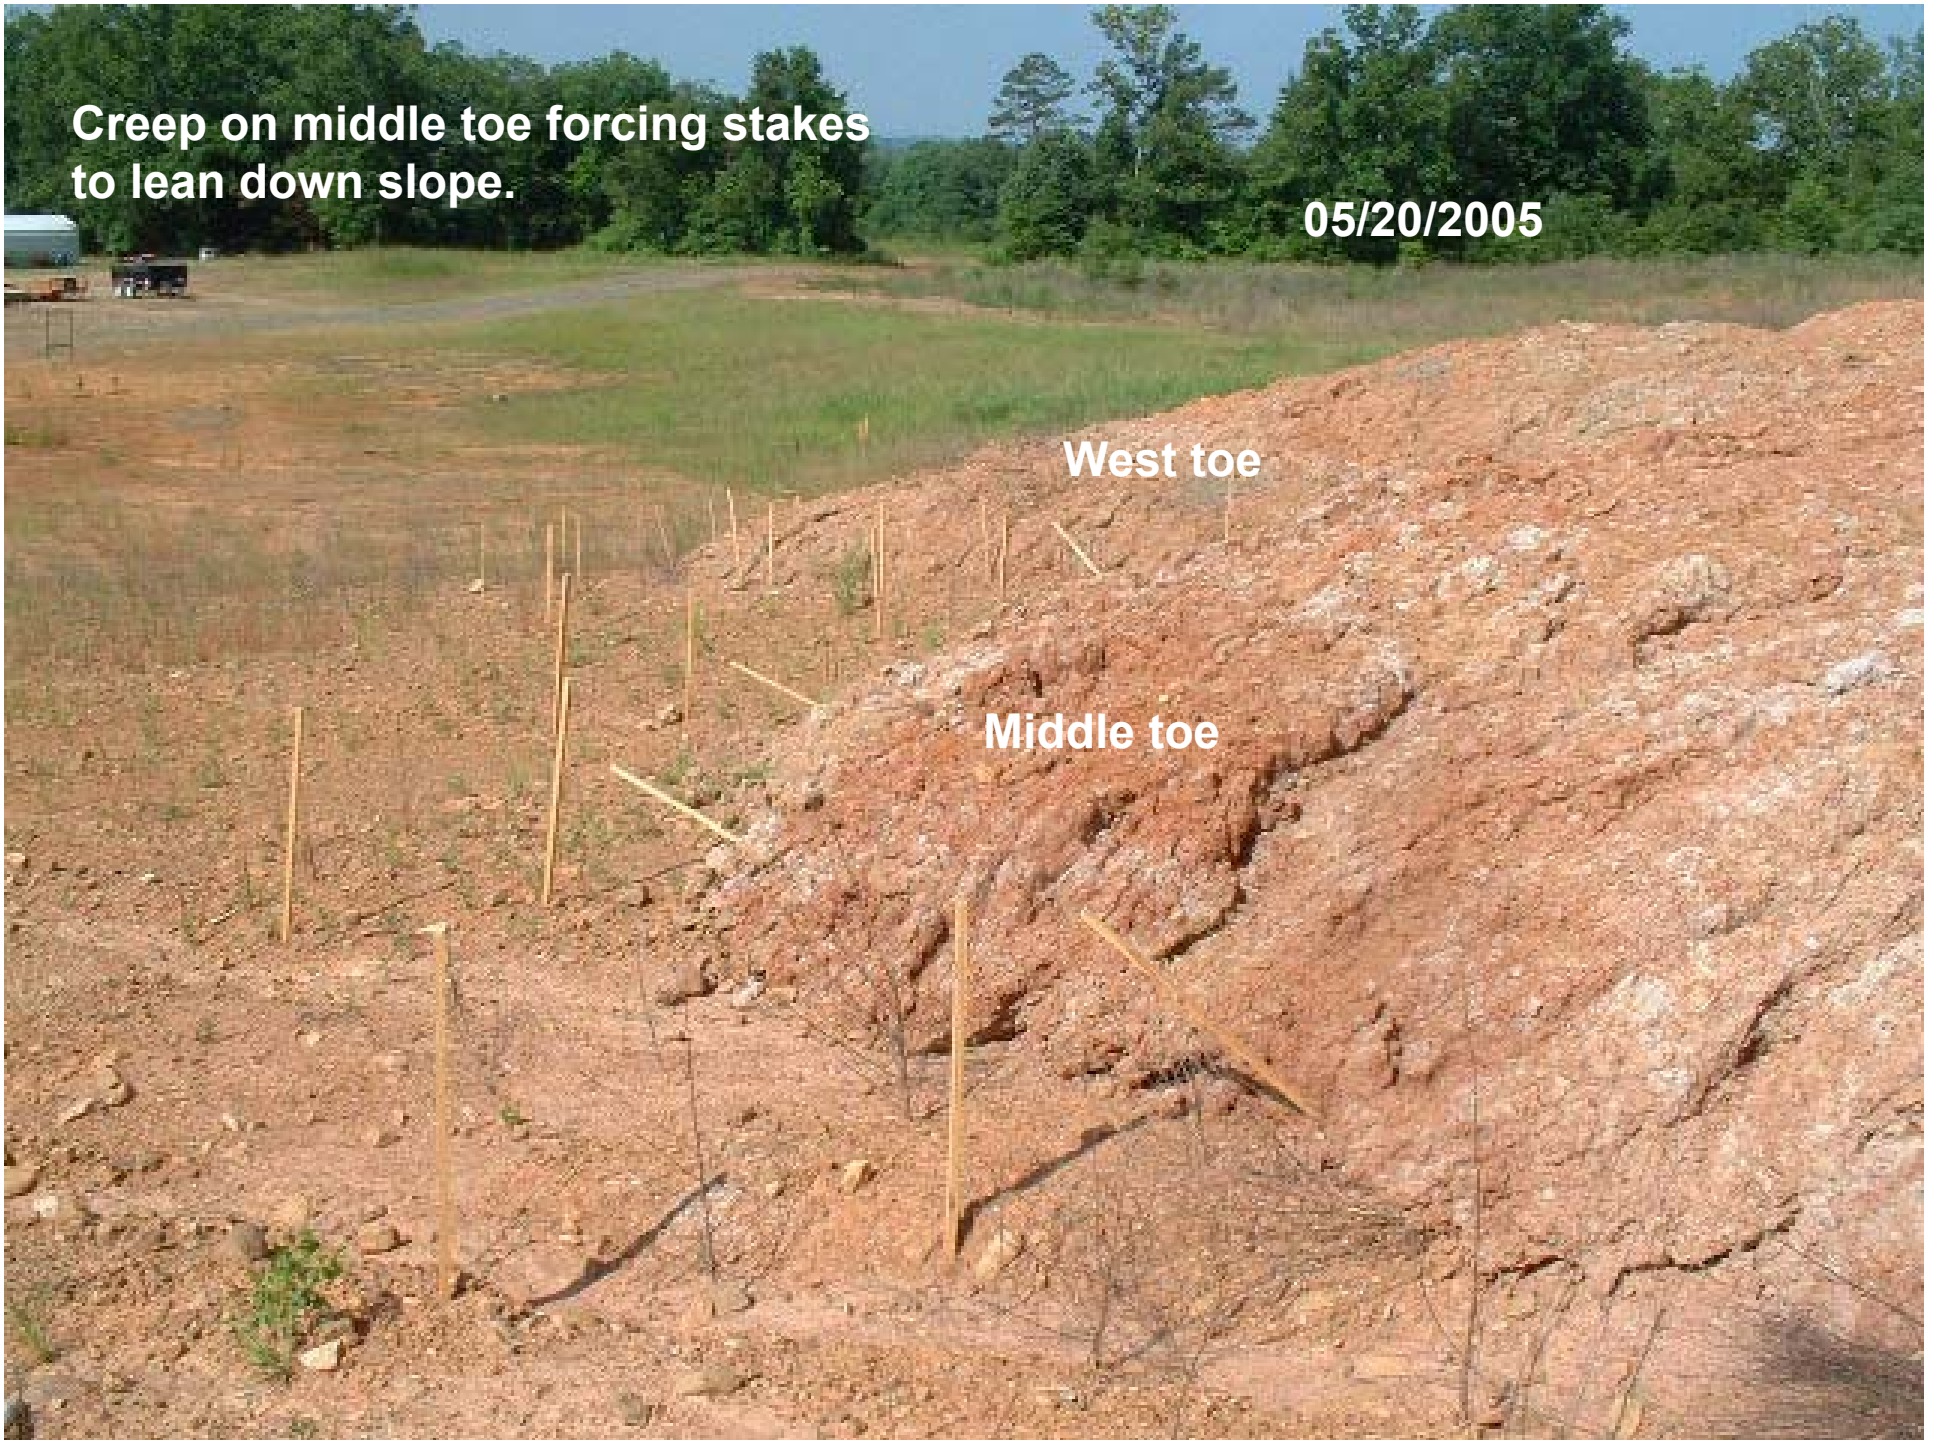
**Stake 10B History: stake was vertical all previous visits until noted horizontal on 07/10/06. Note that 11B is also horizontal. 10A & 11A are buried by process of creep of middle toe.**

**Creep on middle toe forcing stakes  
to lean down slope.**

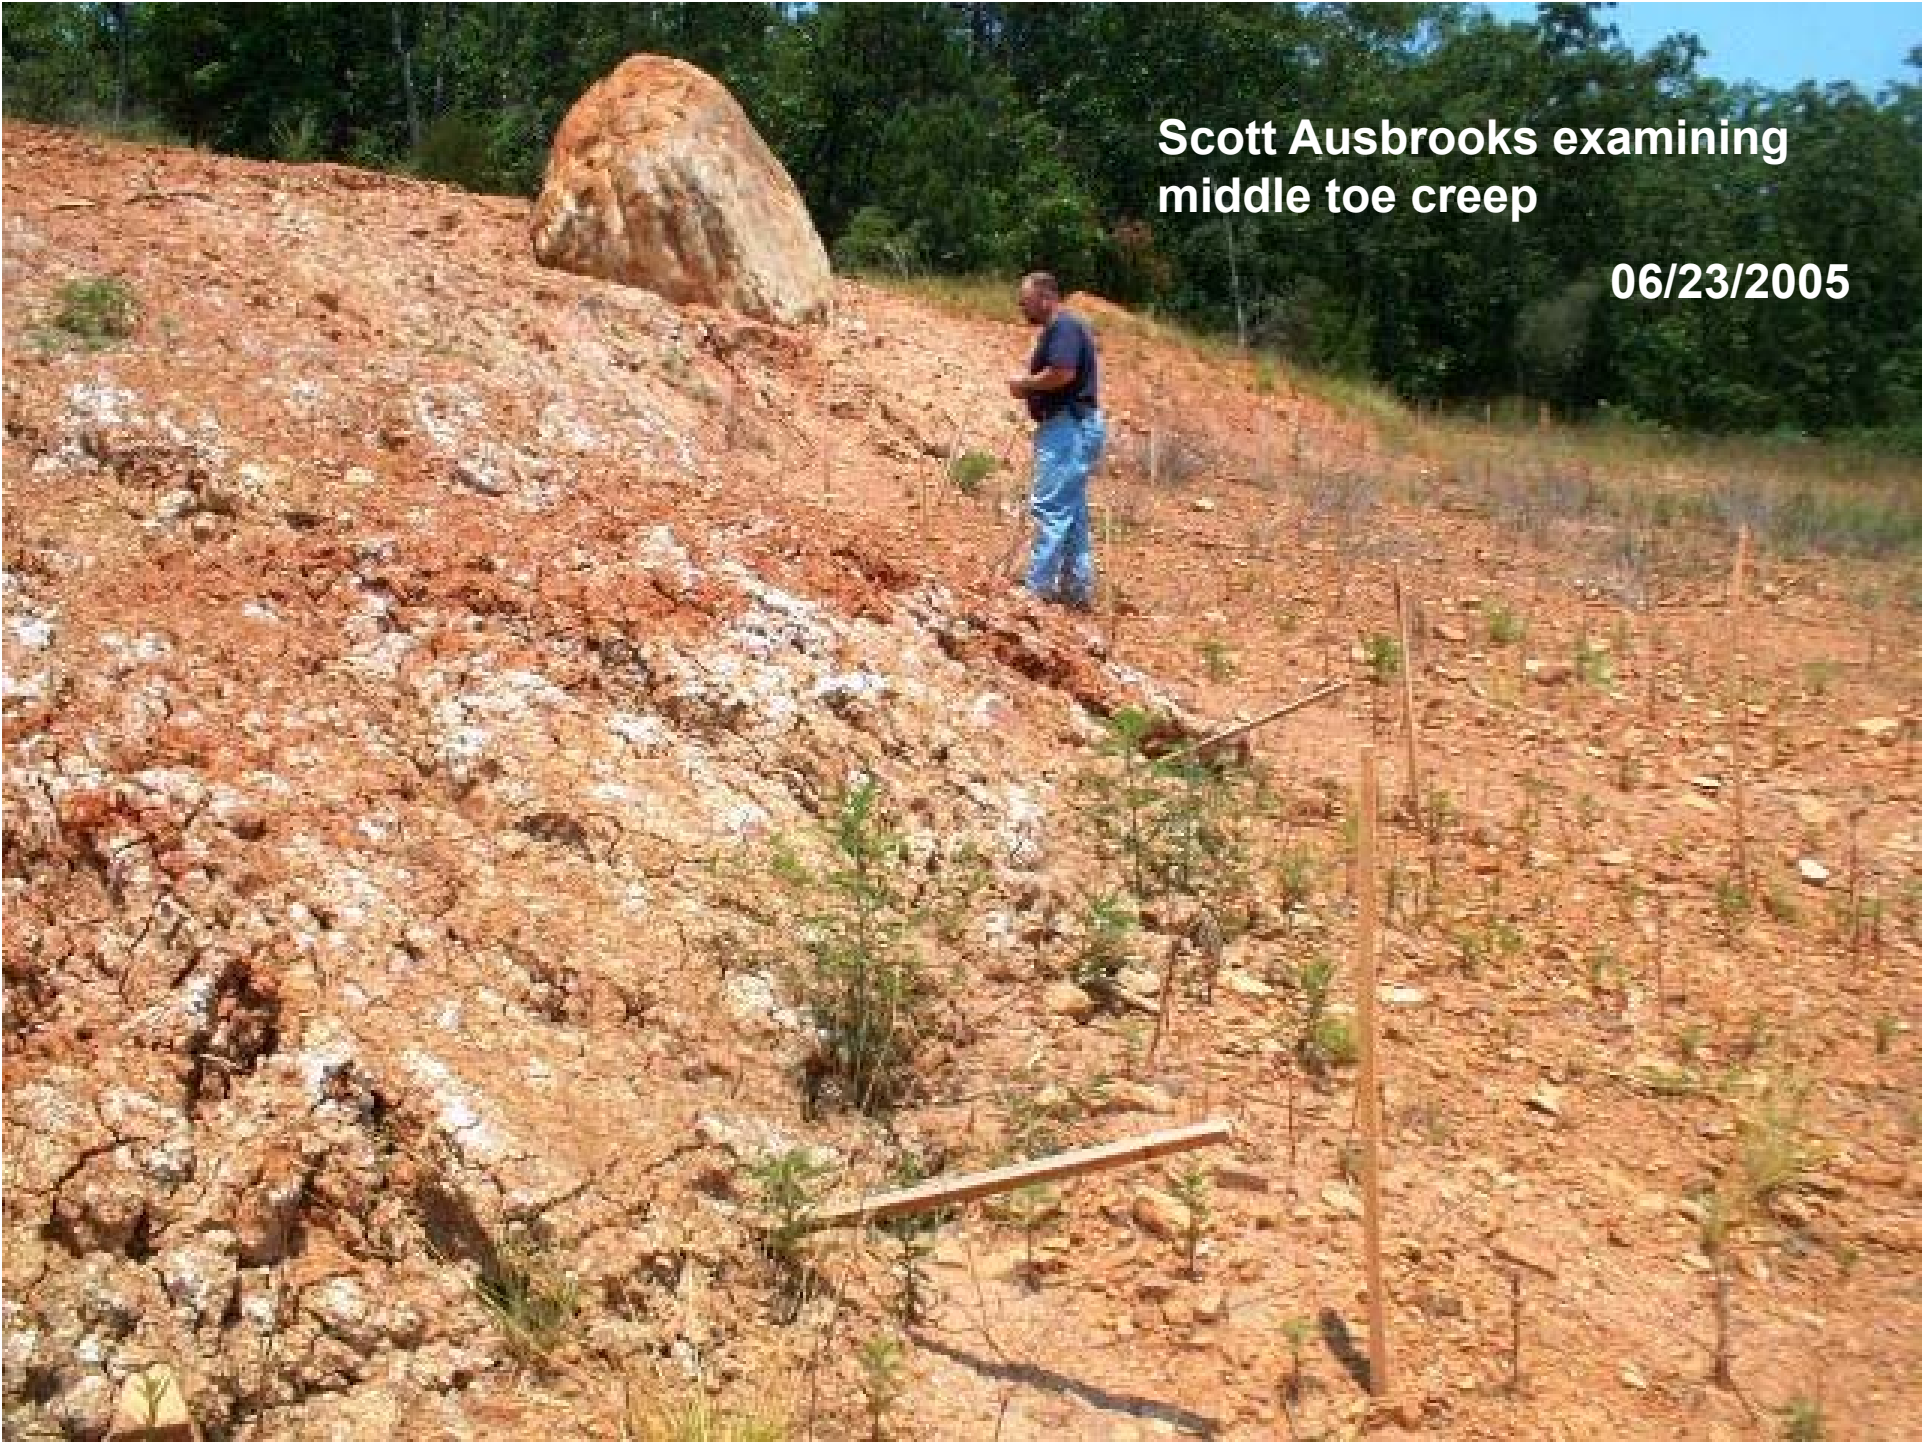
**Scott Ausbrooks examining  
middle toe creep**

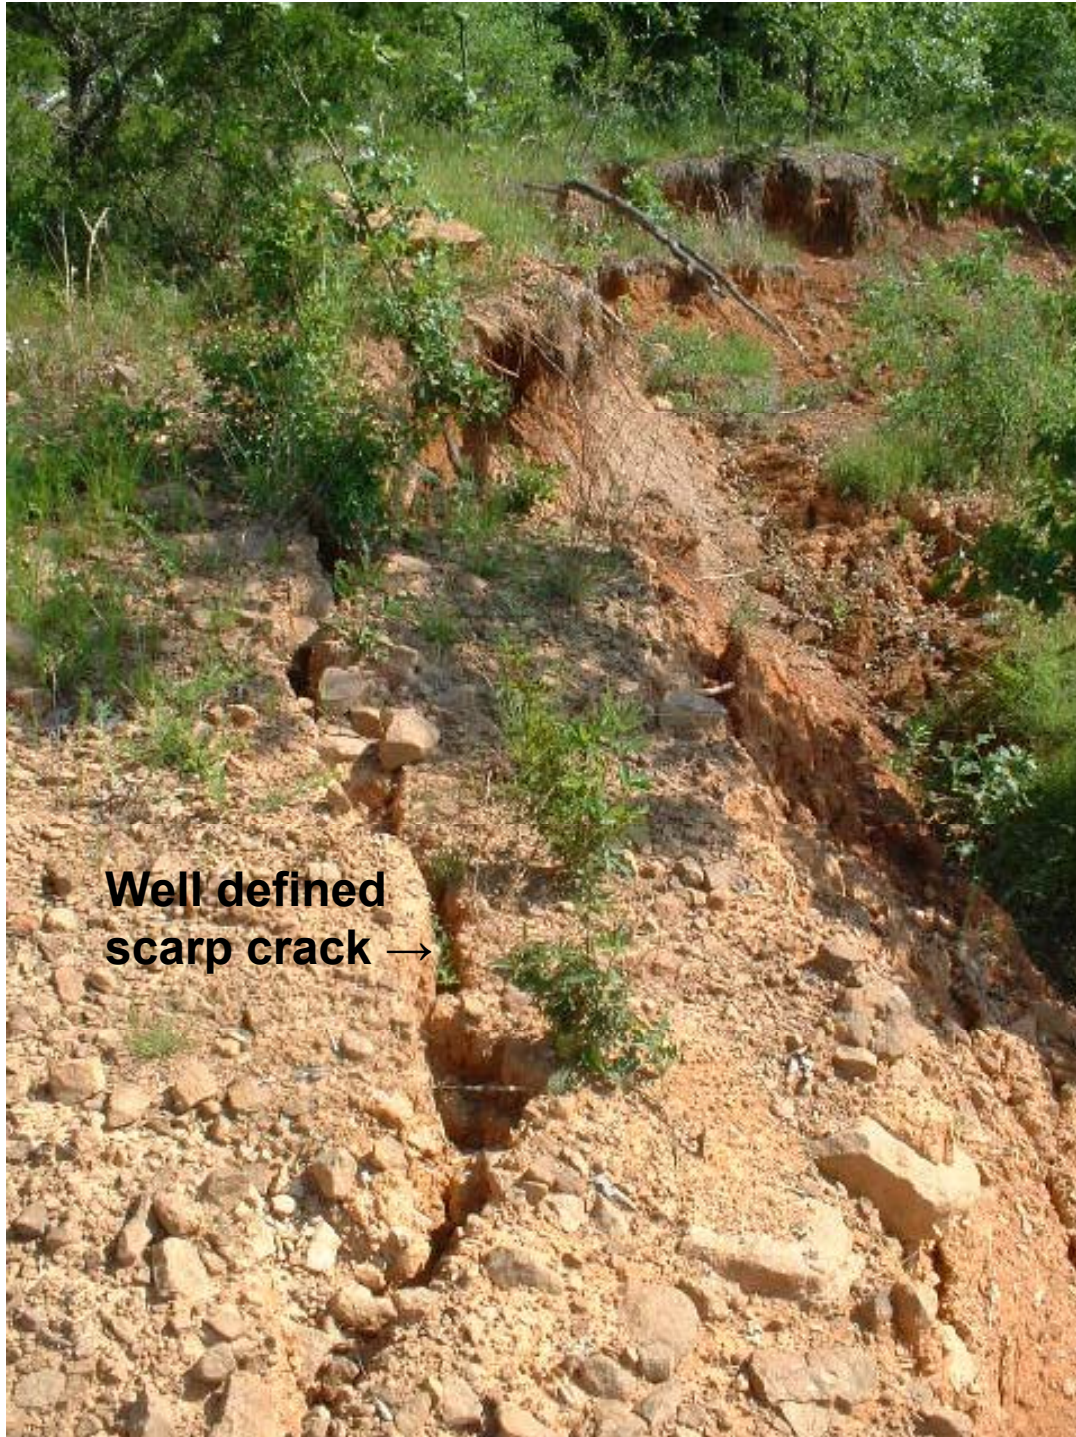
**Well defined  
scarp crack →**

**Continued erosion by  
developing drainage on  
west edge of landslide  
resulted in development of  
scarp crack by mass  
wasting of unconsolidated  
colluvium into drainage,  
looking northeast.**

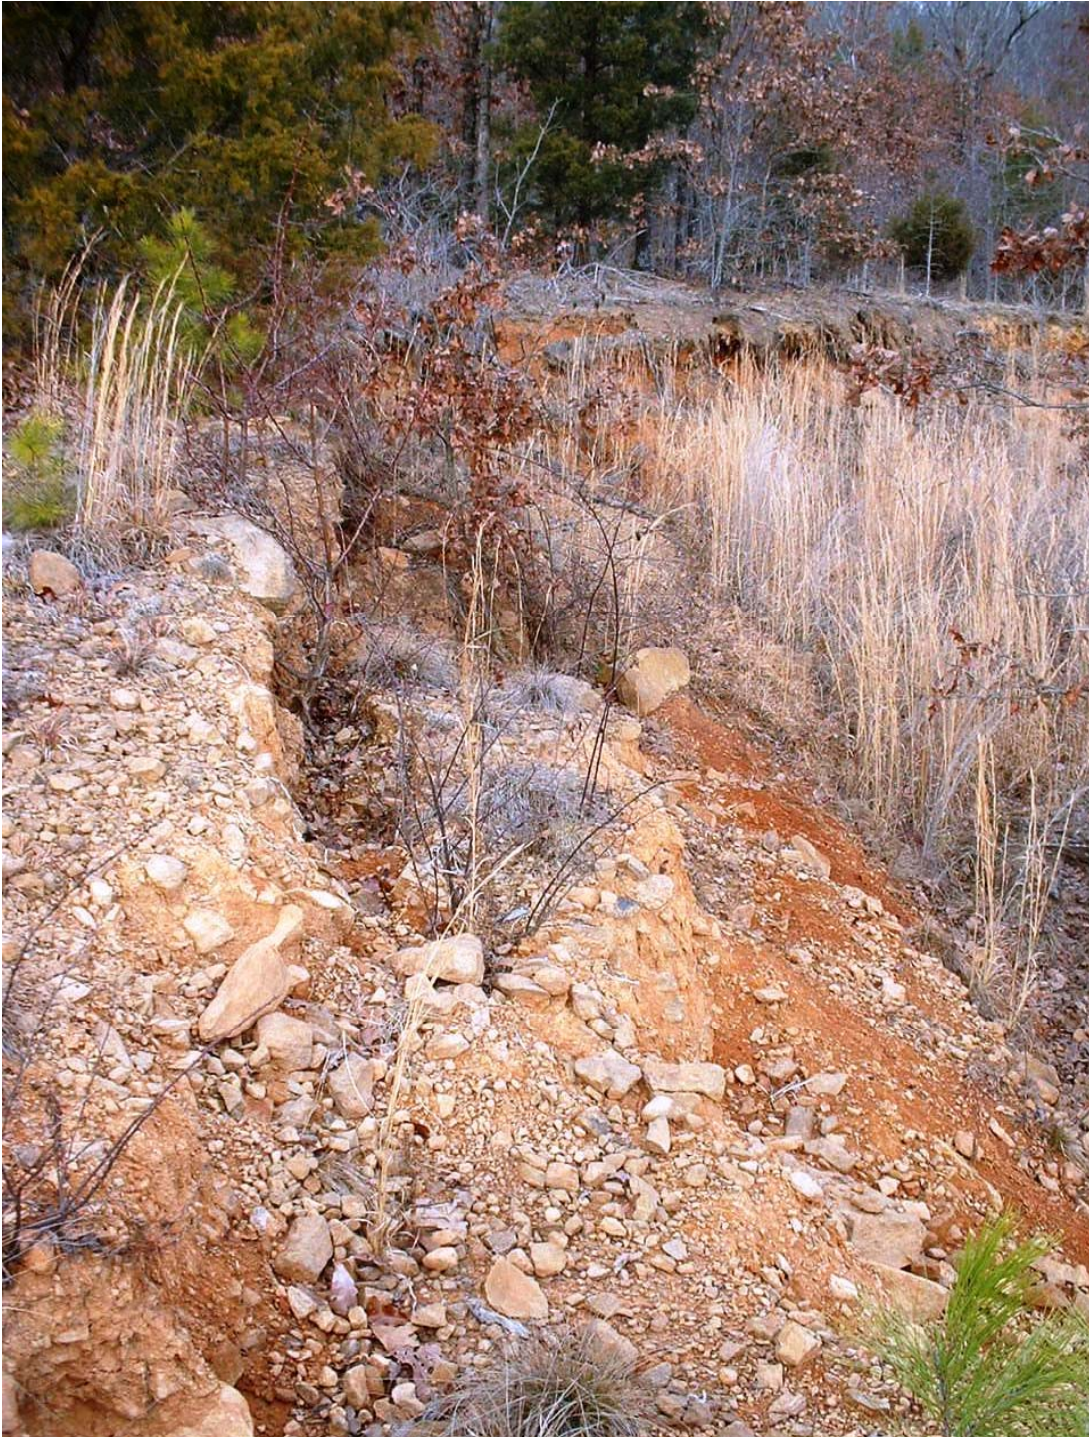
**Same view, 01/17/2008**

**Note down drop of slump  
block into the slide and  
covering of crack extension  
by wash. Look direction is  
north.**

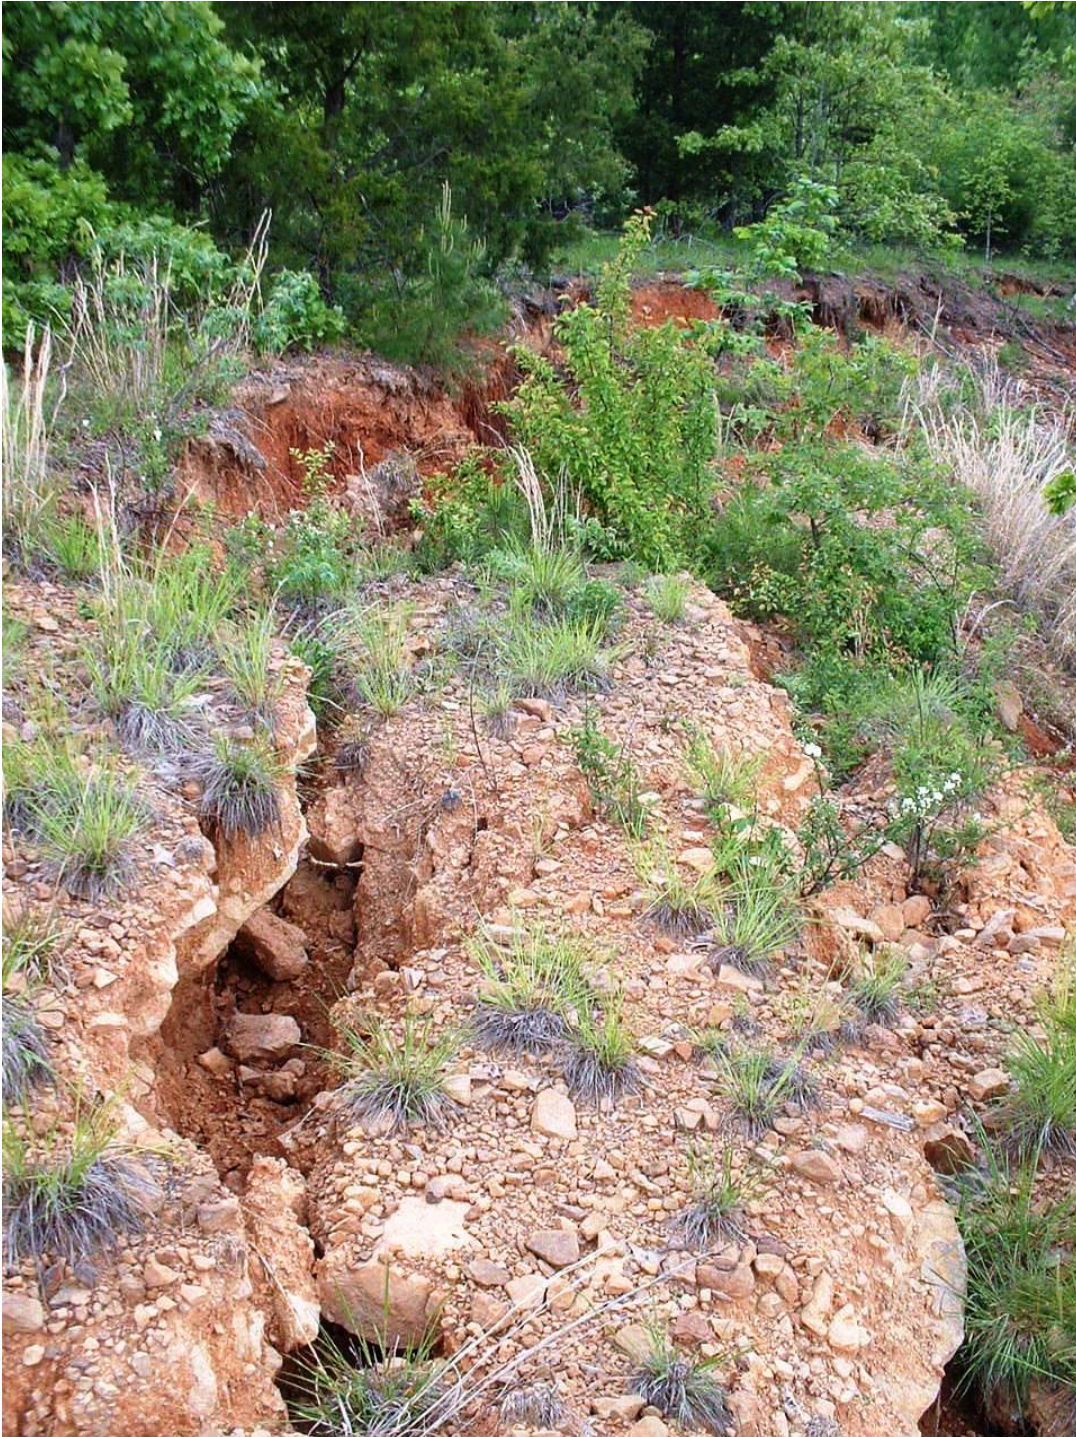
**Continued down drop and  
separation of block on west  
side to the east**

**West scarp again exposed**

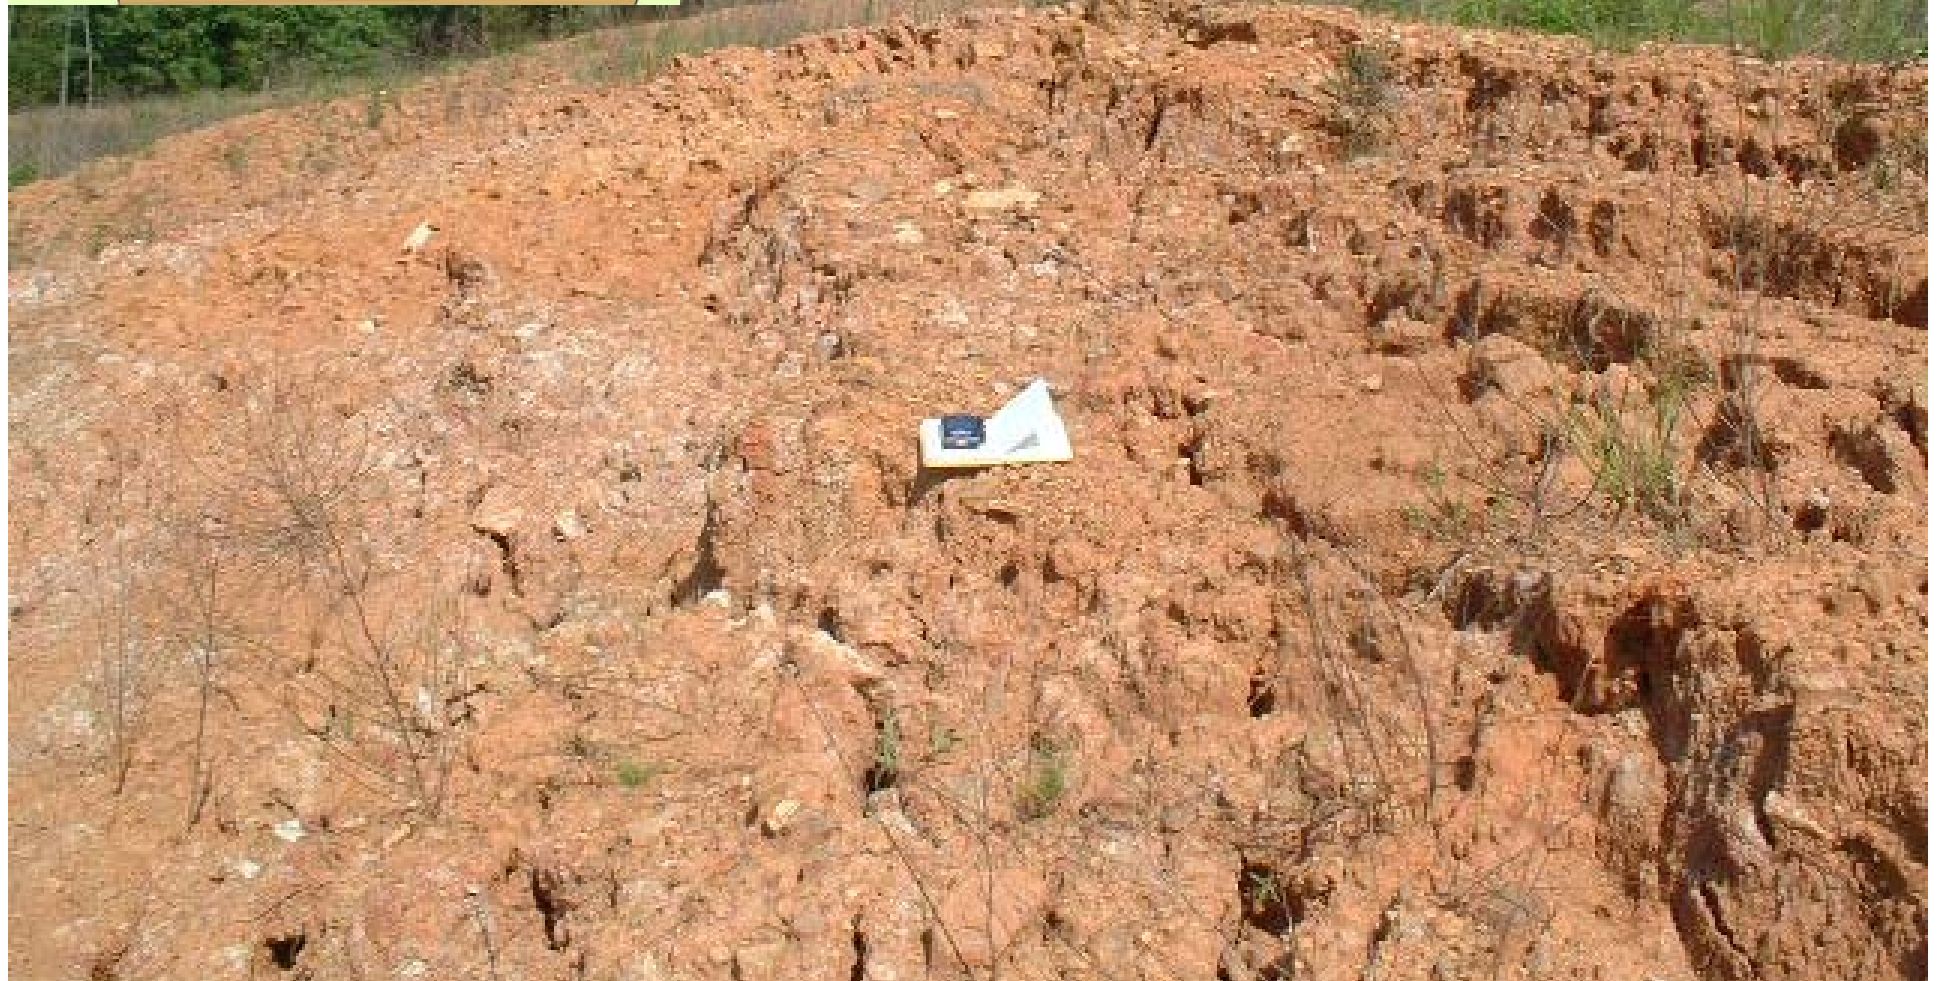
Minor step down scarp development  
above mid-point of landslide on active  
middle toe. 05/20/05

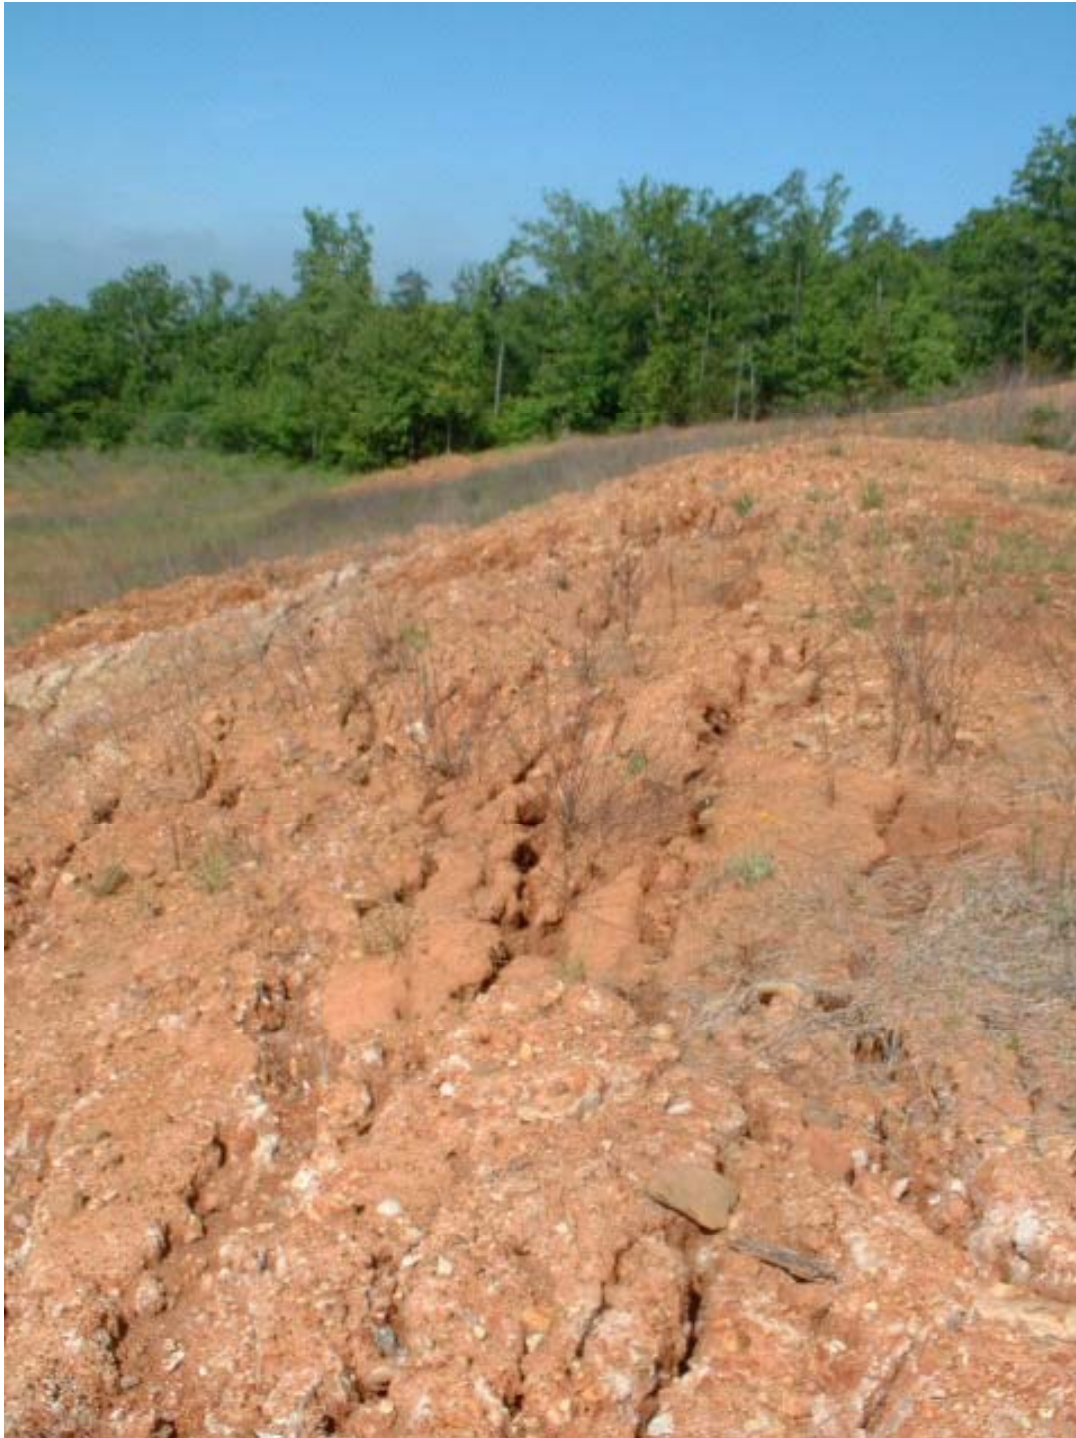
Upper limit of transverse surface cracks extending from east toe west of large SS boulder to west toe, below mid- line string on landslide. Note the change in slope. This should approximate the toe of the surface of rupture at the base of the initial slide.

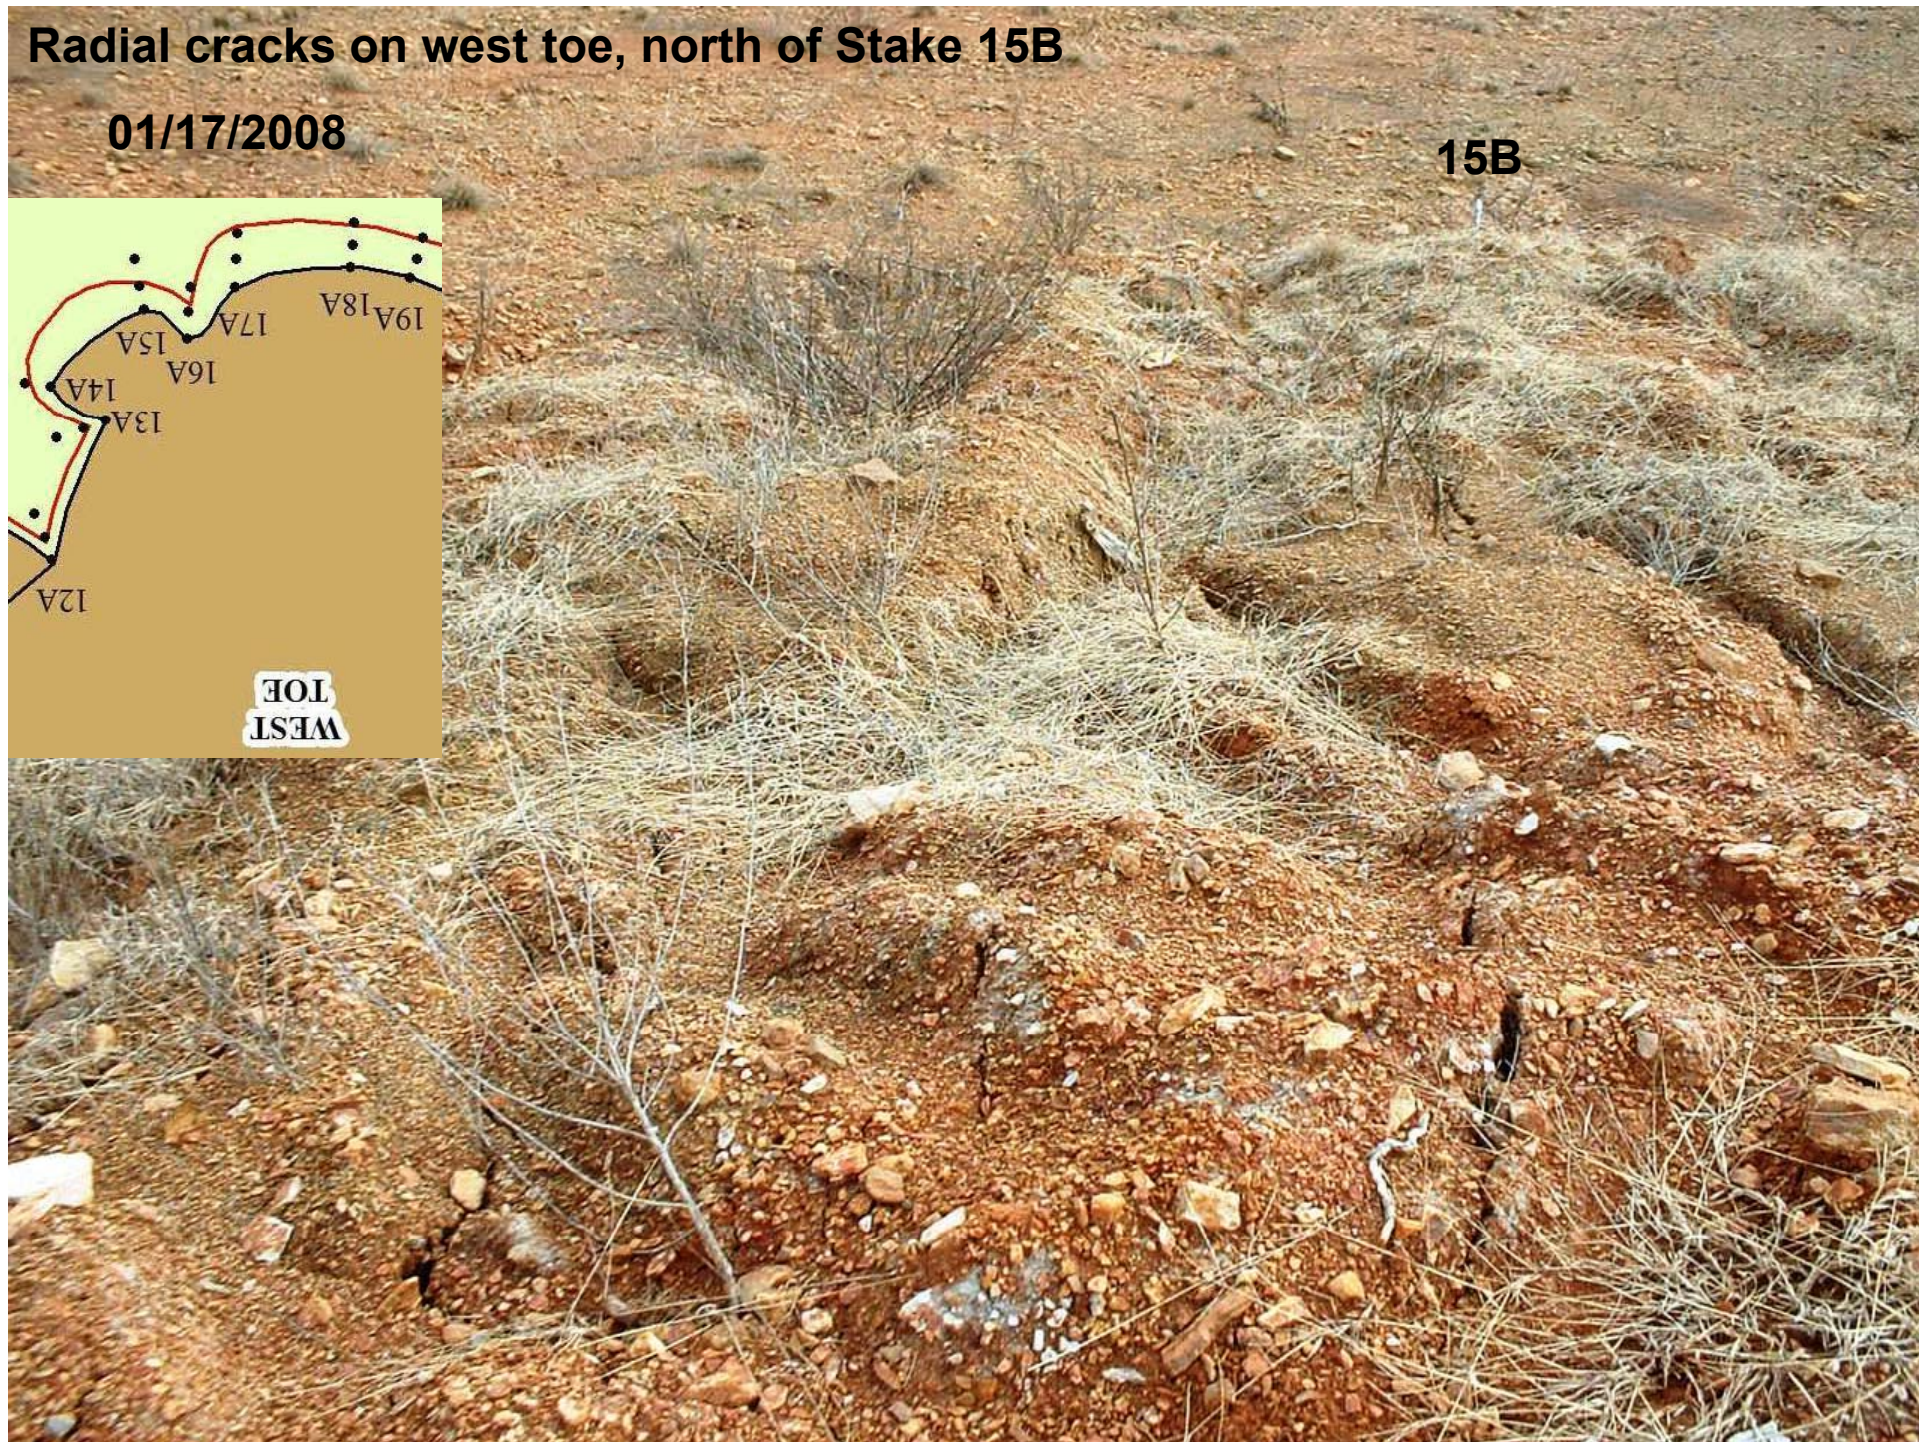
# Radial cracks on west toe, north of Stake 15B

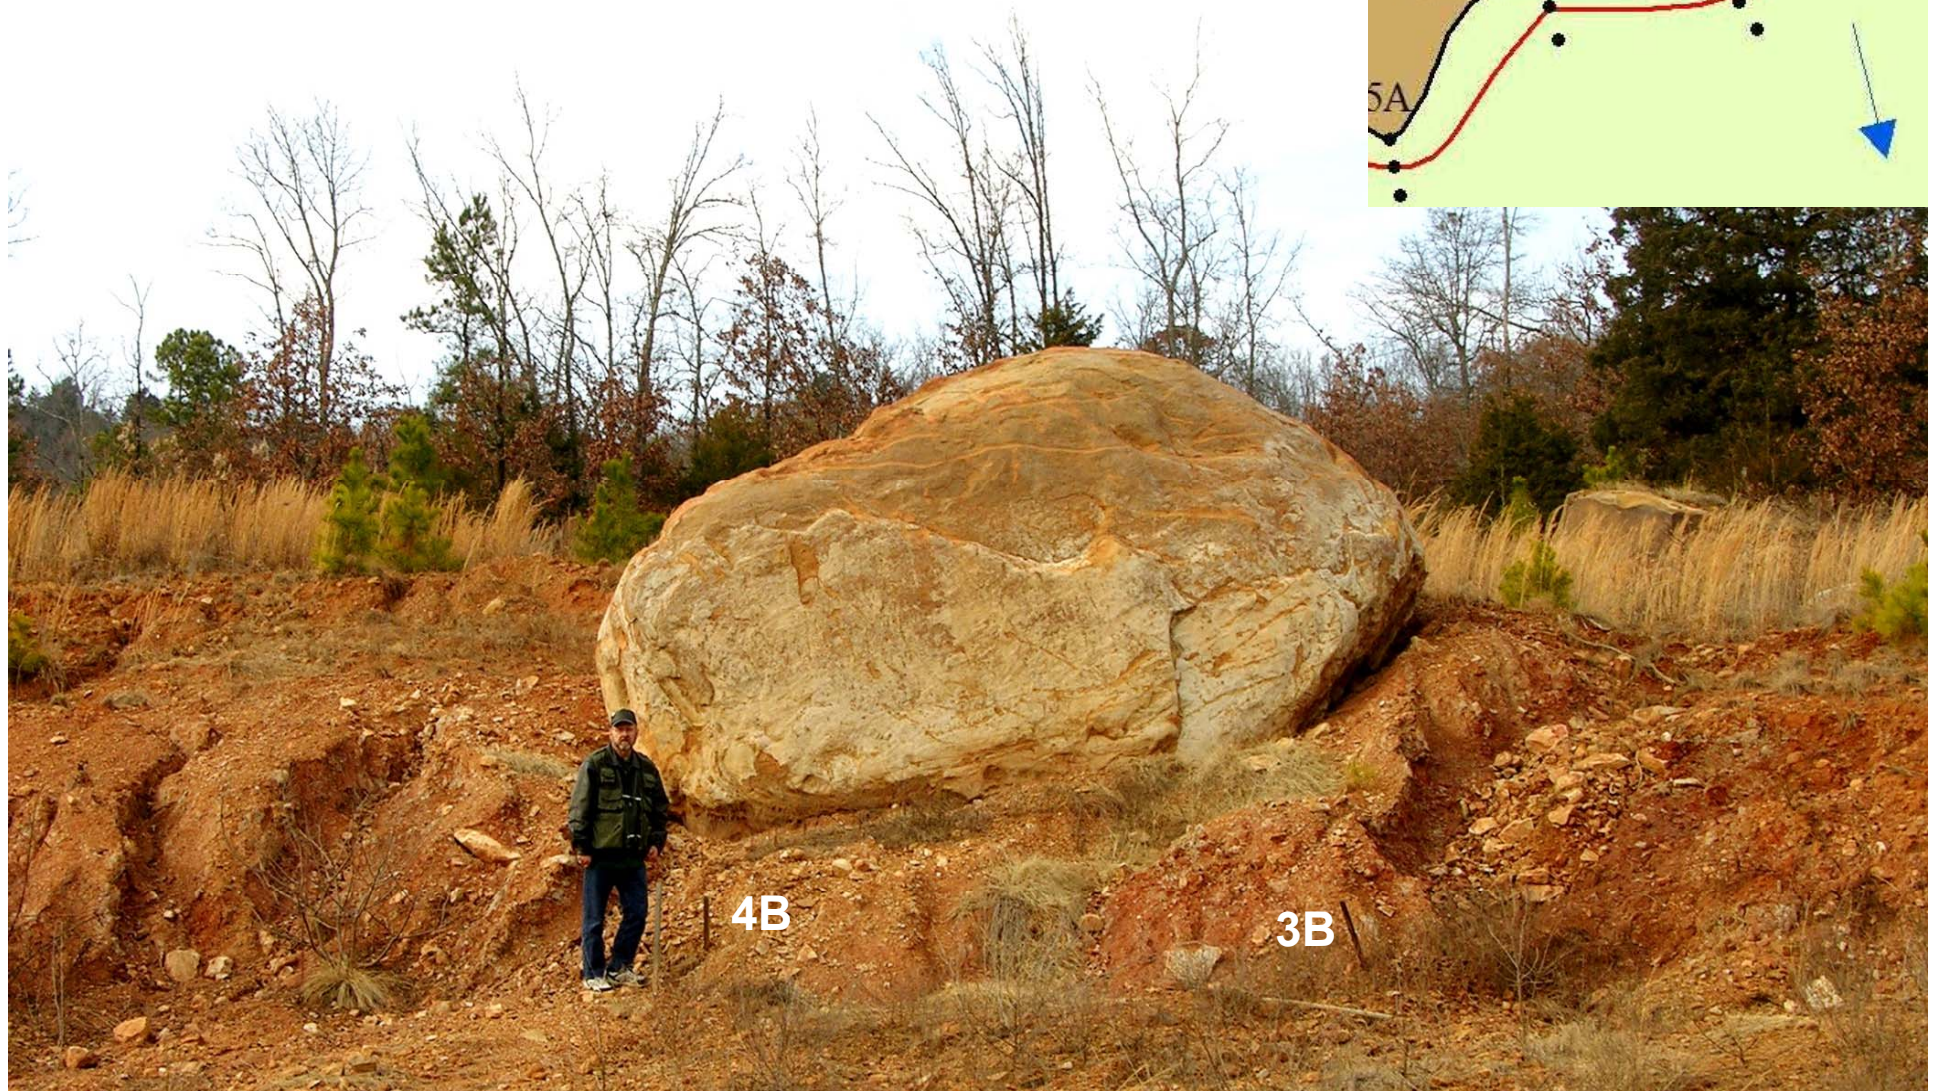
# Active gully development on east toe
