# Jones Landslide, Pottsville, Arkansas – 2 ½ years of Monitoring

By  
J. Michael Howard

# Background

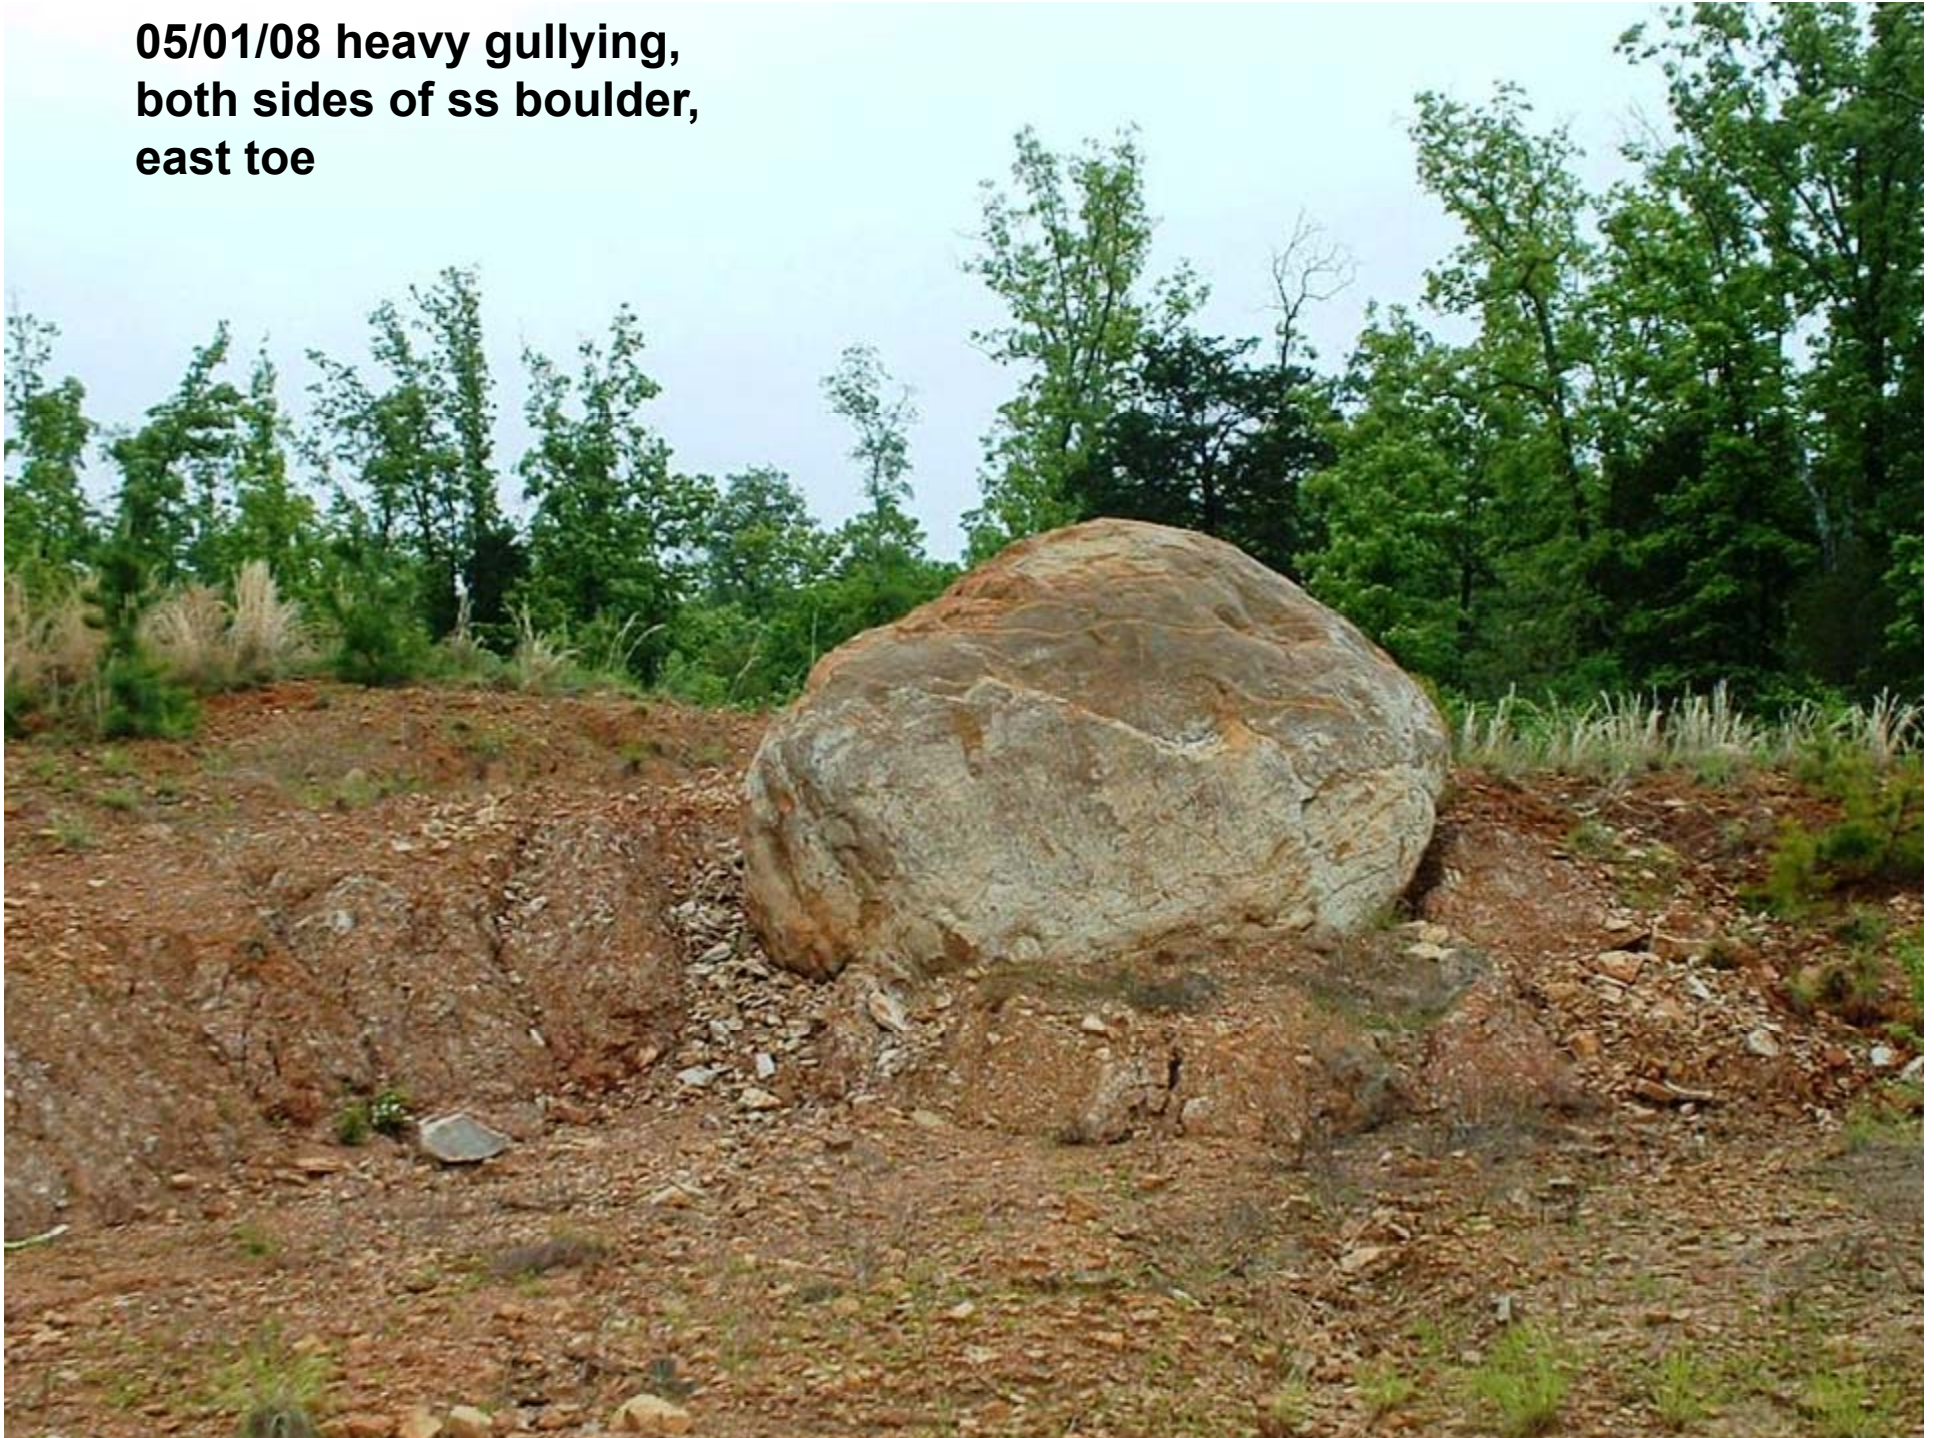
**05/01/08 heavy gullying,  
both sides of ss boulder,  
east toe**

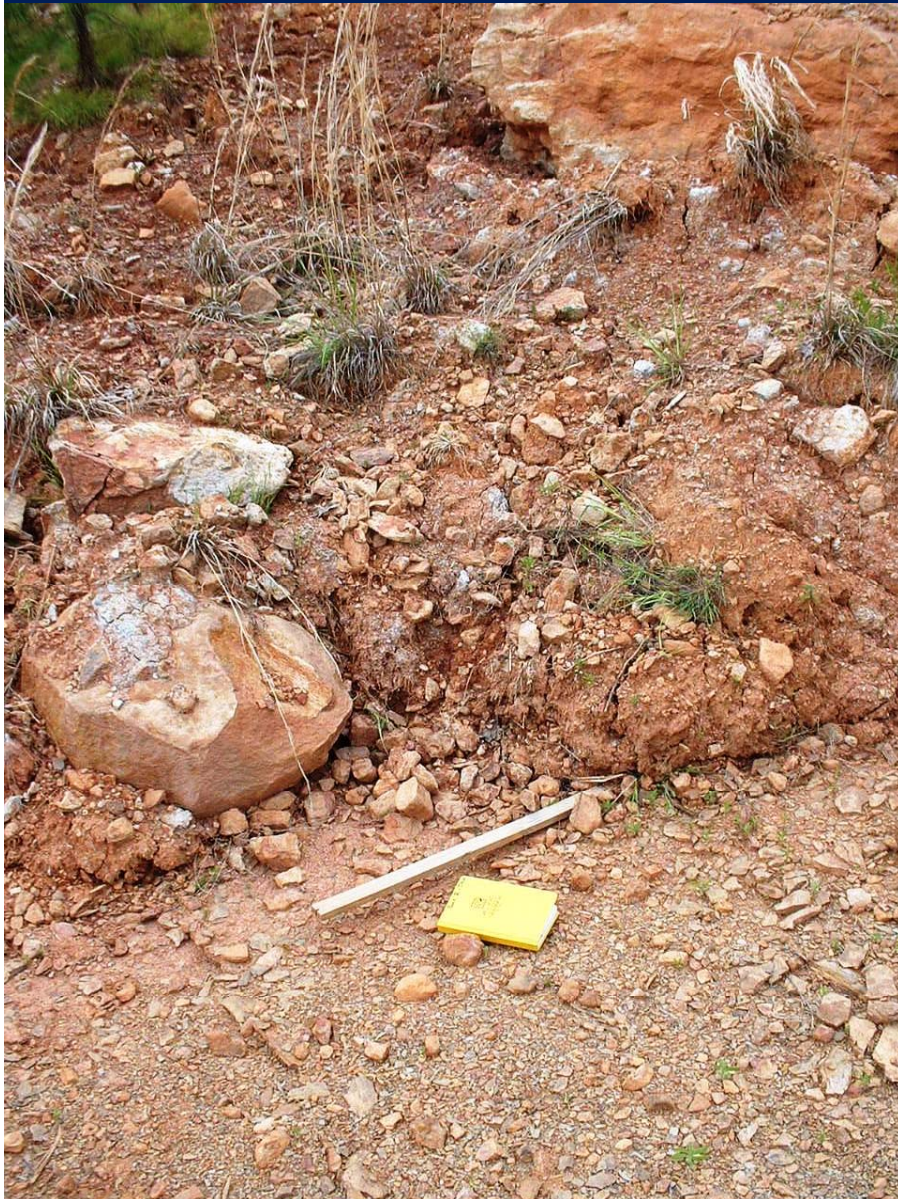
**Stake 2C covered, east toe**

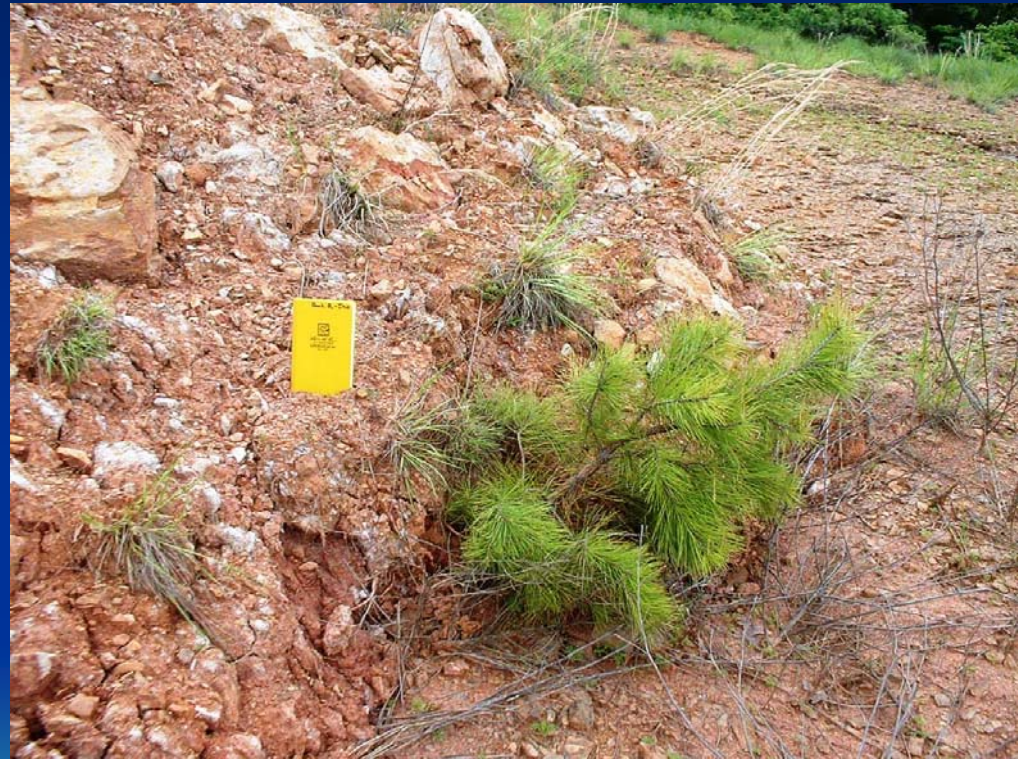
**Middle toe, no stakes visible, 2 year growth pine being pushed over**

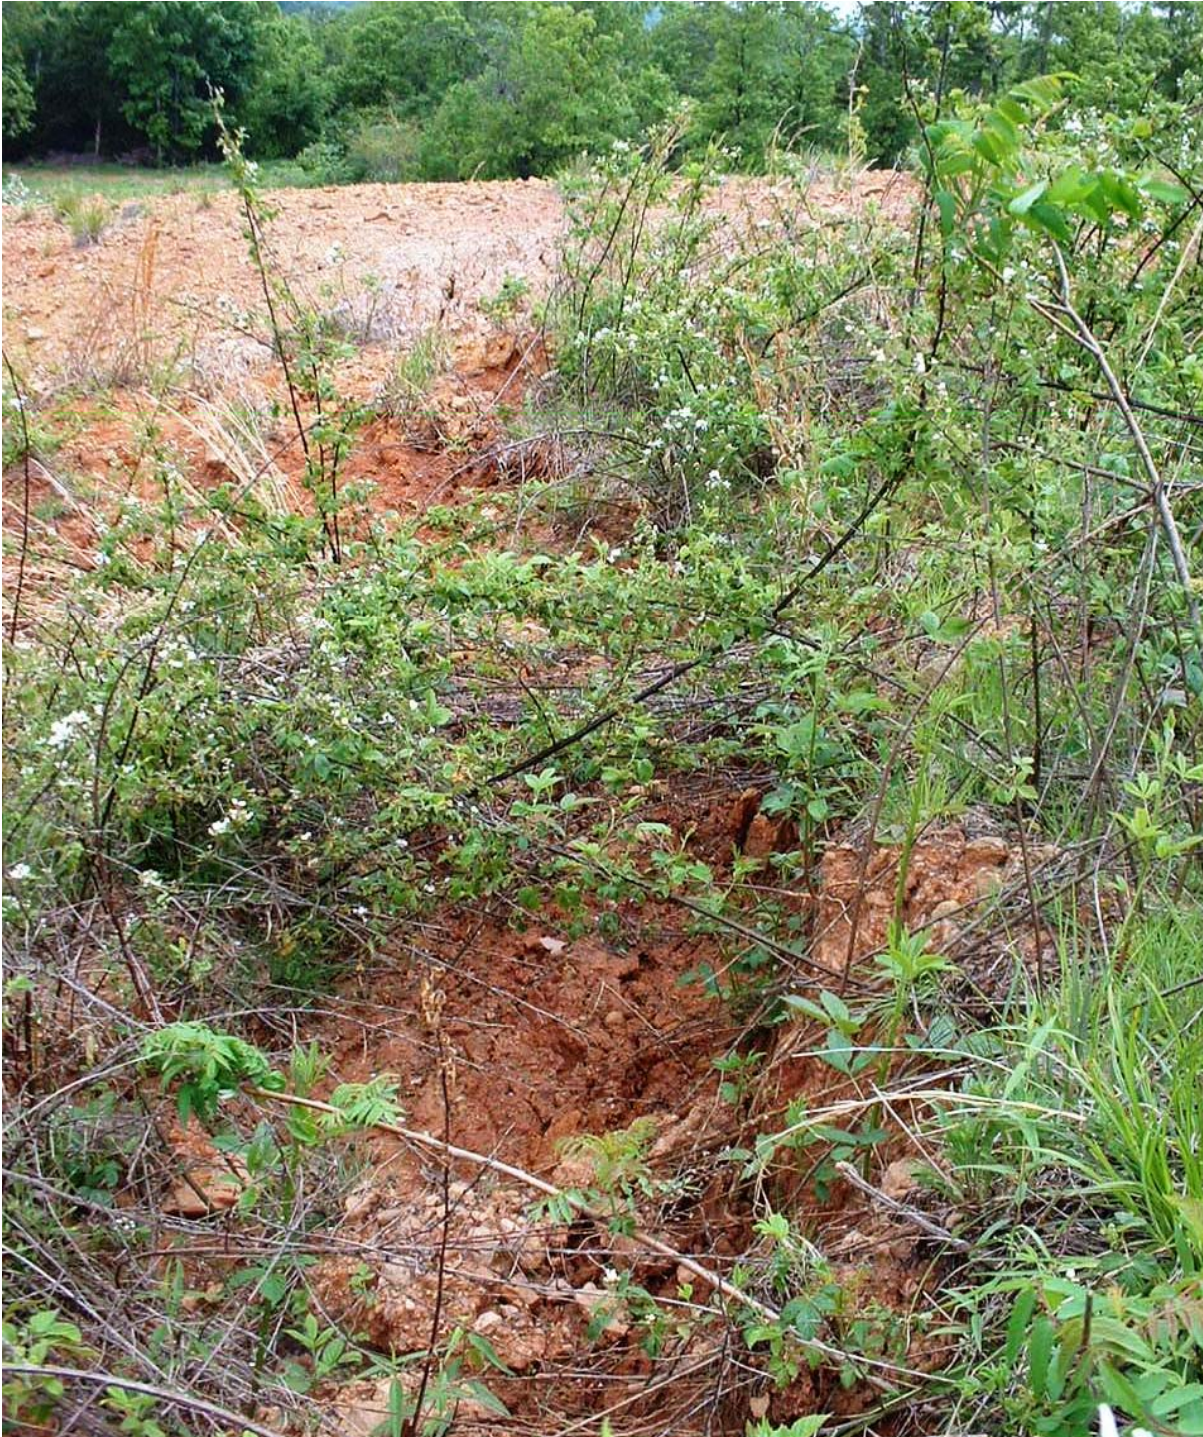
**2 feet of displacement  
on internal scarp, west  
toe...looking west**

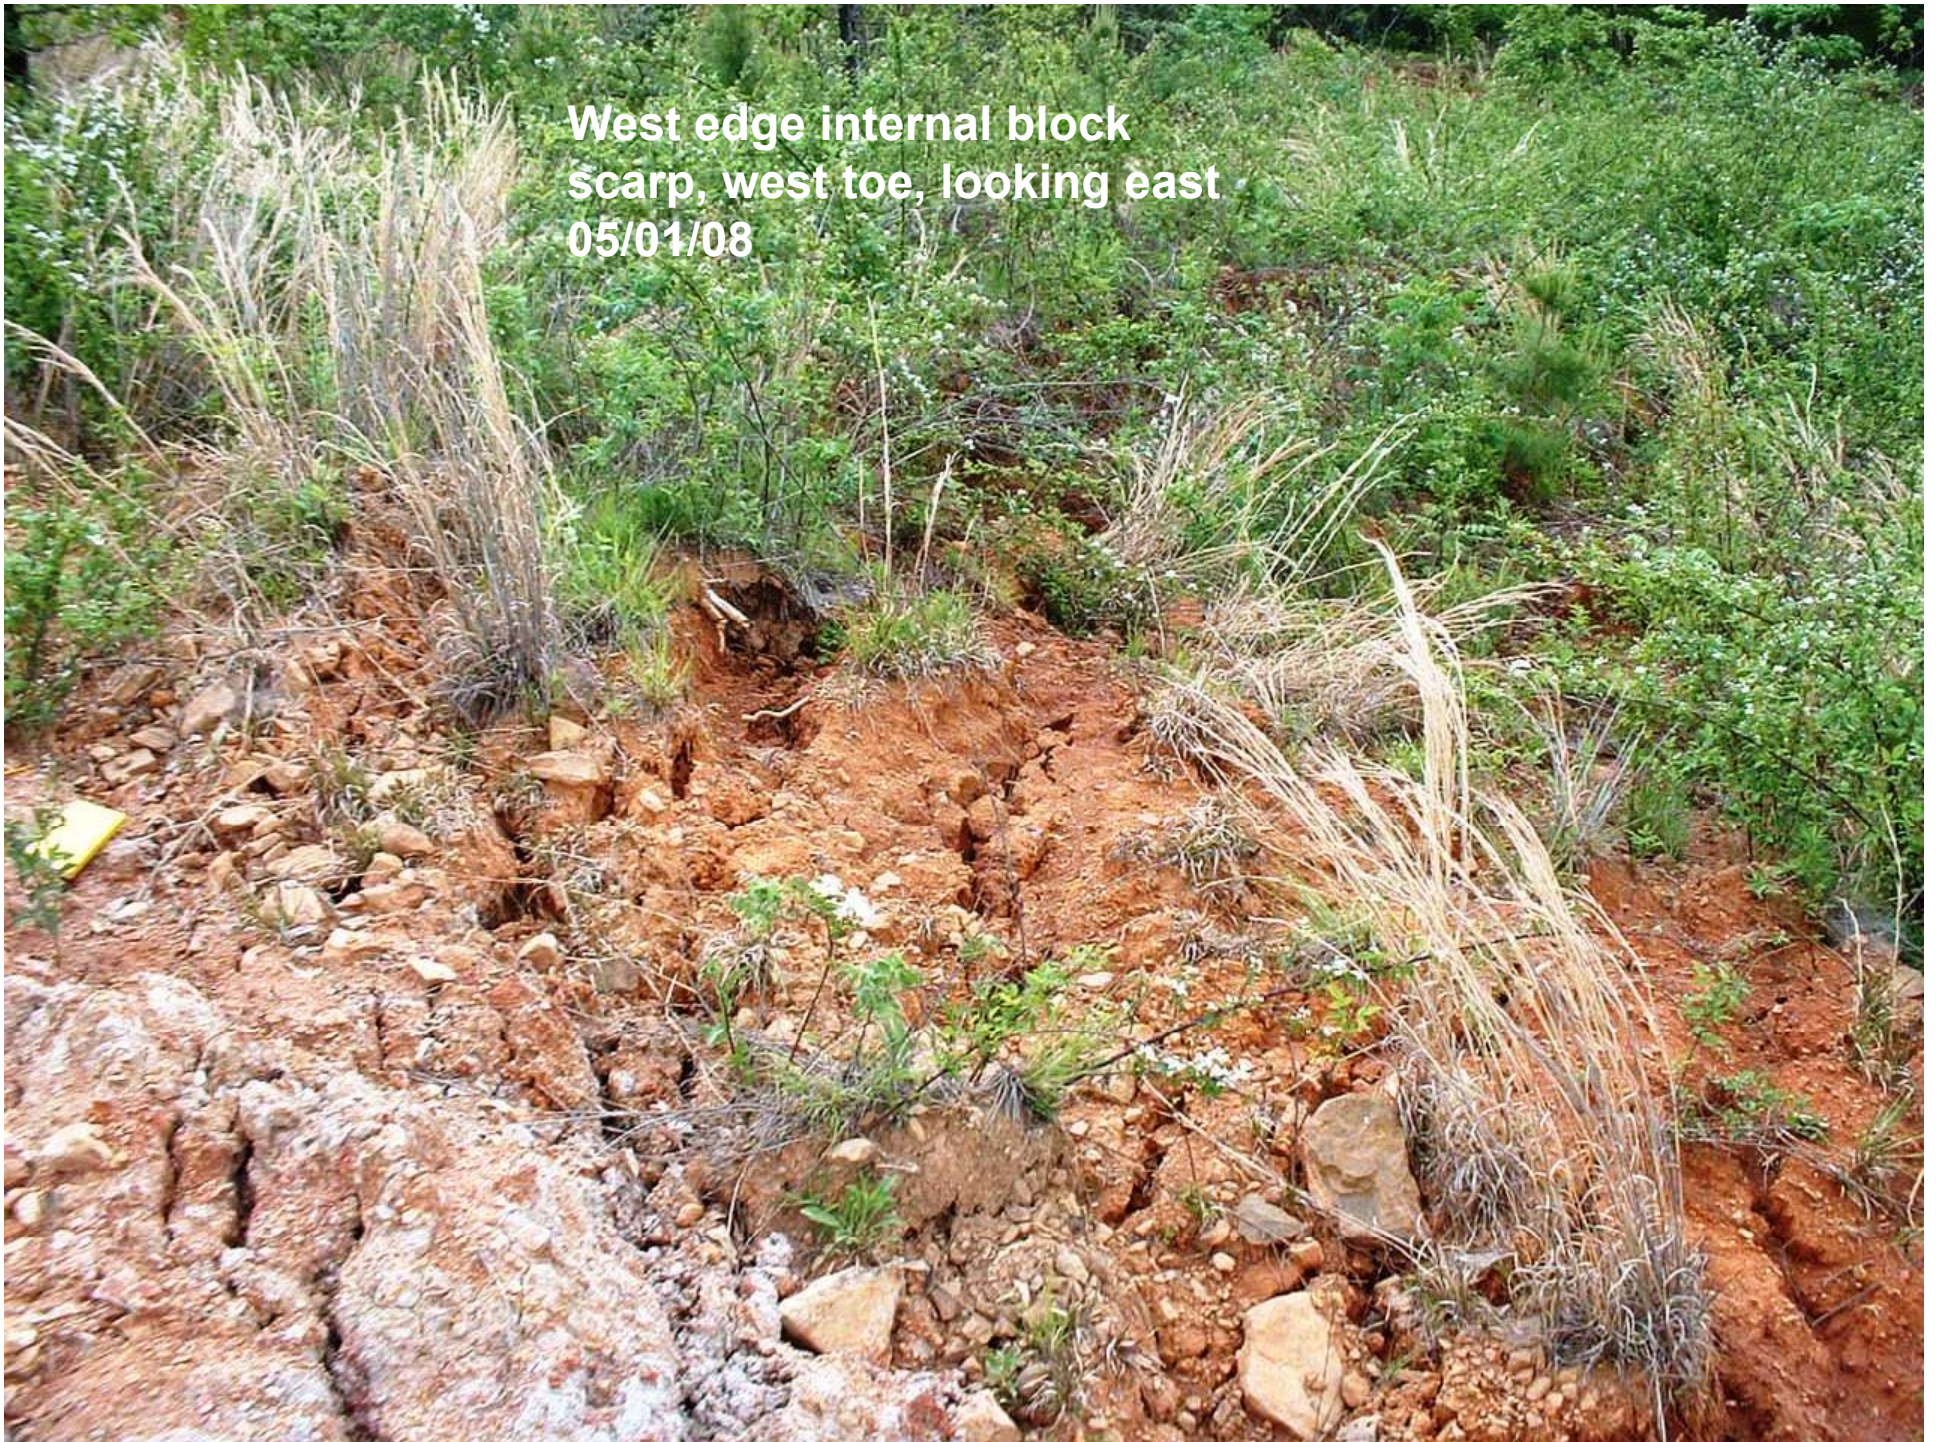
West edge internal block  
scarp, west toe, looking east  
05/01/08

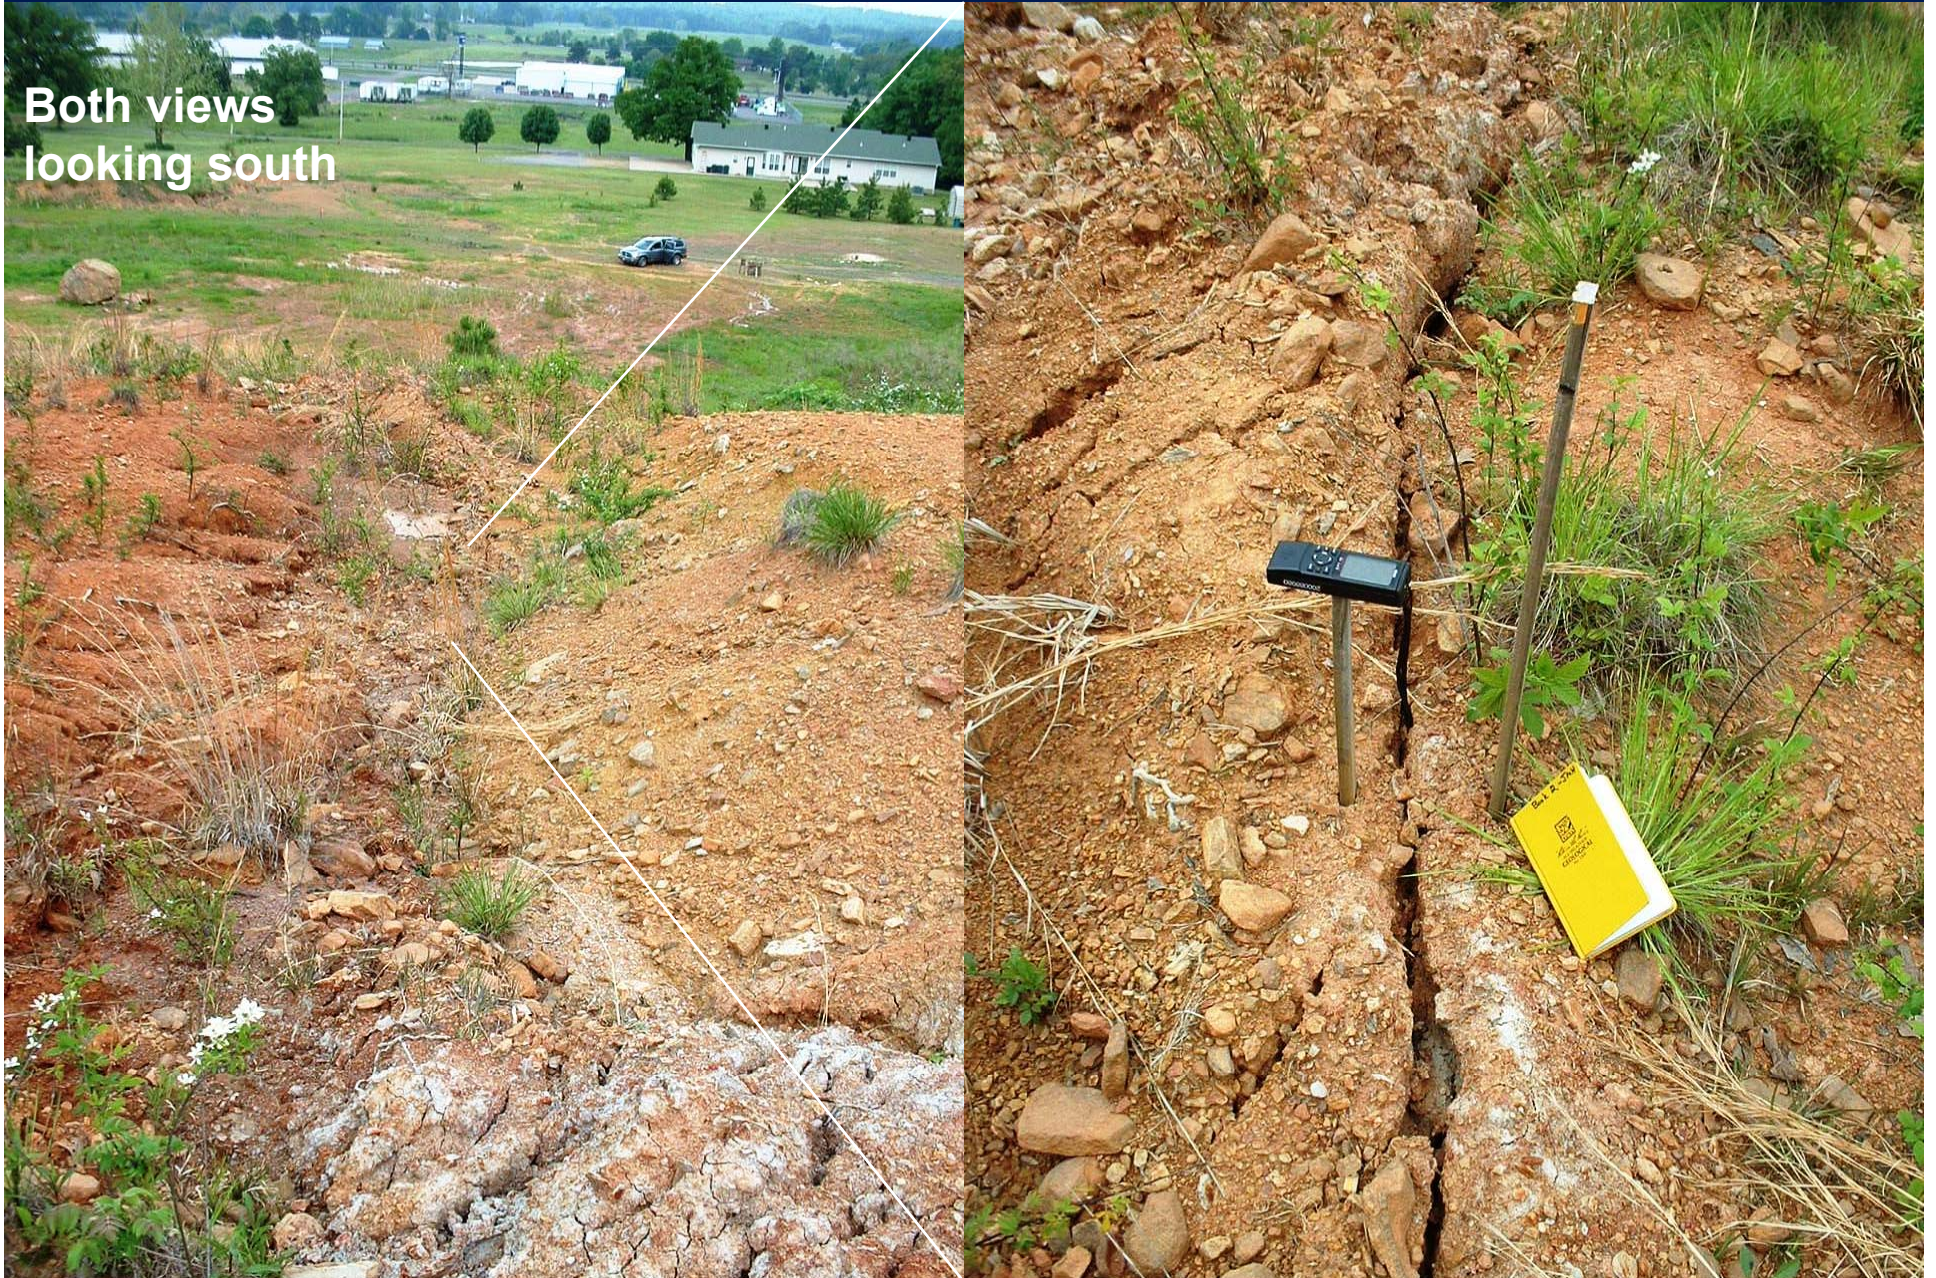
West edge new fracture

Close up with monitoring stakes in place
