## Richland Creek Road Landslide

Angela Chandler and Erica Doerr  
Arkansas Geological Survey  
2008

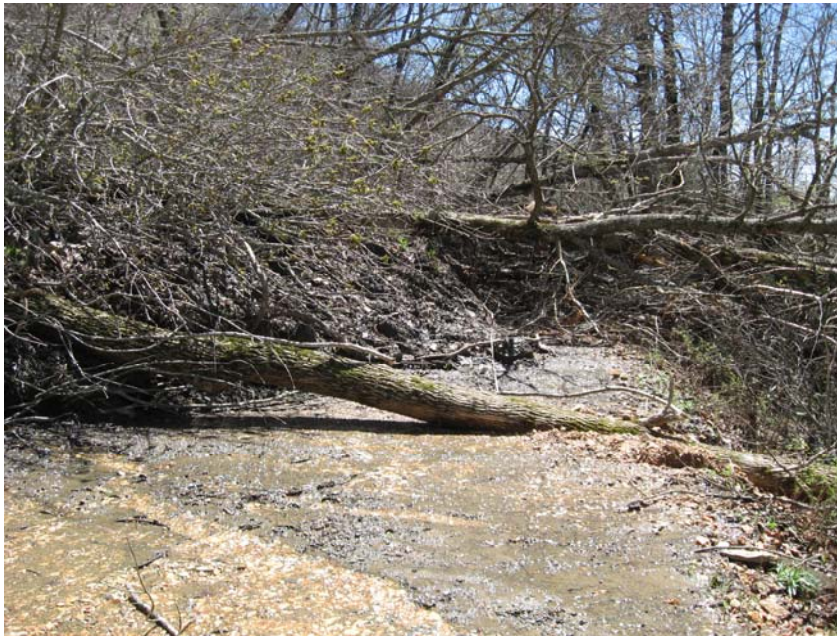
A landslide occurred along Richland Creek Road bordering Falling Water Creek in the Richland Creek Wilderness Area in response to a heavy rain event during the week of March 17, 2008. The landslide blocked the road (picture below) 2 miles north of the bridge over Falling Water Creek on the Moore 7.5-minute quadrangle. A short section of the Ozark Highlands Trail (between milepost 142 and 143) was displaced due to the slide as well.

View (north side) of landslide covering road. Notice water flowing from slide onto road.

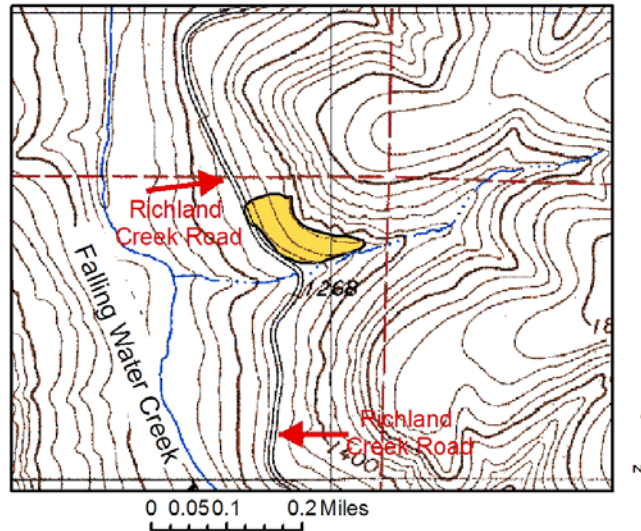
This picture illustrates the slide area (in yellow) on the Moore quadrangle (topographic base). The small Cane Hill bluff is present at the 1400 index contour above the slide.

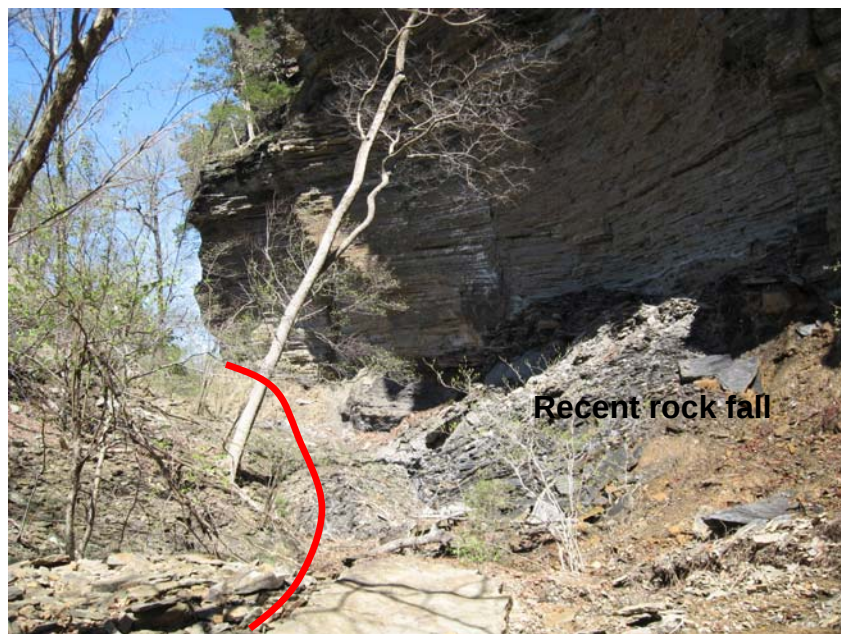
This landslide is likely the result of a combination of super saturation of the formation and excessive runoff. The small bluff above the head of the slide probably contained a number of waterfalls directed along joints into an area that previous moved (slid) away from the bluff line (see pictures below).

Cane Hill bluff over which several waterfalls probably poured over onto shaly interval. Red line shows head of old slide scarp.

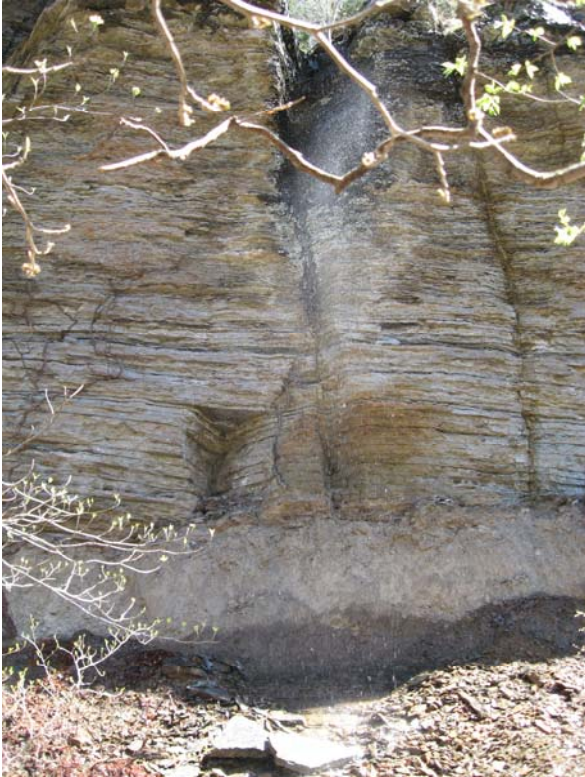
This photo shows well developed joints in the small Cane Hill bluff above the slide. A small waterfall is pouring over the bluff via the joint.

Much of the water probably went into the rock formation traveling along joints and bedding planes thus saturating the shale on the slope below the bluff. Eventually the amount of water became so great that a small stream developed near the base of the bluff and flowed southward becoming the southern boundary of the slide area.

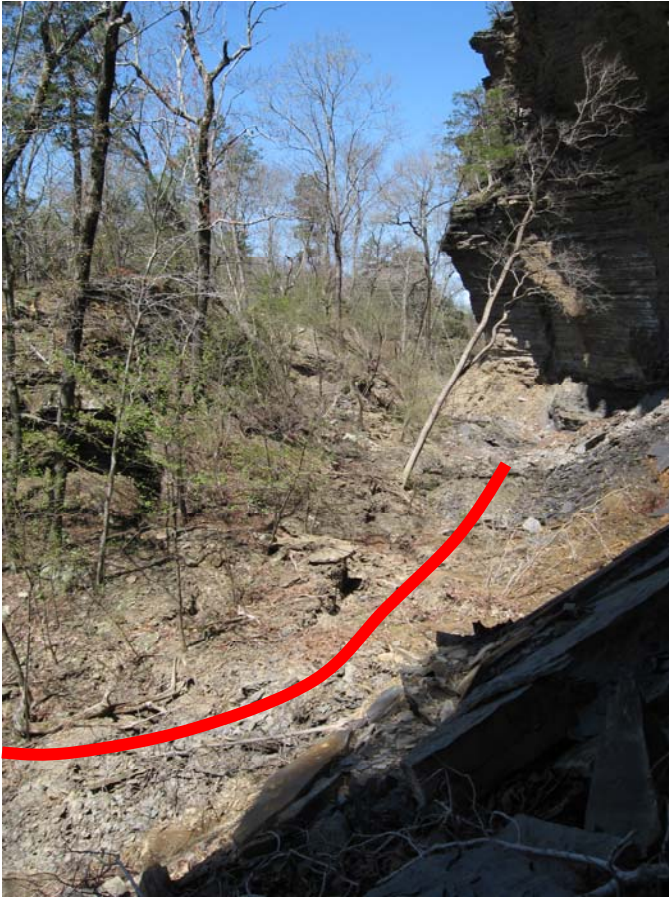
This photo shows where runoff developed into a small stream (red line) at the base of the bluff then flowed downhill creating the southern extent of the slide. Ripple marks and small sand bars are present in this area below the bluff line.

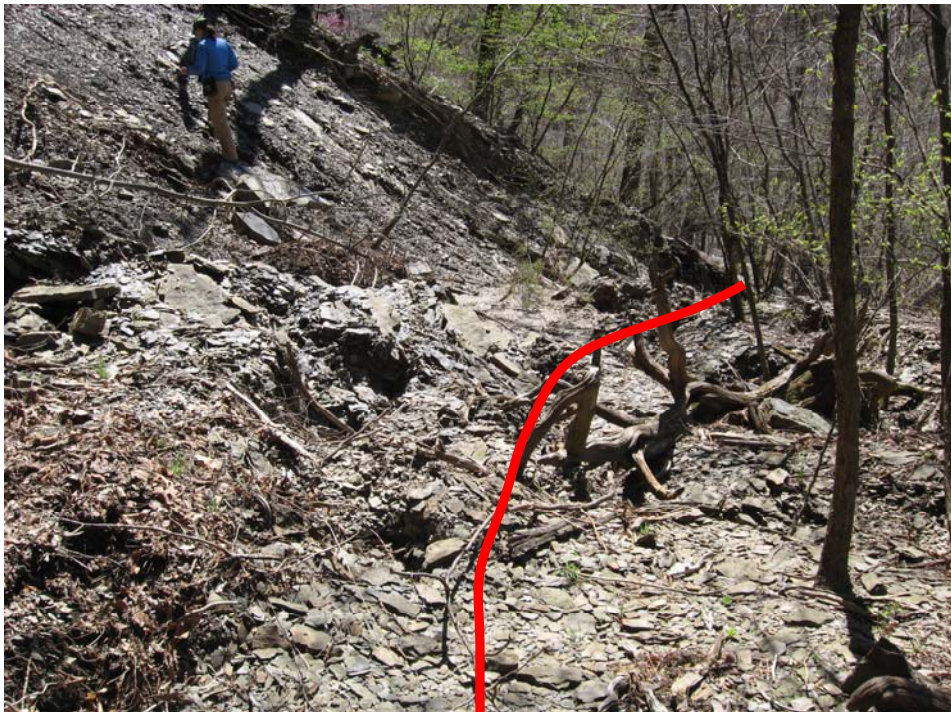
This photo displays the southern edge of the slide with the red line illustrating the path water flowed from below small bluff line.

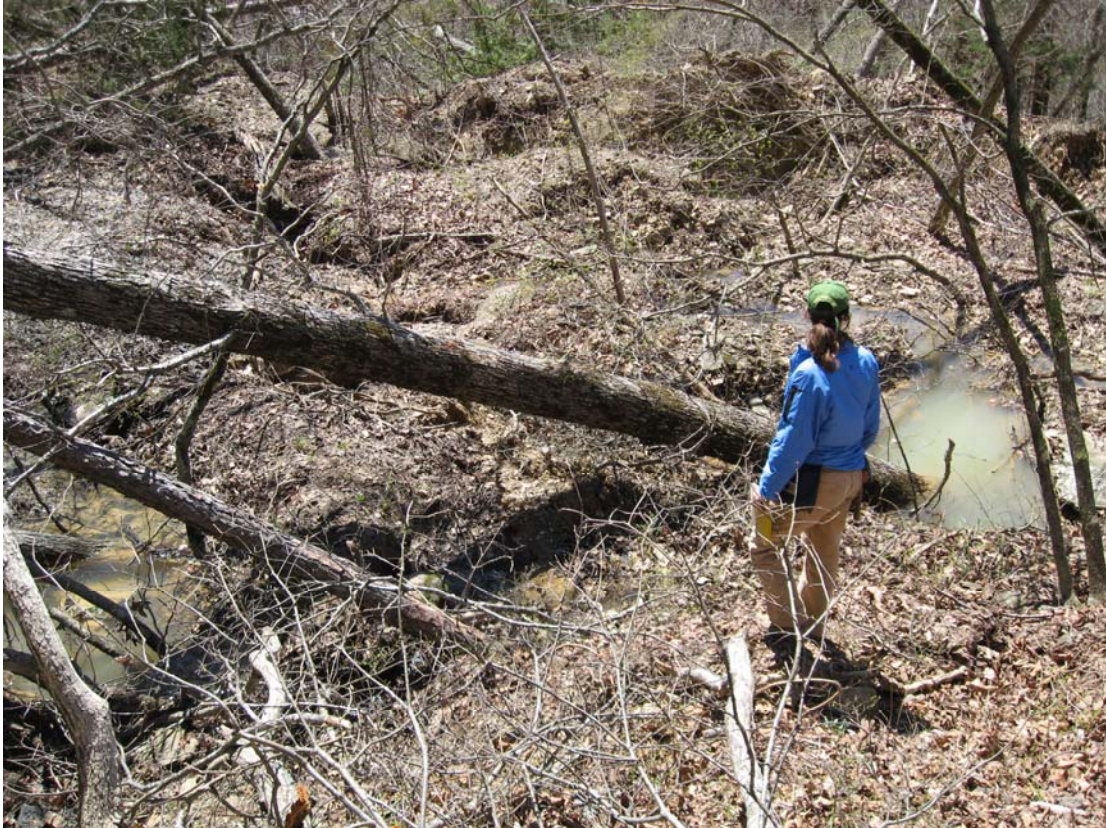
The rock formation continues to de water as can be seen by the pooling of water in portions of the slide and drainage from the toe of the slide onto Richland Creek Road.

Water pooling in the slide area.

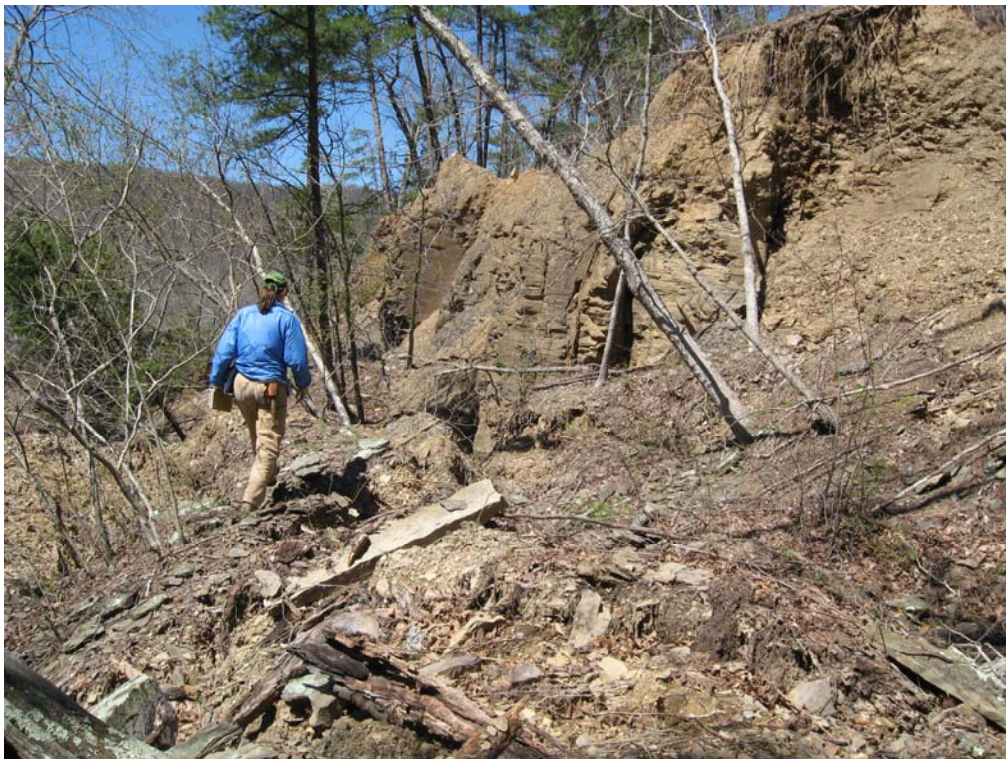
Cane Hill shale virtually in place within the slide.

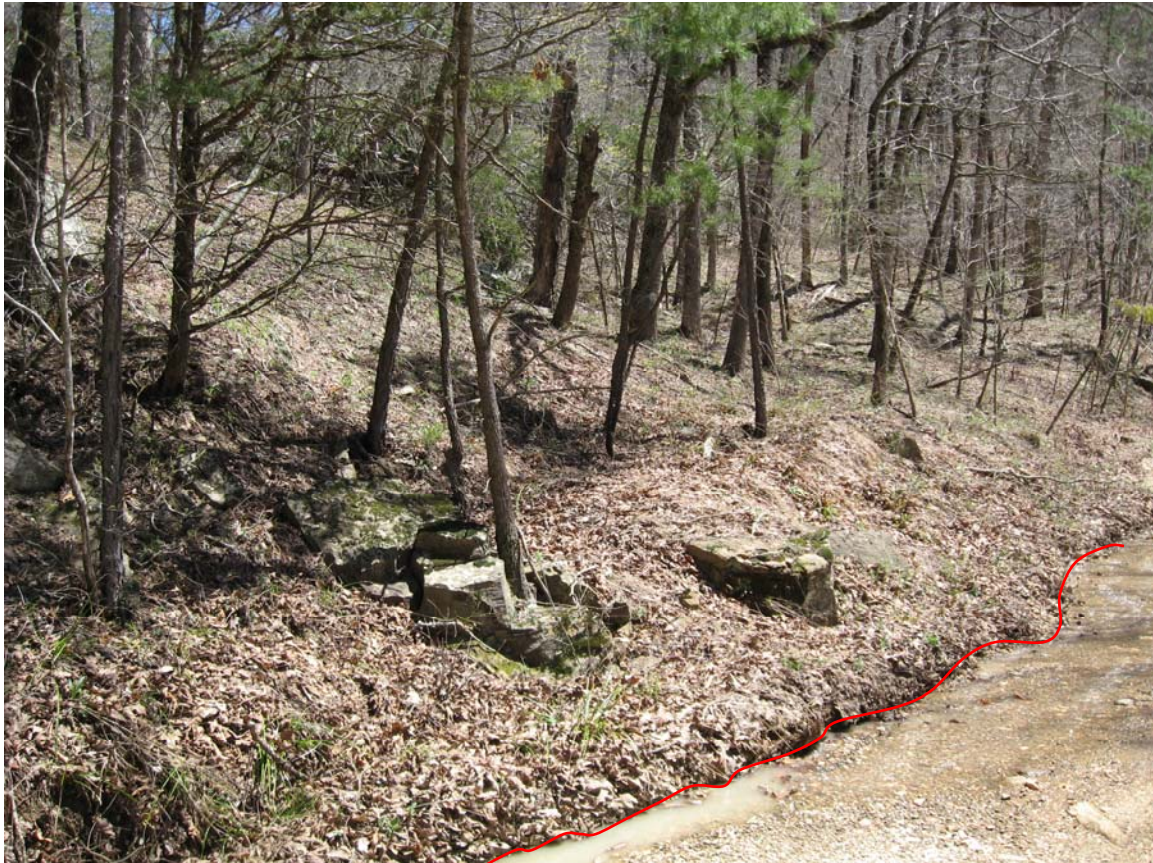
Several meters south of the landslide obstruction, a minor soil creep was developing and had advanced approximately 0.5-1 meter /2-3 feet onto Richland Creek Road between the debris obstruction and the drainage. Significant amounts of water were present, and water was pooling around the toe of the material, see picture below. South of the small drainage, more ground failure had occurred, and the likelihood for future ground failures in this area is probable.

This picture was taken approximately 30 feet from the major road obstruction.
