## The Duck Crusher Landslide Site

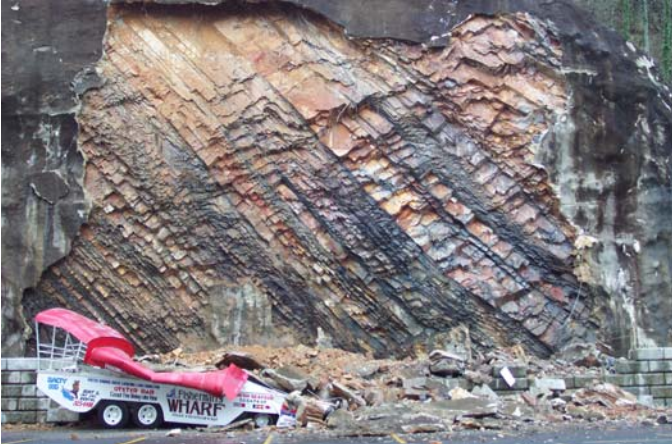
Gunnite collapse in 2005 that destroyed duck.

On the morning of January 29<sup>th</sup>, 2005, a rock fall occurred in the parking lot across the street from the Arlington Hotel (Fig 10 and 11A). Unlike other landslides in the area, this slide involved little, if any, of the natural rock outcrop. This fall was caused by the separation of gunnite (sprayed-on concrete) from the nearly vertical highwall at the back of the parking lot. In the pictures below, it can be noted that the failing gunnite was evident over a period. Fortunately, no one was injured or killed by this collapse. The gunnite was first employed in the 1950's as a means of mitigating the landslide issue.

Unfortunately, the gunnite has only created a greater problem. Gunnite seals some of the fracture and joint planes, preventing water from escaping. The trapped water will lubricate and weaken the joint planes, and can accelerate the landslide potential (McElwaine, 1966). Future rock failures are inevitable and visitors should think twice before using this parking facility.
